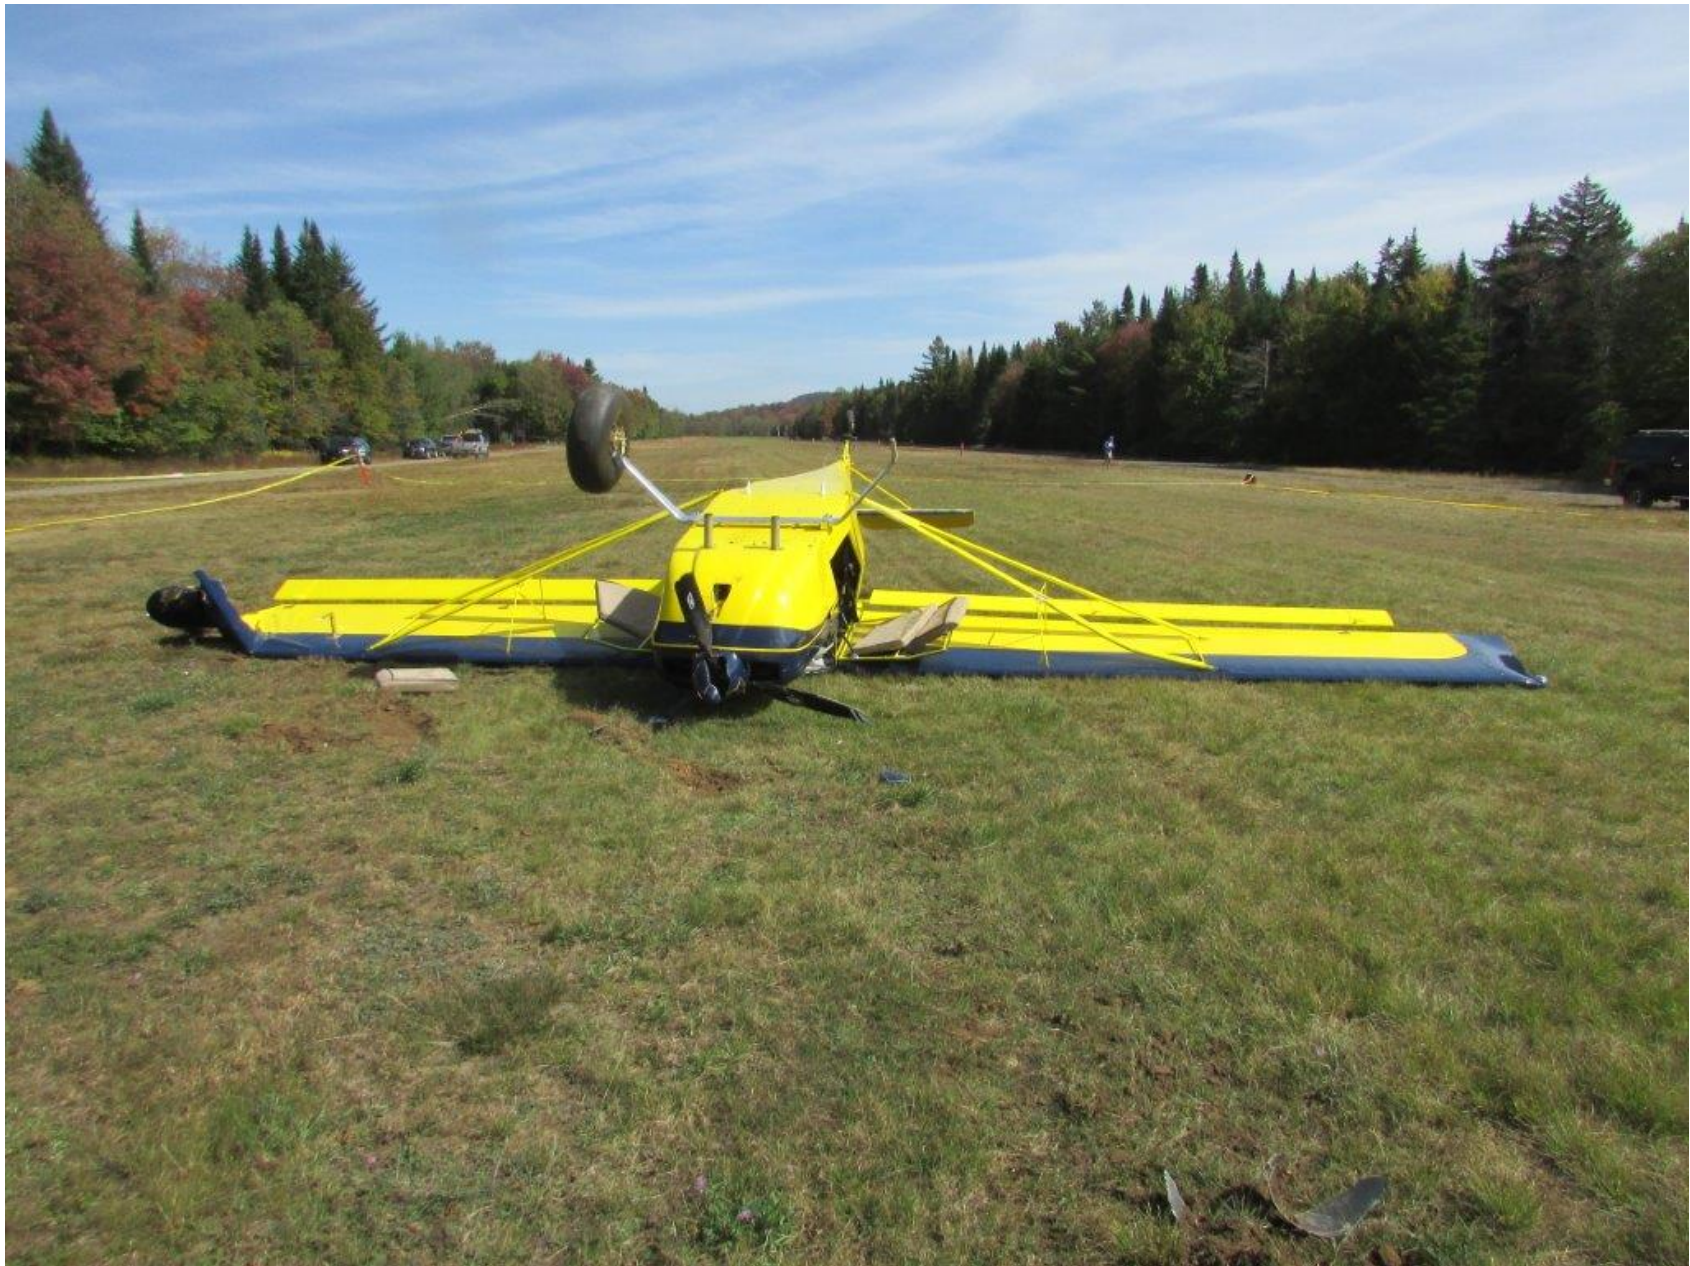
**Photo 1 – View of damage to the left wing and right-wing strut (Courtesy of FAA)**

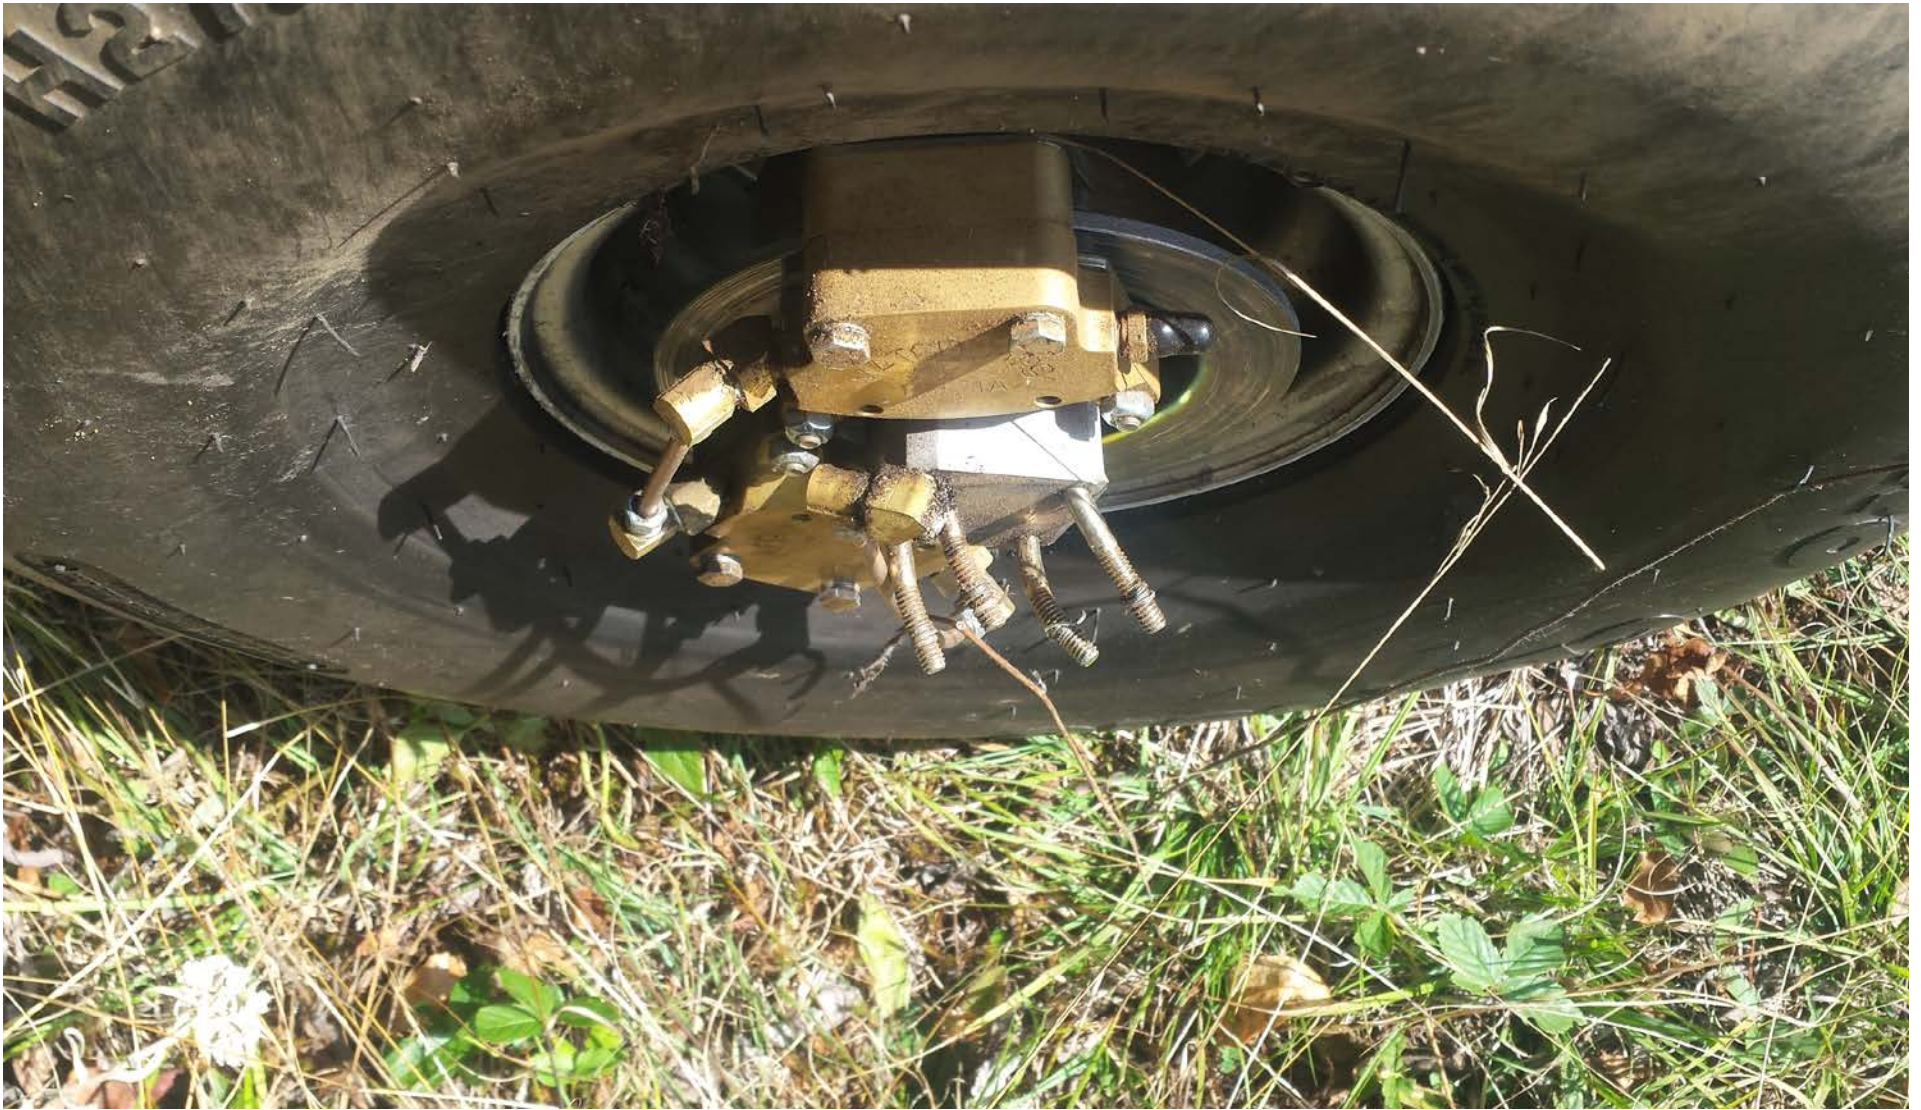
**Photo 3 – View of damage to the bolts that were not provided in the manufacturer’s kit (Courtesy of FAA)**
