NTSB Accident #GAA18CA458  
N608US Wreckage Distribution Sketch

8 AUG 2018

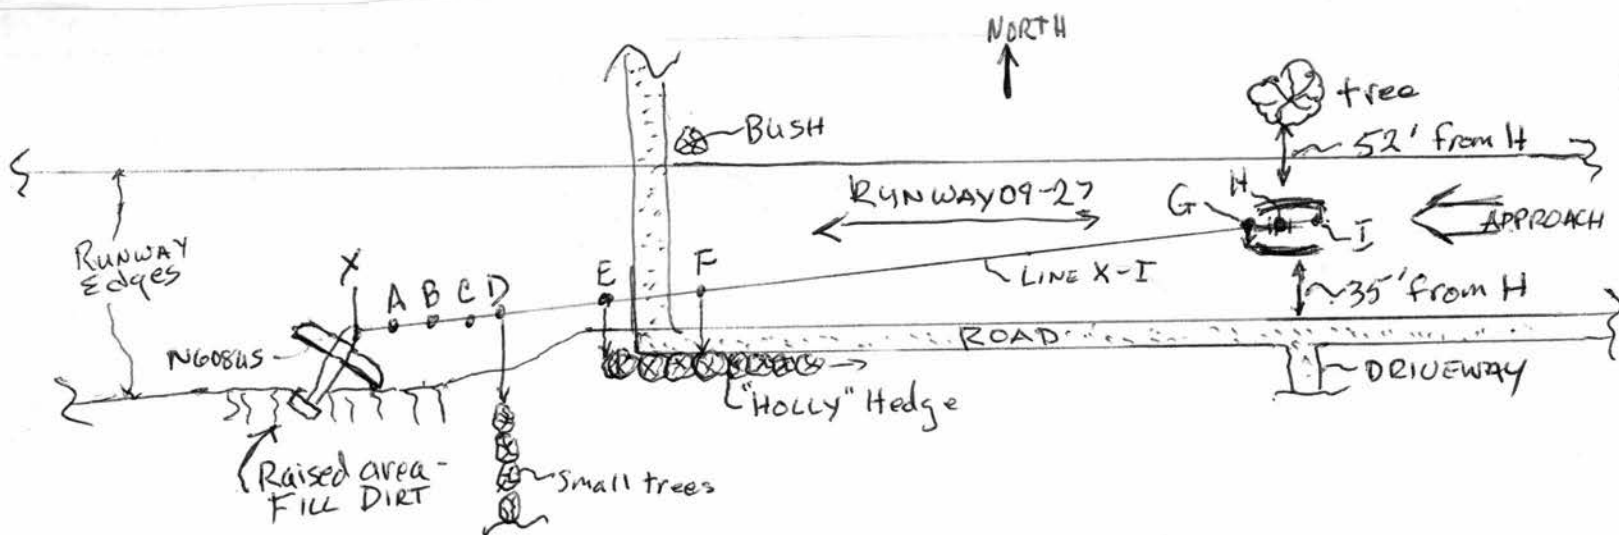
(NOT TO SCALE)

X - final resting point of aircraft. Measurements done from right nose area along a line X-I (from X to initial touchdown at point I).

A - Gouge in grass, probably from tail boom end, about 18.5 feet from X.

B - L-shaped Com antenna mounted on belly found impaled in ground, about 33.5 feet from X

C - Second touchdown/impact, part of one blade of prop found impaled in ground with nose wheel next to it, about 60 feet from X

D - Line of short trees/shrubs running southward from runway, 76.5 feet from X

E - End of "holly" hedge, 127 feet from X (not sure of exact name of plant, looks like some kind of holly)

F - Broken branches found in "holly" hedge, about 168 feet from X, about 5 feet up.

G - End of tire marks, about 500 feet from X.

H - Center of section of 4 prop strike marks, about 510 feet from X.

I - Beginning of rear tire marks, about 533 feet from X.

Runway has an east-west orientation, aircraft was landing from east (right in the sketch below),
