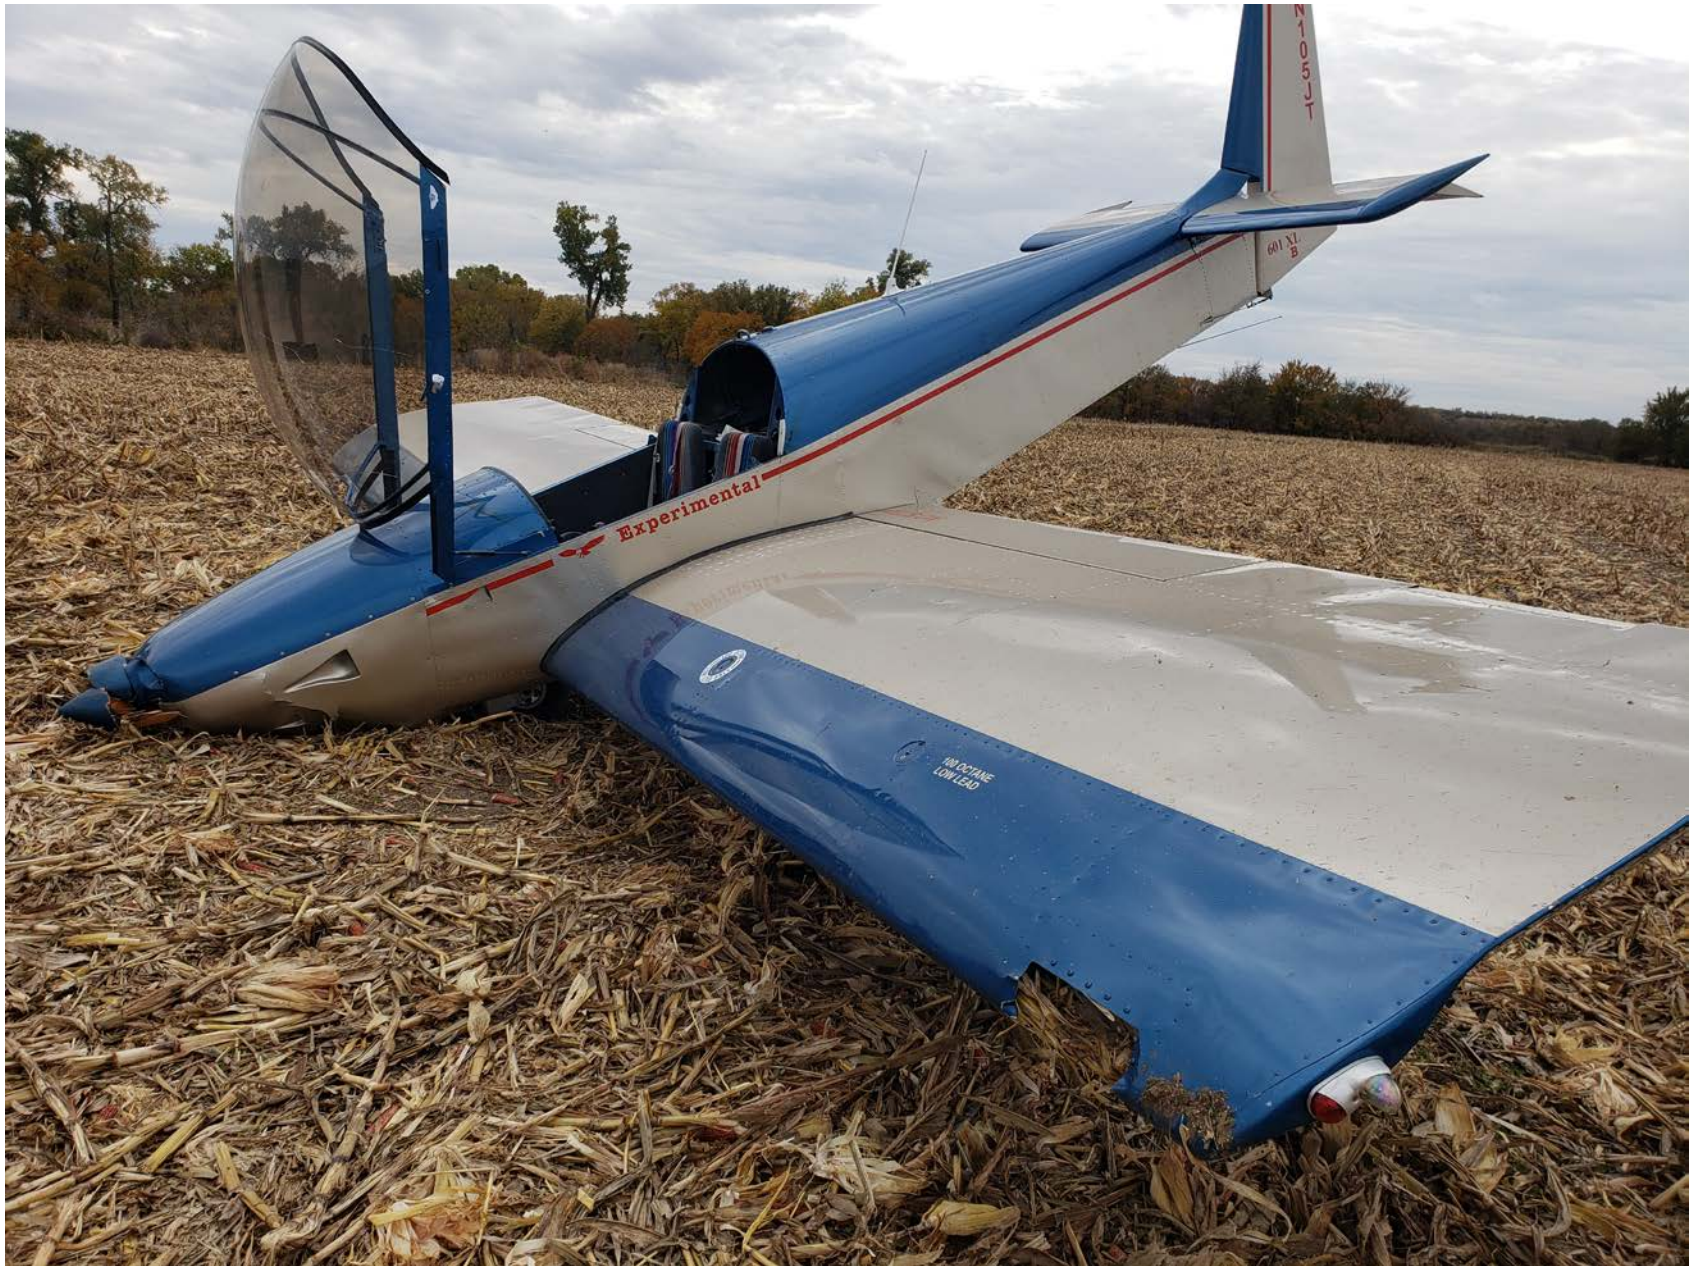
**Photo 1 – View of the airplane minus the nose landing gear (Courtesy of FAA)**

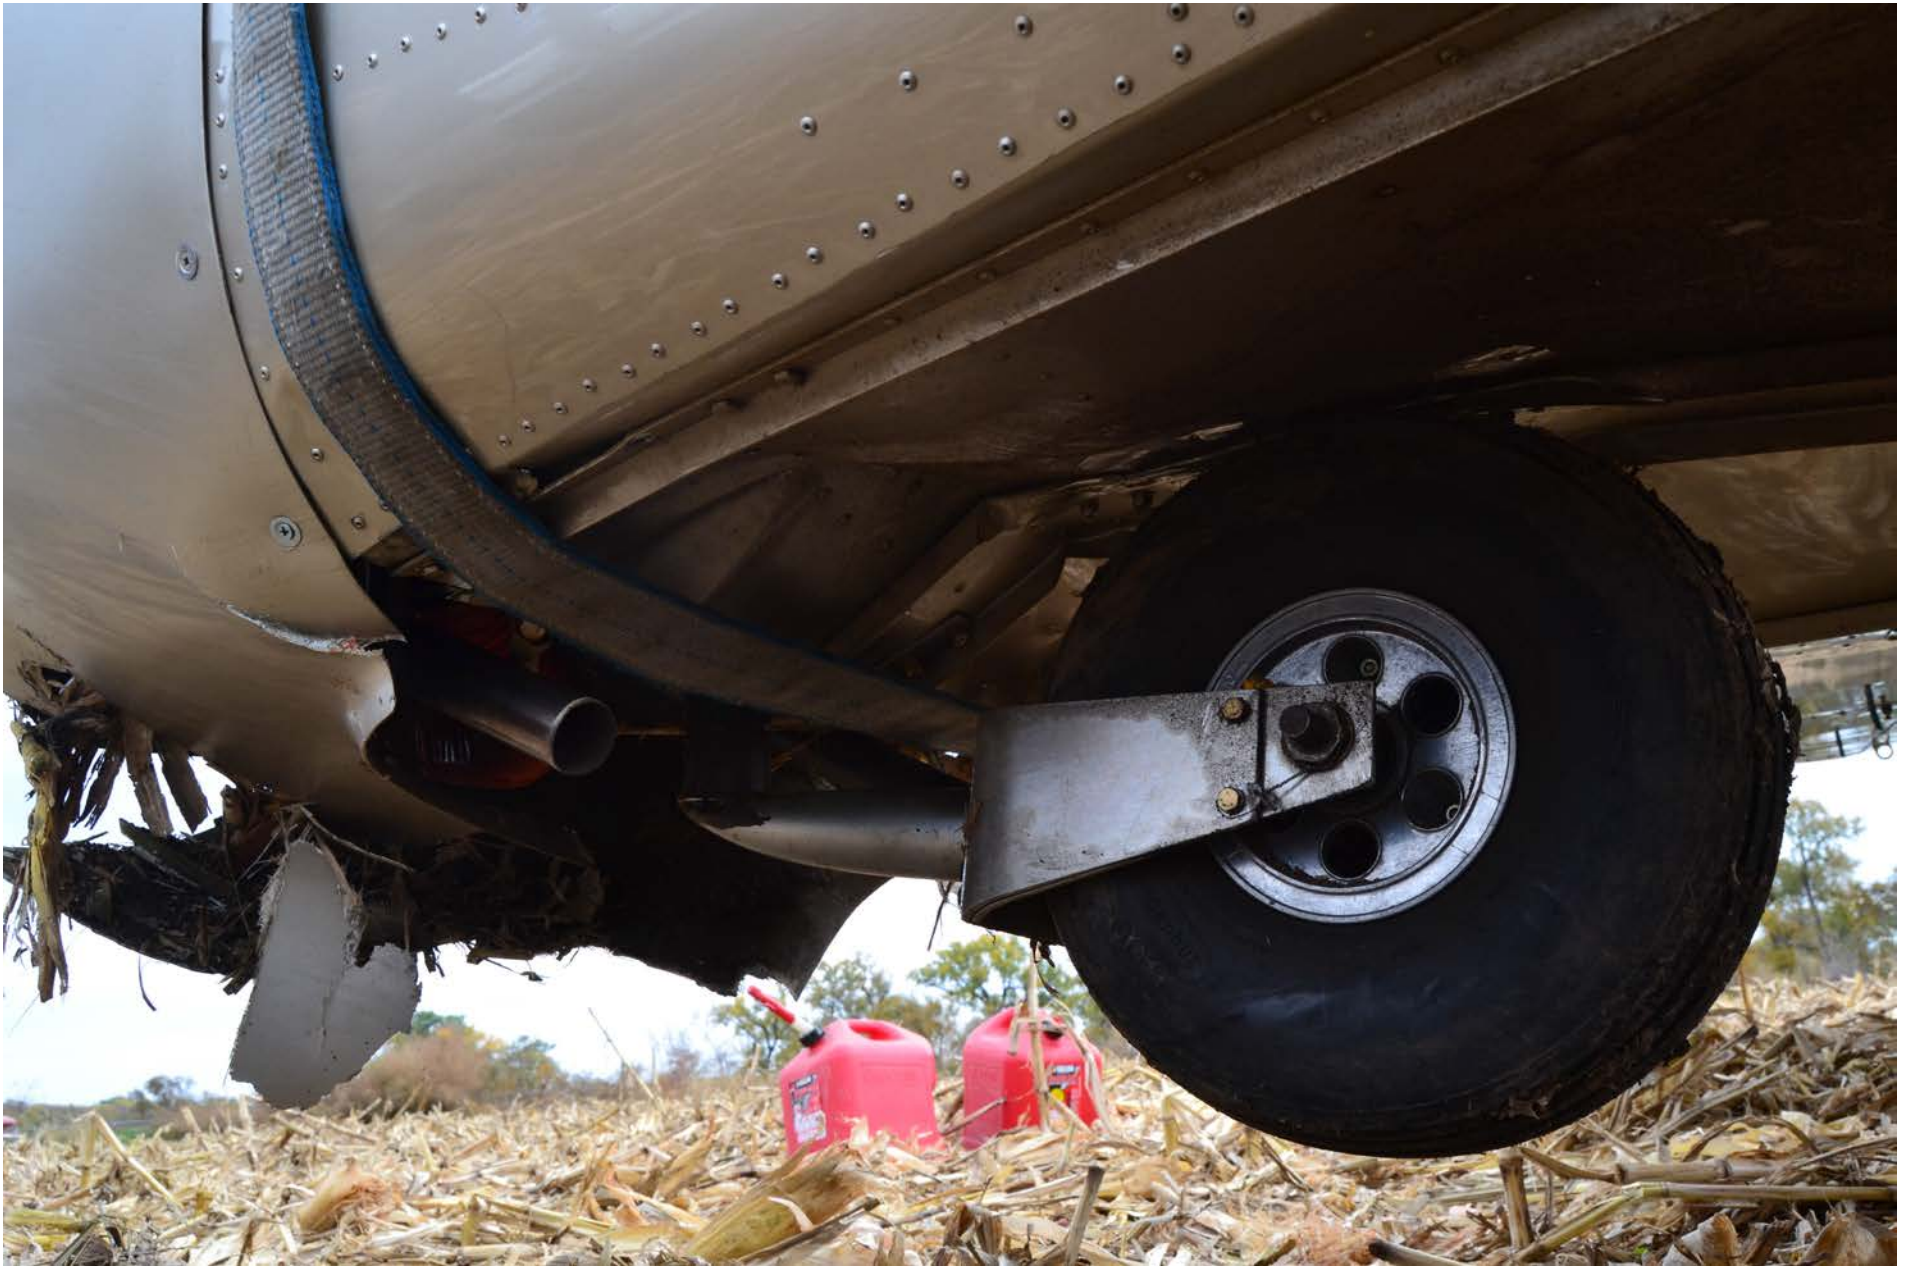
**Photo 2 – View of damage to the lower fuselage longerons (Courtesy of FAA)**
