## **Operational Safety Notice OSN2019-004**

### What **NOT** to do with Anti-torque Pedals

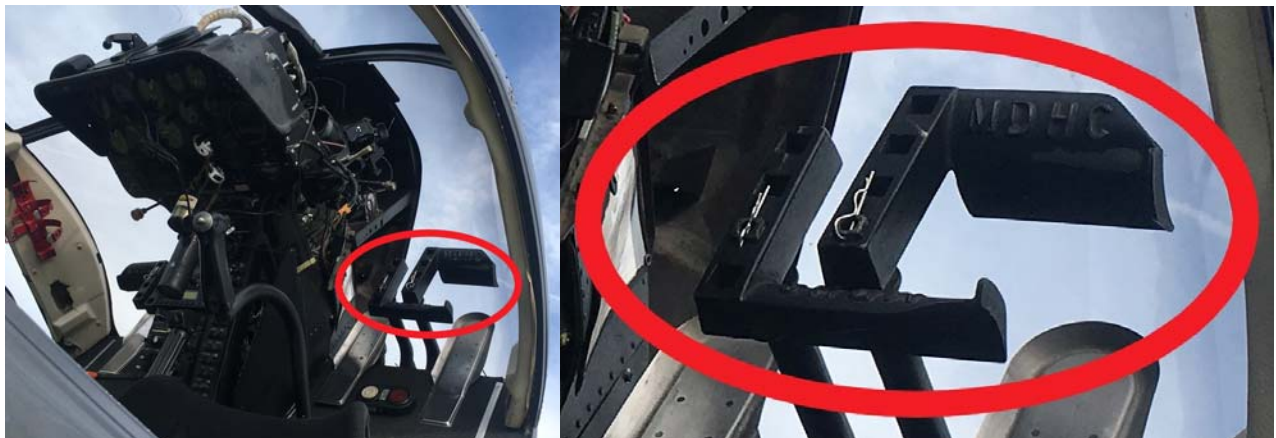
Previously, as the crew prepared to leave the aircraft, Pilot 1 removed his left-hand anti-torque pedal and reinstalled it 180 degrees from its original position, effectively blocking the travel of both anti-torque pedal assemblies.

As Pilot 2 lifted off, control of the aircraft was lost, the tail hit the ground, and the aircraft was substantially damaged, but luckily, the pilot was not injured. Pilot 2 was unaware that Pilot 1 had “locked” the anti-torque pedals on the right-hand side of the cockpit.

Locking the anti-torque pedals in this manner is not an MDHI-approved procedure, and may result in substantial aircraft damage and potential pilot injury. Before takeoff, always check that all flight controls are free and correct.
