**NATIONAL TRANSPORTATION SAFETY BOARD**  
Vehicle Recorder Division  
Washington, D.C. 20594

## **Personal Electronic Device (PED)**

**Specialist's Factual Report**  
**By Sean Payne**

Location: Carey, Idaho  
Date: July 2, 2015  
Aircraft: Piper PA-22  
Registration: N8195C  
Operator: Private  
NTSB Number: WPR15FA206

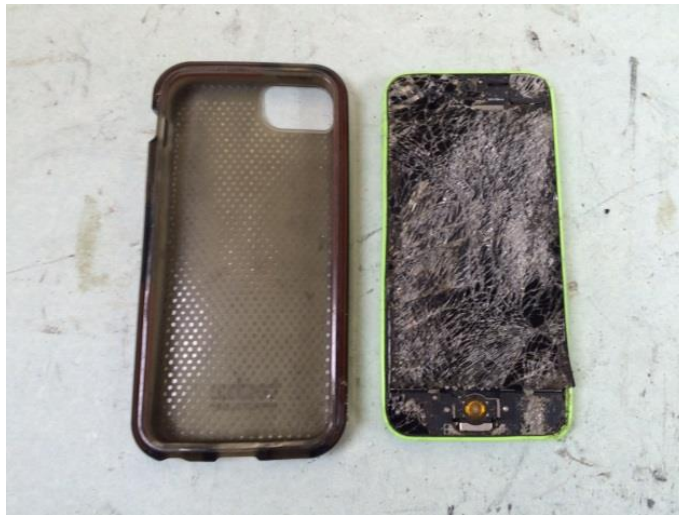
**Figure 1. Exterior of iPhone 5c.**

The iPhone 5c was delivered to the lab and exhibited significant impact damage. The unit's touchscreen display was non-functional and is shown in figure 1. The device's screen was removed and the internal circuitry was examined (figure 2). The examination revealed the internal circuitry was slightly damaged but potentially recoverable. Figure 3 shows the device's main circuit board after cleaning and removal. The main circuit board was installed in a surrogate iPhone 5c and was able to successfully boot. Figure 4 shows the remnants of the destroyed iPhone 5c (left) next to the laboratory surrogate iPhone 5c functioning with the accident pilot's damaged circuit board (right).

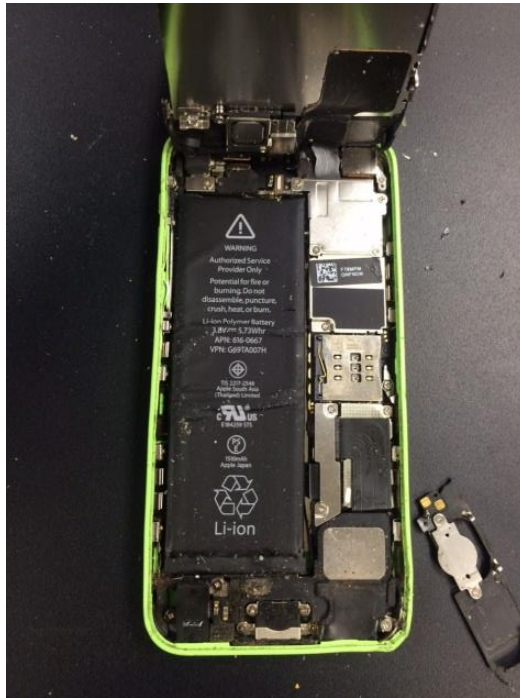
**Figure 2. The iPhone 5c with the screen removed.**

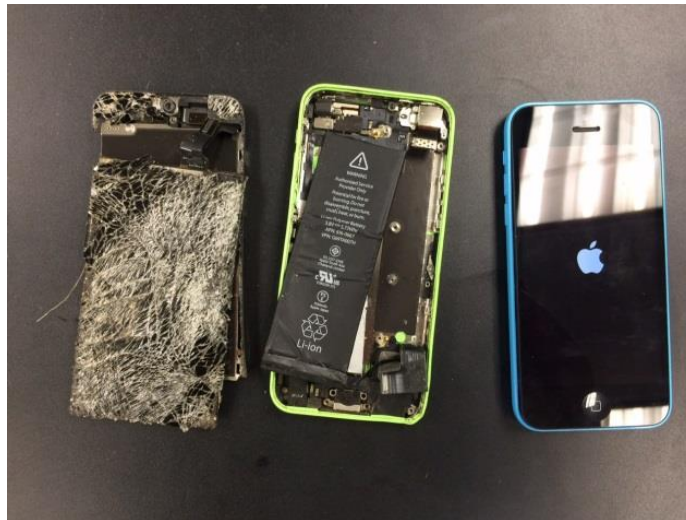
**Figure 4. The NTSB surrogate device (right) booting with the accident device's circuitry installed.**

The surrogate device functioning with the accident device's circuitry was then connected to a Macintosh computer running forensic examination software; its contents were downloaded and documented for this report.
