**NATIONAL TRANSPORTATION SAFETY BOARD**  
Vehicle Recorder Division  
Washington, D.C. 20594

## **Engine Data Monitor (EDM)**

**Specialist's Factual Report**  
**By Douglas Mansell**

Location: Llano, California  
Date: August 27, 2015  
Aircraft: Piper PA-25-260  
Registration: N4369Y  
Operator: Southern California Soaring Academy  
NTSB Number: WPR15FA250

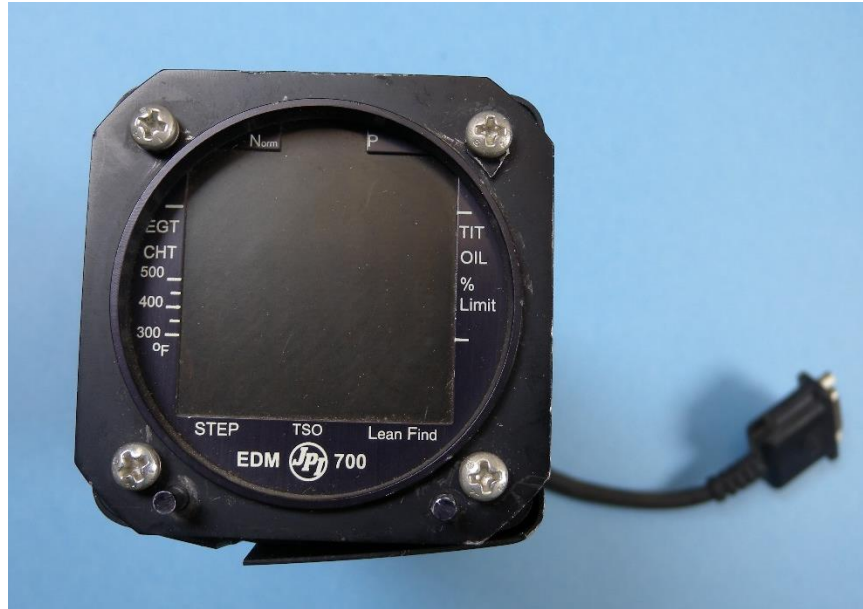
**Figure 1. Damaged exterior of device, front view.**

The recorder was damaged in the accident, preventing subsequent normal operation and data download capability from the device. The extent of the damage is shown in figures 1 through 3. Data was recovered by removing the appropriate memory chips from the circuit board assembly, and decoding the raw data that was stored on the chips.

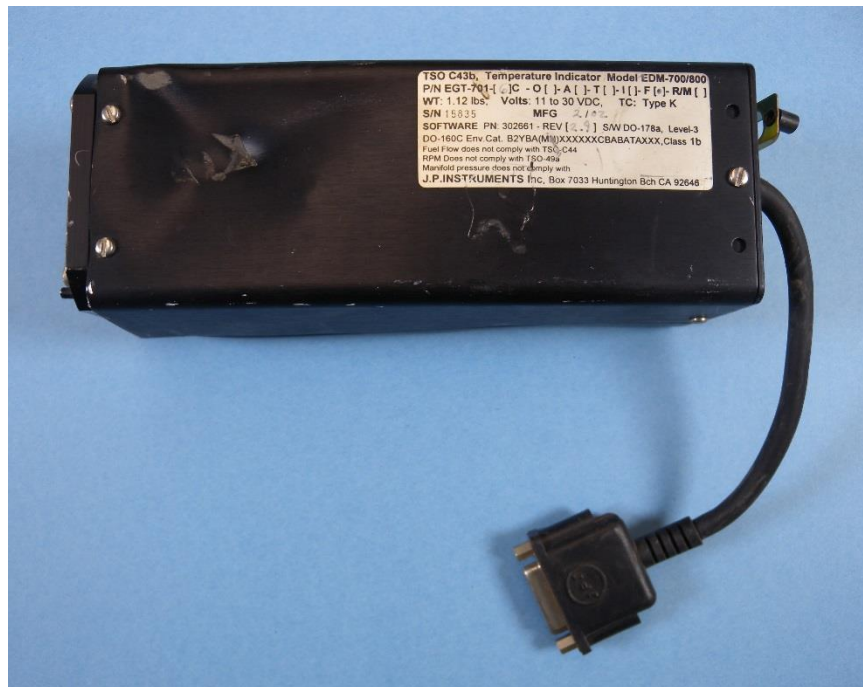
**Figure 2. Damaged exterior of device, side view.**

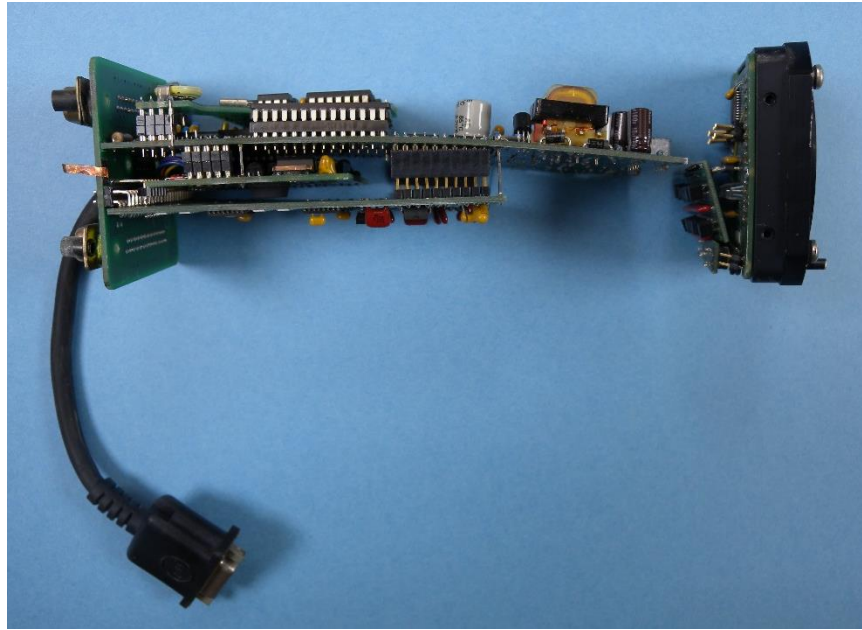
**Figure 3. Damaged interior of device, side view.**

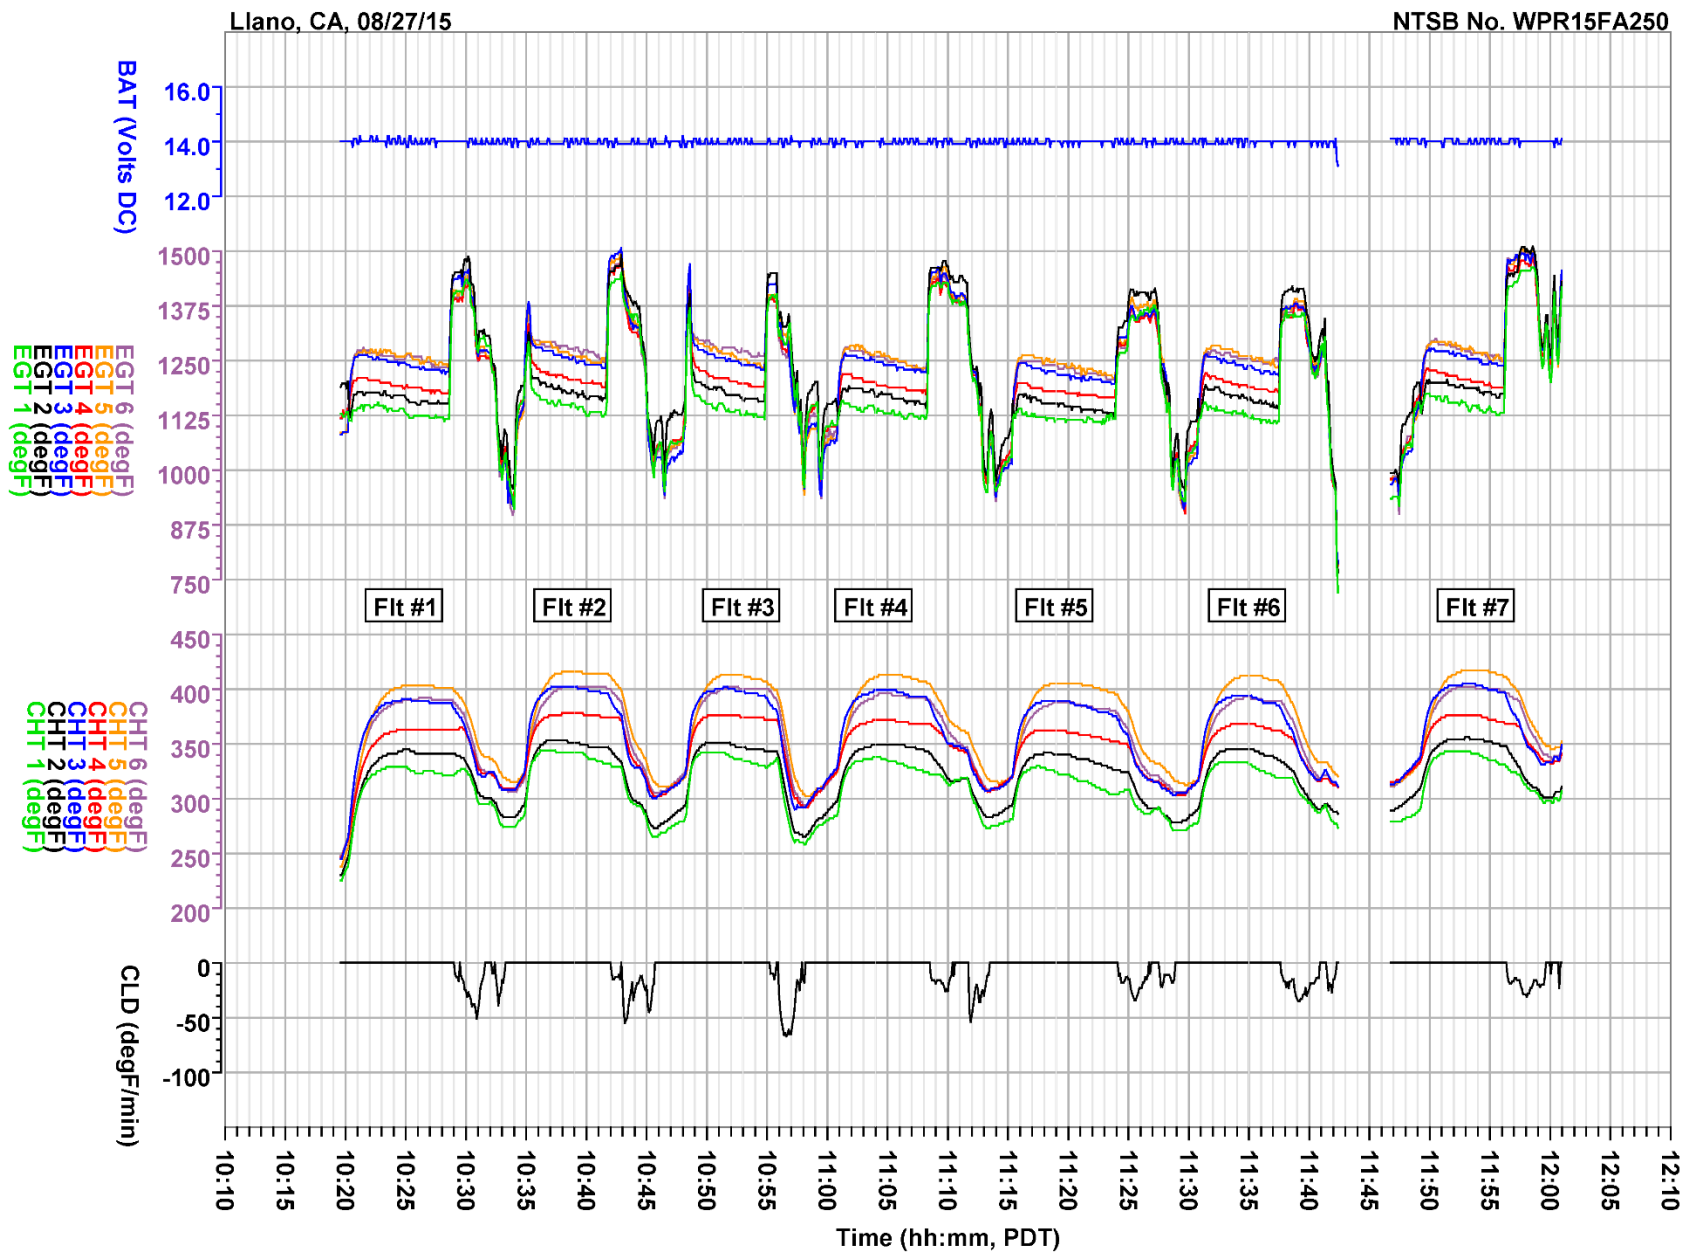
Figure 4. Plot of engine parameters.

Figure 4 shows engine data recorded during the flights conducted on August 27, 2015, beginning about 1020 PDT. Annotations indicate the cumulative flight count for the day; the accident occurred at the end of the seventh flight. The corresponding tabular data used to create the plot are provided in electronic (\*.csv) format as attachment 1 to this report.

The EDM records time based on the unit's internal clock. Date and time is set by the user, and is not slaved to an external time source. By comparing EDM data to airplane flight records from the days leading up to, and including, the accident flight, the EDM time was determined to be approximately 12 hours ahead of PDT<sup>2</sup>. Tabular data and plots provided in this report reference PDT.
