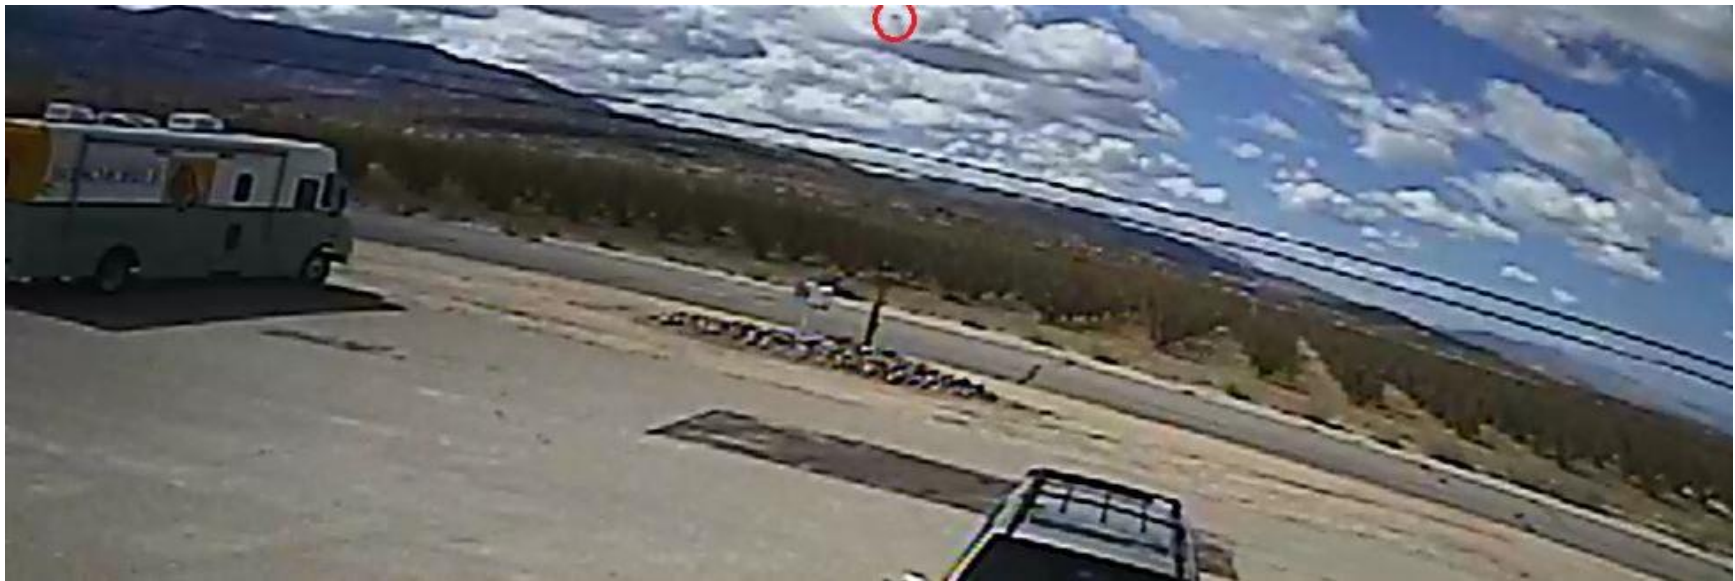
In an effort to calculate the tow planes flight path relative to the standard traffic pattern, a series of flight tests were performed utilizing SCSA's second PA-25 tow plane. It completed multiple takeoffs and landings to and from runway 7, while both cameras were recording. Review of the footage revealed that while flying the standard pattern and altitudes, the airplane was above Camera 5's field of view for most of the approach, becoming briefly visible at the top center for about 5 seconds as it transitioned from the base to final leg. The circled feature above was recorded by Camera 5, and is the second PA-25 transitioning from base to final approach leg for landing on runway 7.
