# Fleet Campaign Directive

17-7310-FCD-1320

Inspection fuel line B Nut, checking for torque and leakage

**Effectivity:** All AMC owned/operated EC130 T2s**Complete By:** 48 hours (2 days) after the release of this FCD.

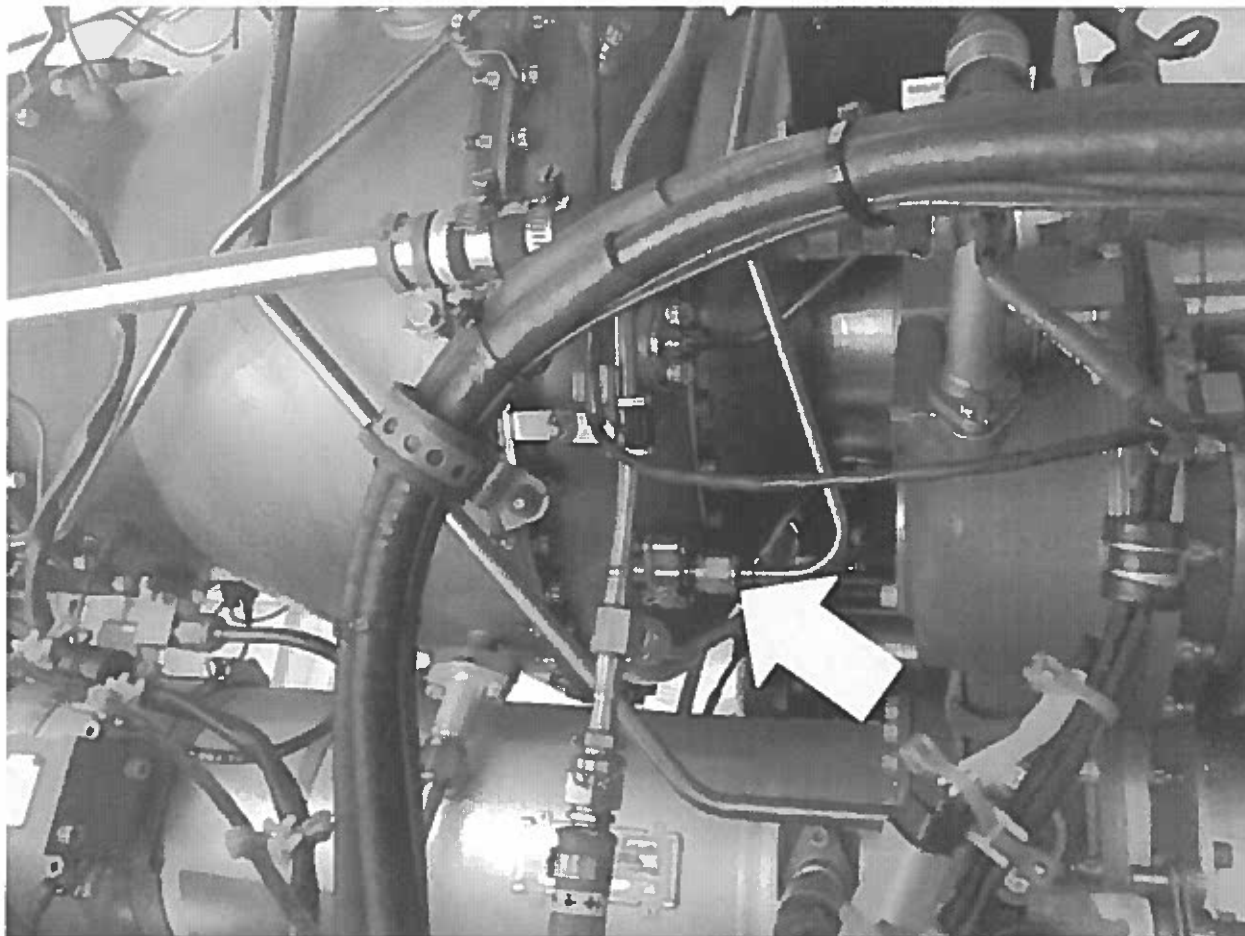
**Figure 1** B Nut installed on Fuel Jet Union

| Step | Work Instruction | Mech /Insp |
|---|---|---|
| 1 | <p>Disconnect the lower B Nut from the Main Fuel Manifold Supply Pipe (line), and visually check for cracks. (Fig 1 and 2)</p> <p>Record findings:</p> <p><input type="checkbox"/> Signs of crack(s) were found:<br/>Describe: _____</p> <p><input type="checkbox"/> No visible signs of crack(s) were found</p> <p>If any signs of cracks were found, remove and replace per MM. (Ref A)</p> | |
| 2 | Reinstall and re-torque B Nut to 124 inch-pounds per MM. (Ref A) | |

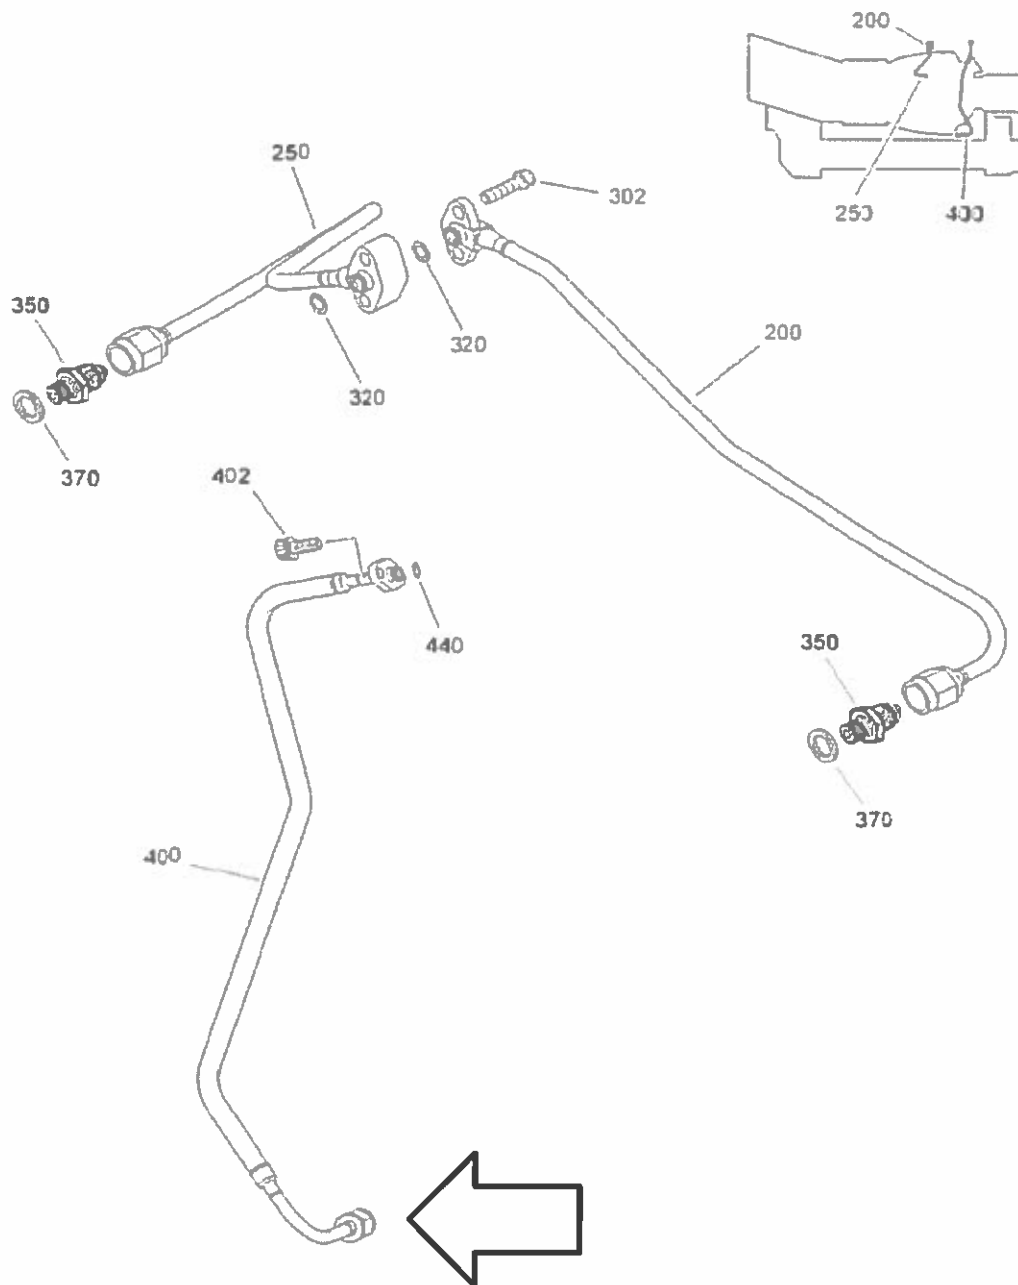
Fig 2 Arriel 2D Fuel Pipe Installation
