## Starter/Generator bearings examination

### Final report

Accident on **17/01/2016**  
in **Hanalei (Hawaii)**  
to the **Rotorcraft EUROCOPTER - EC130**  
registered **N11VQ**  
operated by **Blue Hawaiian Helicopters**

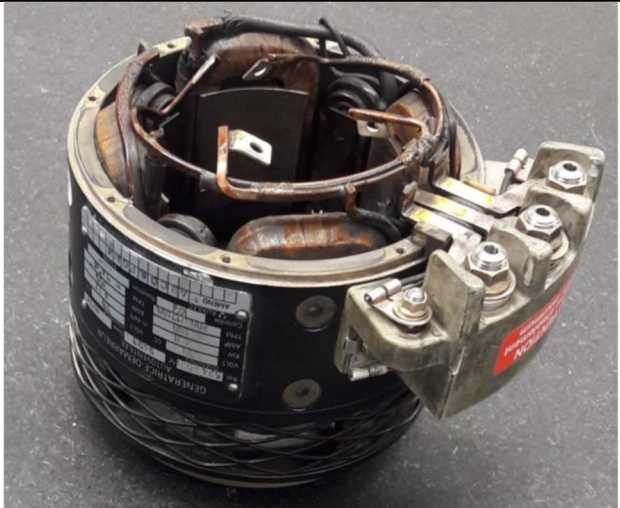
| | <div>Starter/Generator</div> |
| Manufacturer | Thalès |
| Part number | 524-031 |
| Serial number | 5493 |

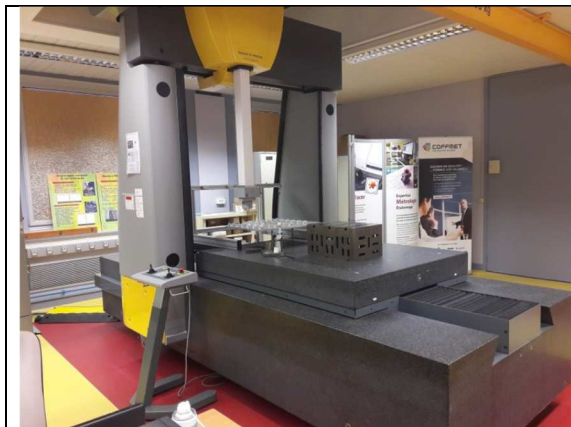
Coordinate measuring machine Leitz PMM

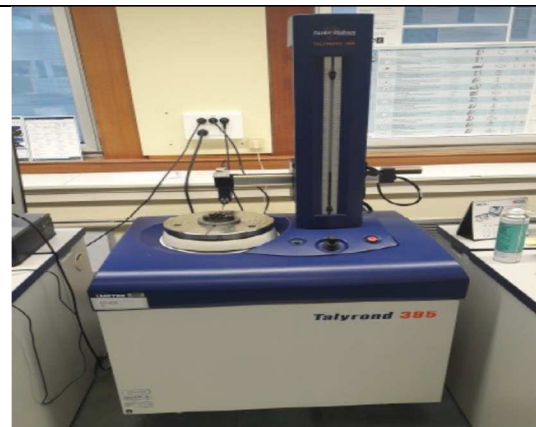
Roundness measuring instrument TAYLOR HOBSON
