## **NATIONAL TRANSPORTATION SAFETY BOARD**

### **FUEL SYSTEM EXAM REPORT**

WPR16FA091

Aircraft: Nokes Matthew Lancair IV P, Registration Number: N438Y, Serial #: LIV-298

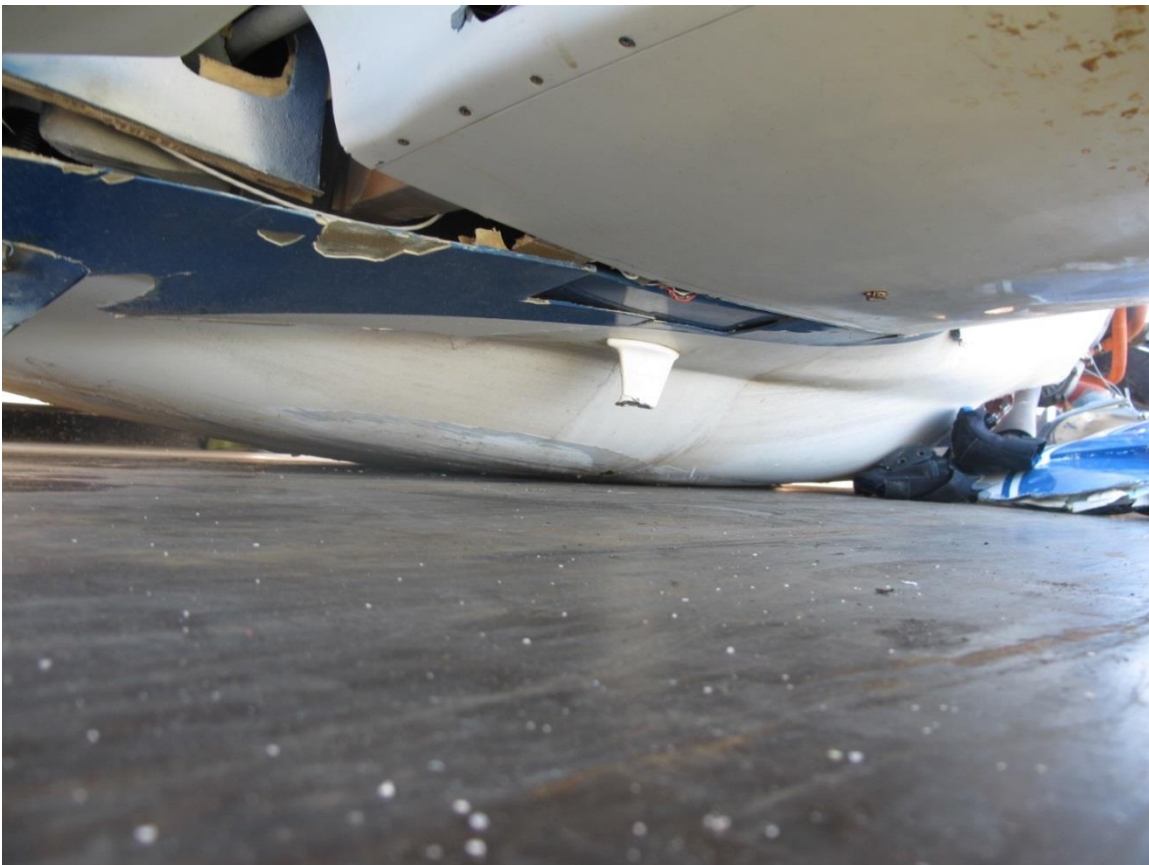
**Photo 1 Belly Tank**

The airplane was equipped with an external belly tank. The belly drain was scraped, ground down, and breached.

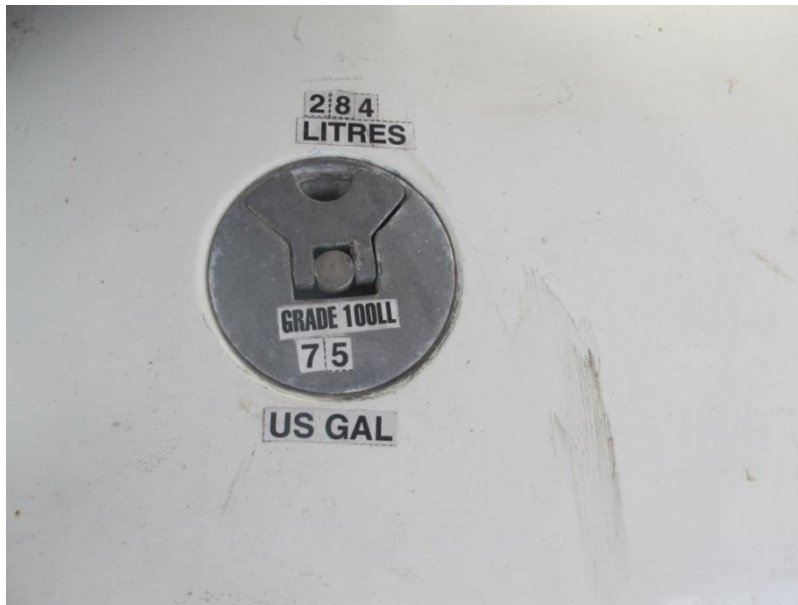
Photo 2 Left Wing Tank Markings

The markings on the left wing indicated a quantity of 75 gallons; the right wing indicated 52 gallons.

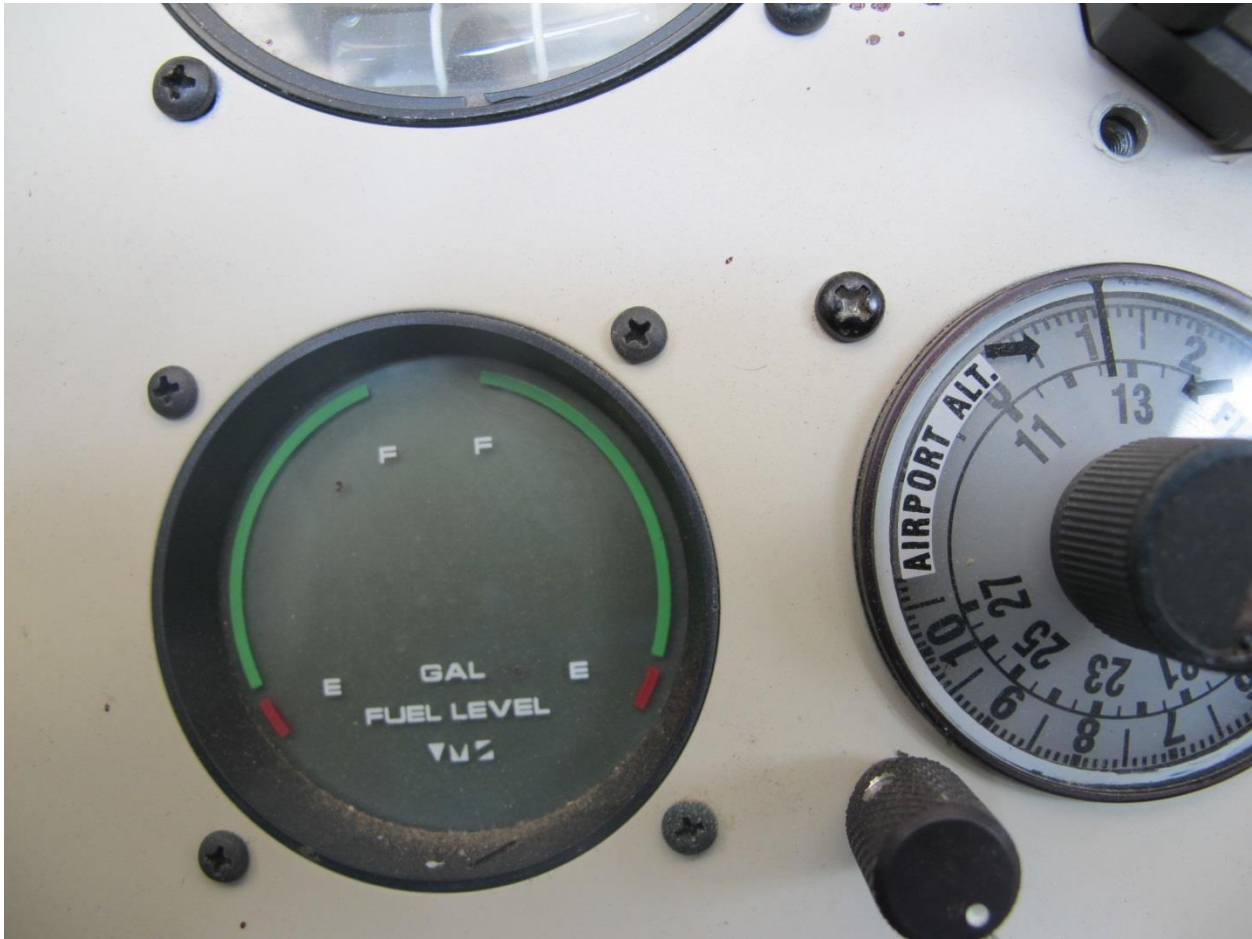
Photo 4 Fuel Quantity Gauge

The fuel quantity gauge had two indicators.

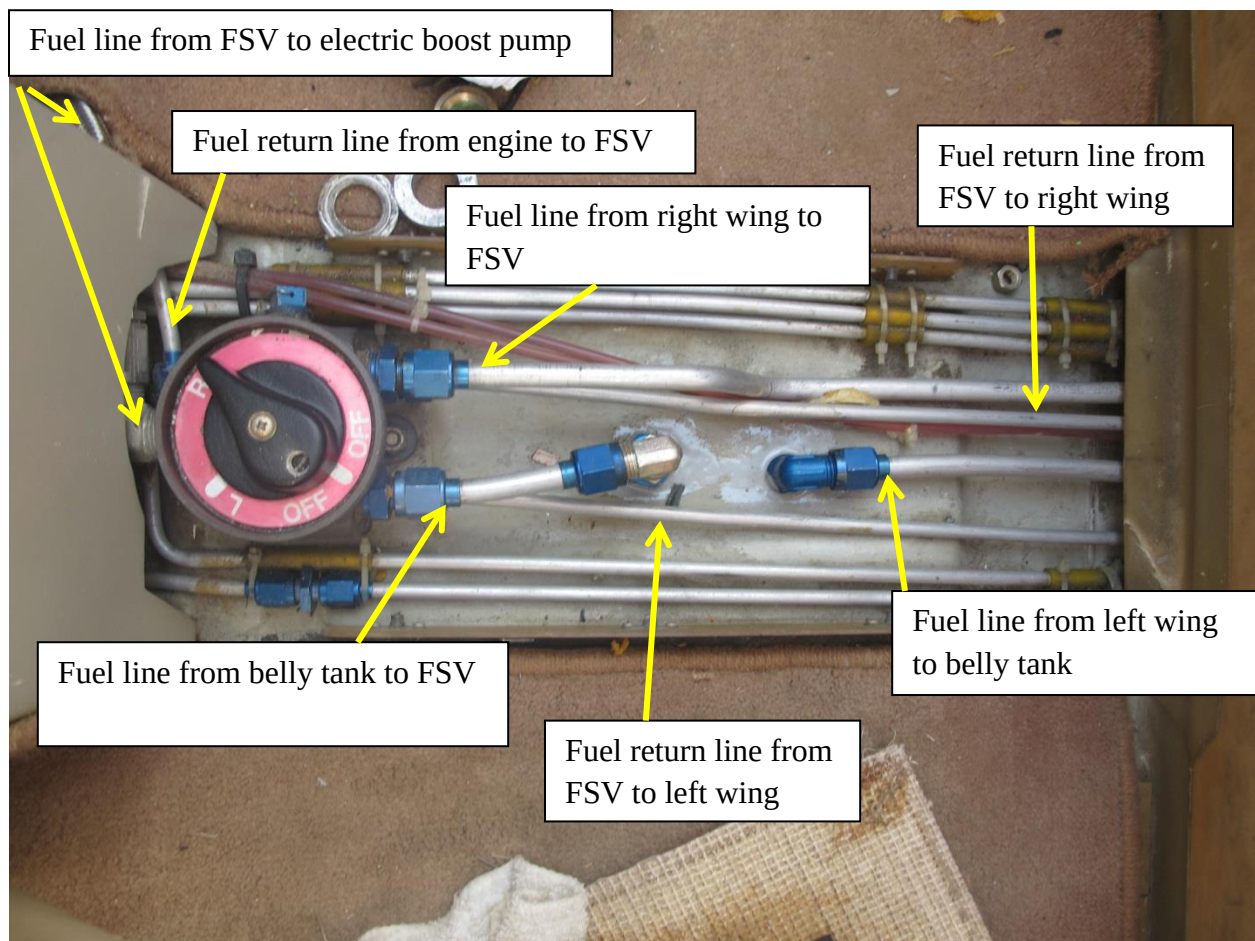
Photo 5 Fuel Lines

The fuel selector valve (FSV) was labeled L, R, and OFF/OFF. The fuel line from the left wing fuel tank was connected to the belly tank, which in turn was connected by a separate line to the FSV. The right wing tank fuel line connected directly to the FSV. The return line from the engine was connected directly to the FSV, which had a separate line going directly to each (left and right) wing fuel tank.

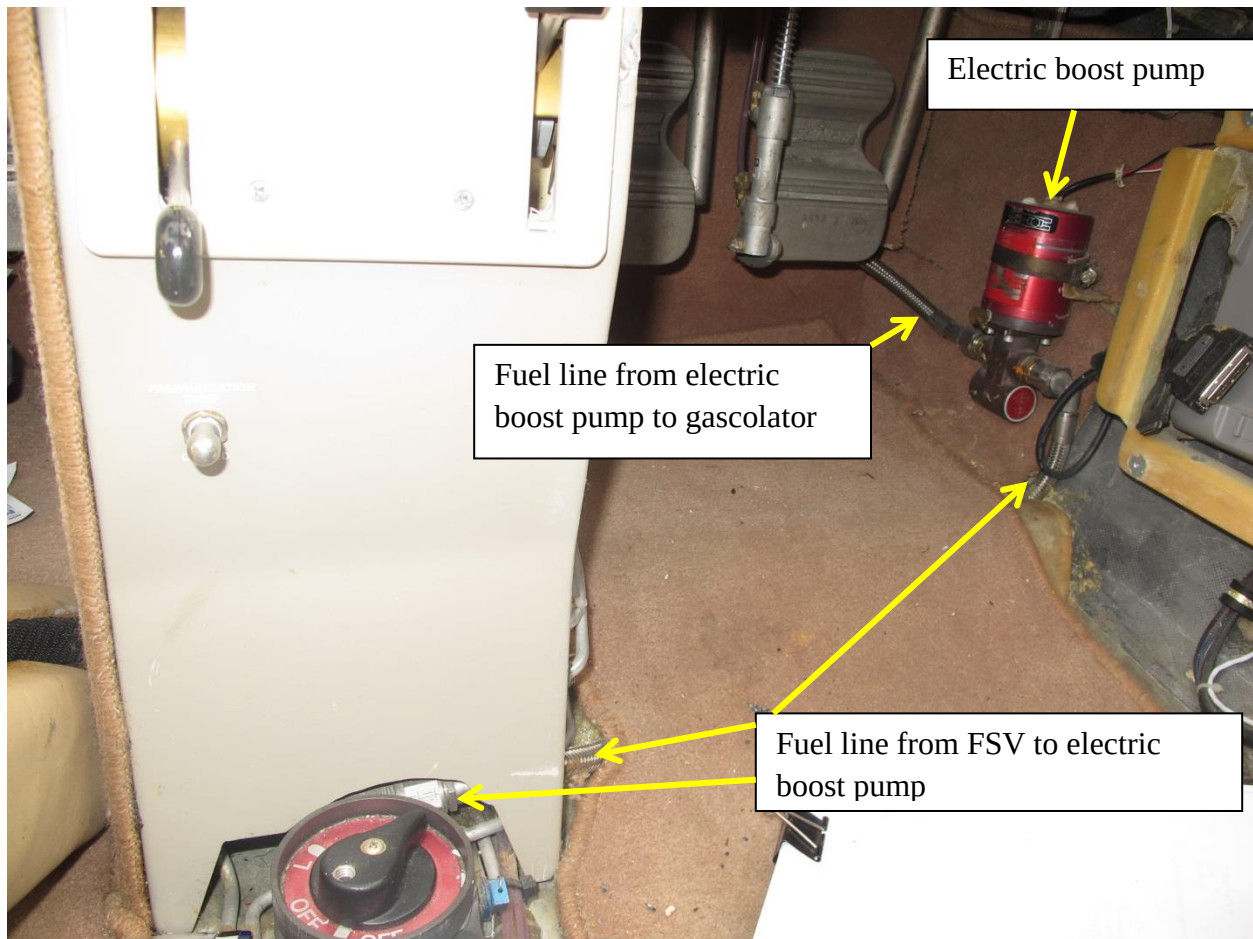
Photo 6 Electric Boost Pump

The outlet from the FSV connected to an electric fuel pump located on the right side wall of the cabin. A line went through the firewall to connect the electric fuel pump to the gascolator.

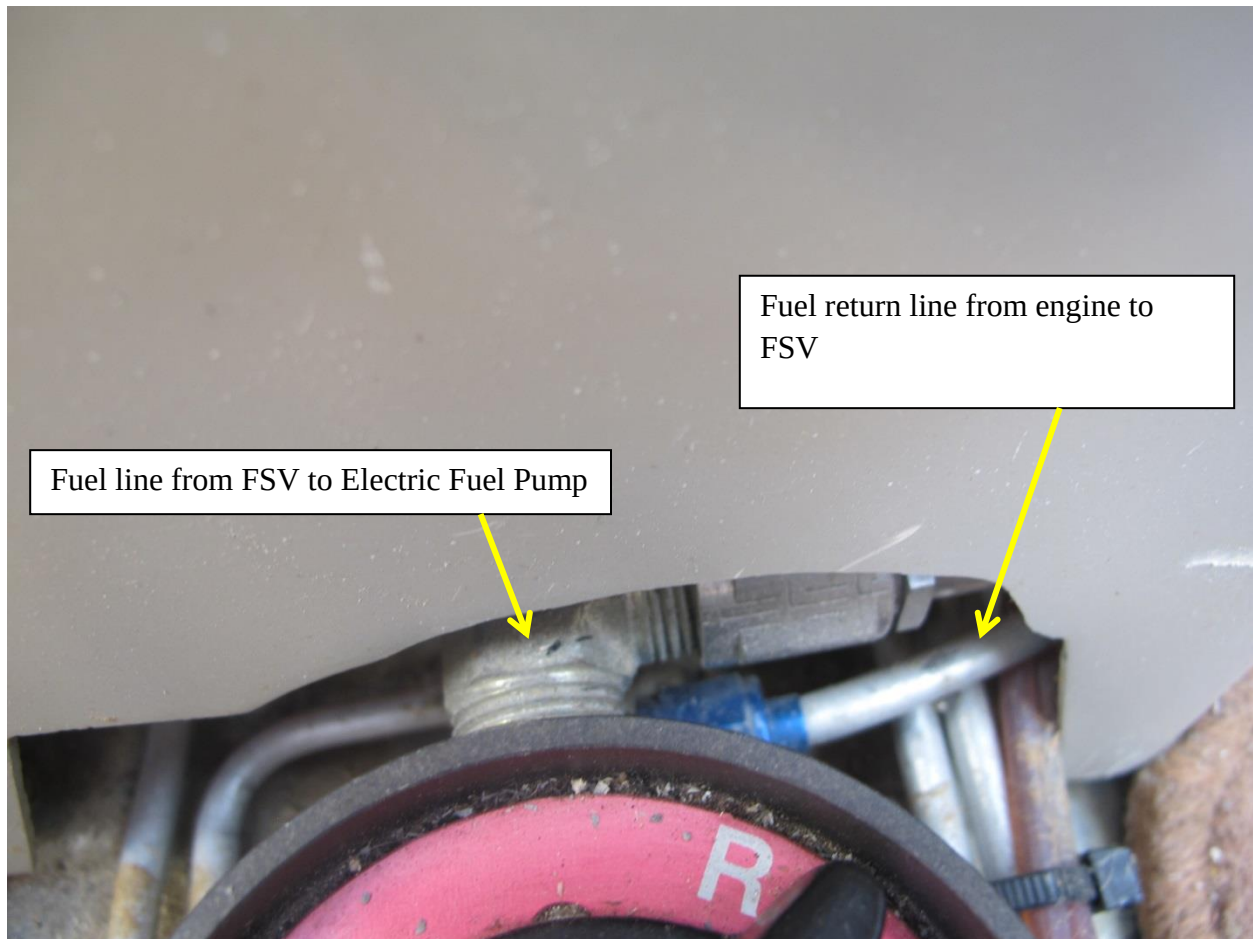
Photo 7 Fuel Lines on FSV

A return line from the engine connected directly to the FSV.

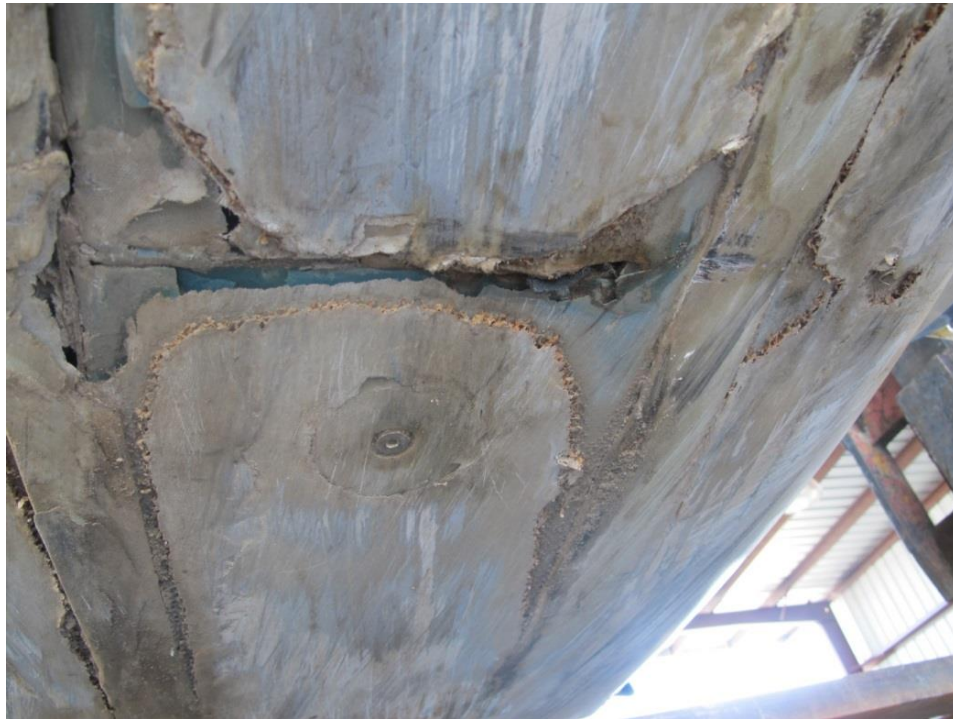
**Photo 8 Bottom of Belly Tank**

The belly tank was scraped and breached during the accident sequence.

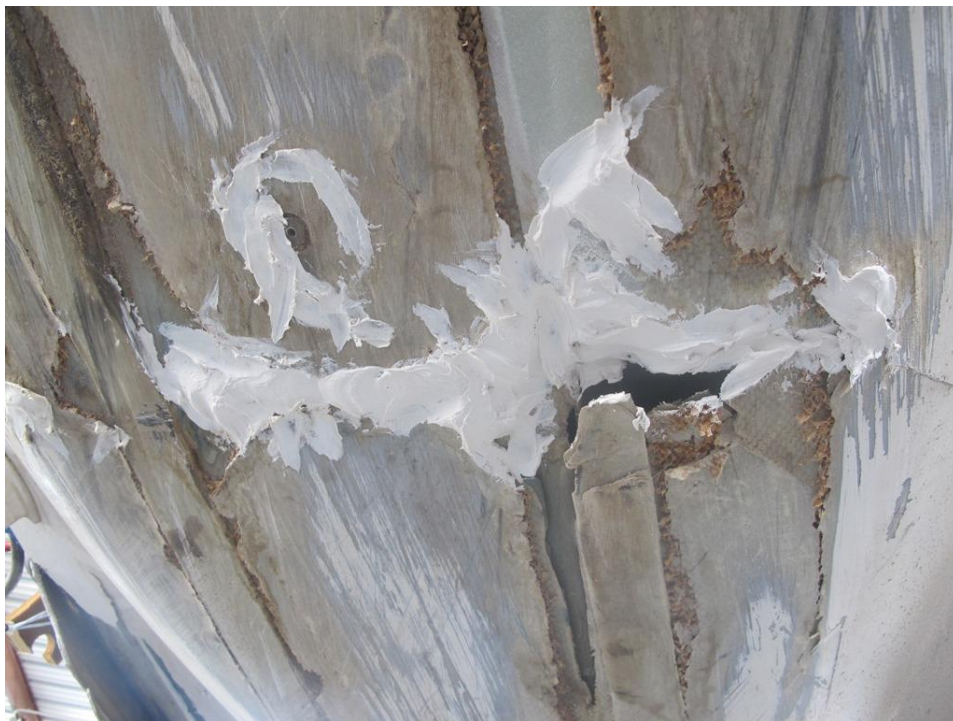
**Photo 9 Scraped Belly Tank**

The IIC attempted to determine the fuel quantity for the belly tank by having recovery personnel seal the scraped parts of the auxiliary tank with silicone.

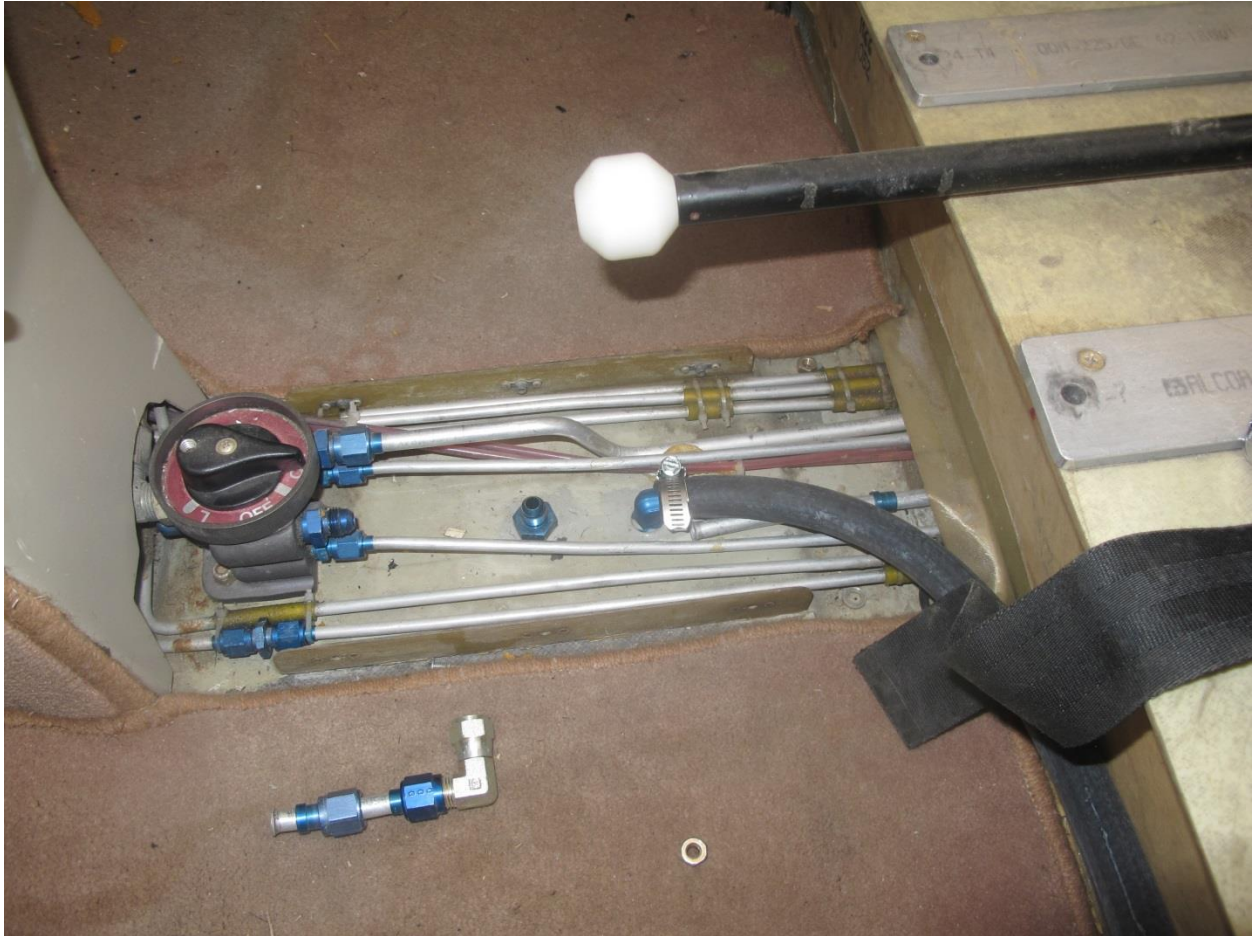
**Photo 10 Fuel Lines Plumbed to Attempt Fuel Measurement**

The FSV was placed in the OFF position, and the line from the belly tank to the FSV was removed so that when the tank was full, it would allow fluid to flow out the top of the tank. The line from the left wing to the FSV was removed, and a line was plumbed in from a plastic jug that contained 5 gallons of water. A valve was opened to allow water into the tank, and it leaked at numerous locations.

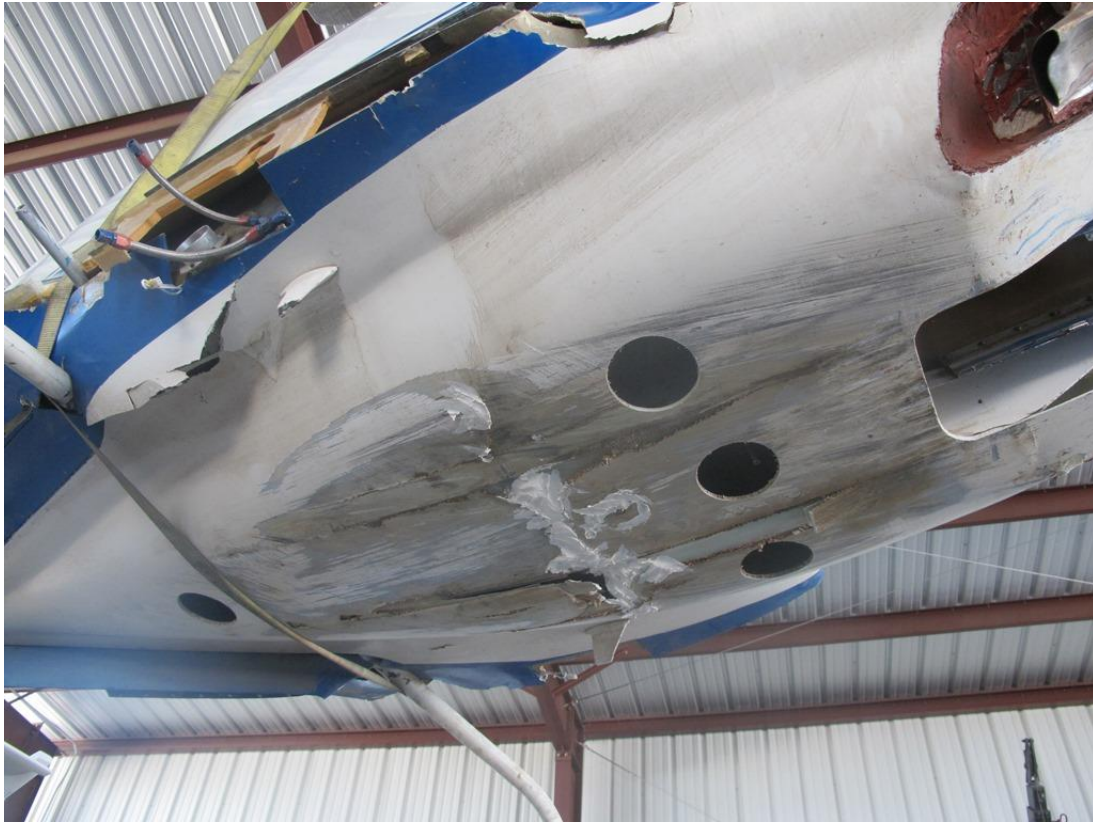
Photo 11 Belly Tank Opened

In an attempt to seal the tank, several holes were drilled into the tank.

It was determined that the extent of the damage was too great to effectively seal the system.

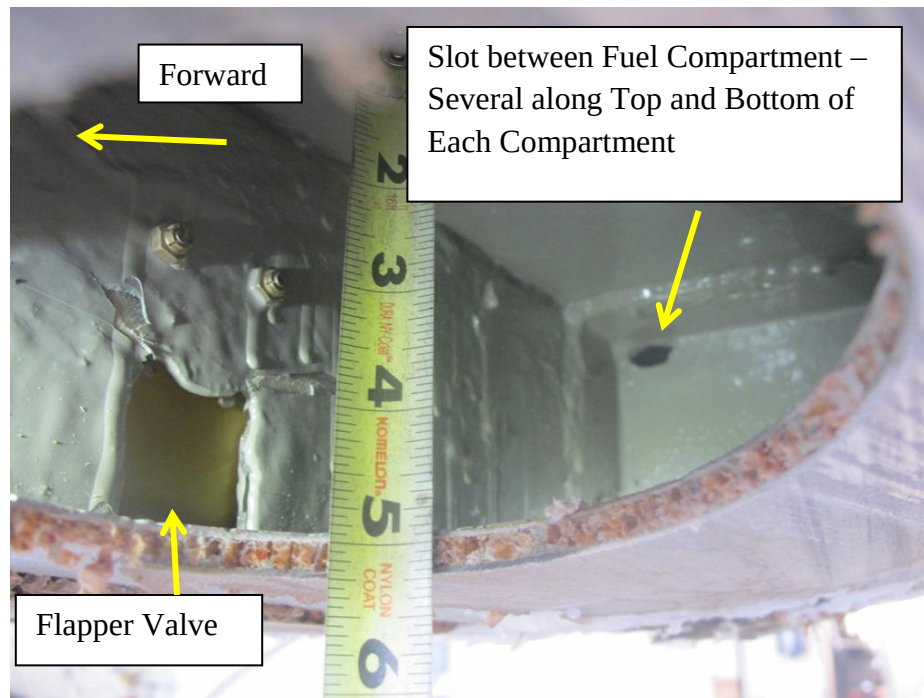
Photo 12 Forward Left Side Compartment

The belly tank was about 7 feet long; the widest point at the front was about 35 inches wide, and it tapered to several inches at the rear. There were numerous compartments in the belly tank. The deepest point at the front was about 5 inches and about 3.5 inches in the aft compartment. All compartments had multiple slots at the top and bottom to allow fuel transfer between the compartments.

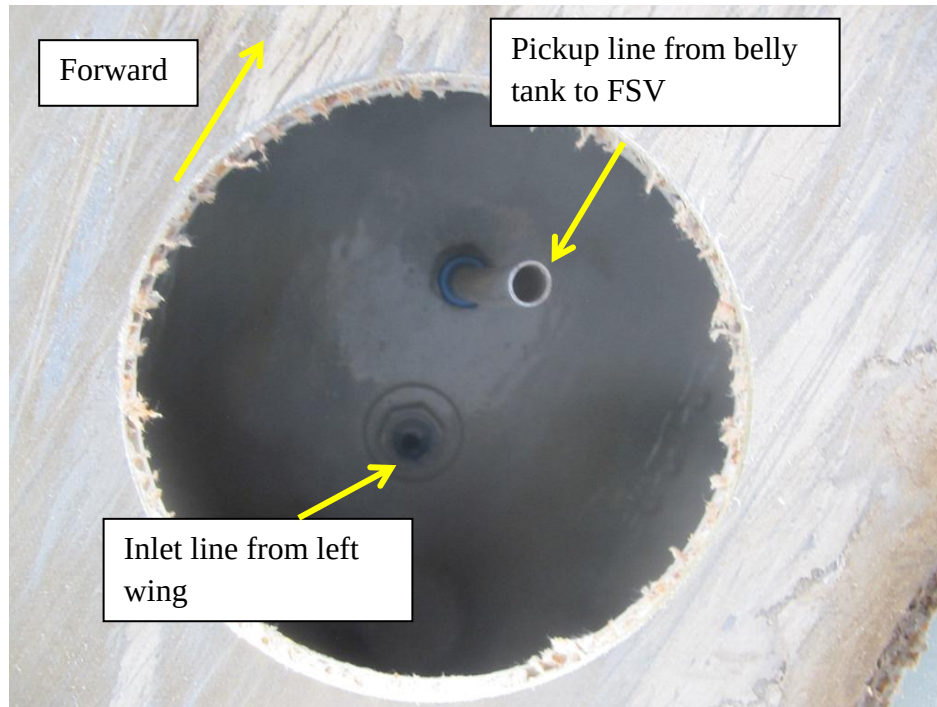
Photo 14 Lines in Center Compartment - Left Wing In FSV Out

The front center compartment contained the feed tube from the left wing and the pickup tube that went to the FSV. This center compartment had fore and aft bulkheads on each side with cutouts covered by flapper valves, presumably to prevent fuel from sloshing away from the pickup tube. The front center compartment also housed the belly fuel drain.

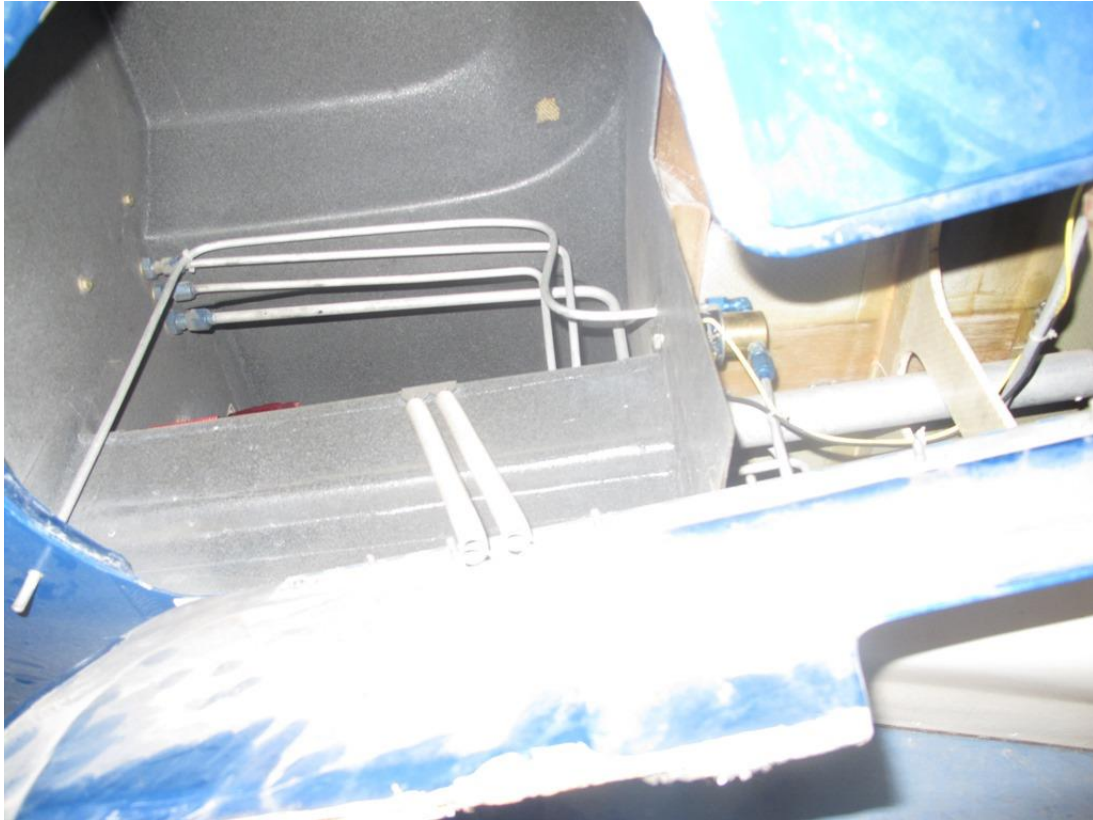
Photo 18 Vent System

The aft tank had a vent line going to a solenoid valve, which in turn was connected to a line exiting the belly skin of the airplane aft of the belly tank. The vent line had an outer diameter of 1/4 inch and an inner diameter of 1/8 inch. Blowing into the vent with electrical power off, air could be heard going into the belly tank.
