# NATIONAL TRANSPORTATION SAFETY BOARD

## Global Positioning System

### Specialist's Factual Report By Sean Payne

Location: Hawthorne, California  
Date: June 10, 2016  
Aircraft: Grumman AA-1B  
Registration: N4SU  
Operator: Private  
NTSB Number: WPR16FA124

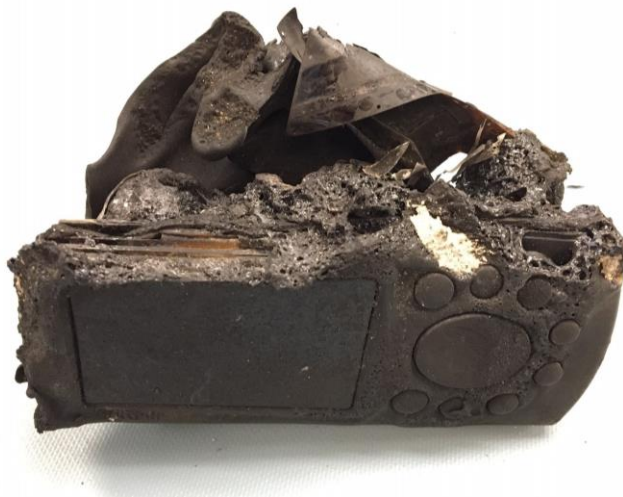
Upon arrival at the Vehicle Recorder Laboratory, an examination revealed the unit had sustained significant thermal and impact damage. The extent of the damage is shown in figure 1. The device was opened and the main board was mostly undamaged with the exception of moderate thermal marking near one corner of the board (figure 2). The backup battery was tested for power and displayed no voltage (figure 3).

**Figure 1.** Photo of damaged unit.

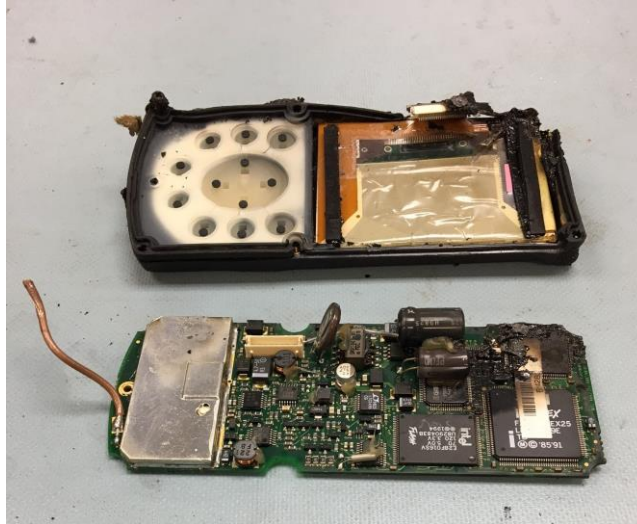
**Figure 2.** Photo of unit's main board.
