# Continental Motors

## Component Examination Report

| NTSB Number: | WPR16LA048 | Air Safety File: | 15-357 | | |
| Engine Model: | IO-470-K | Engine S/N: | 092964 | | |

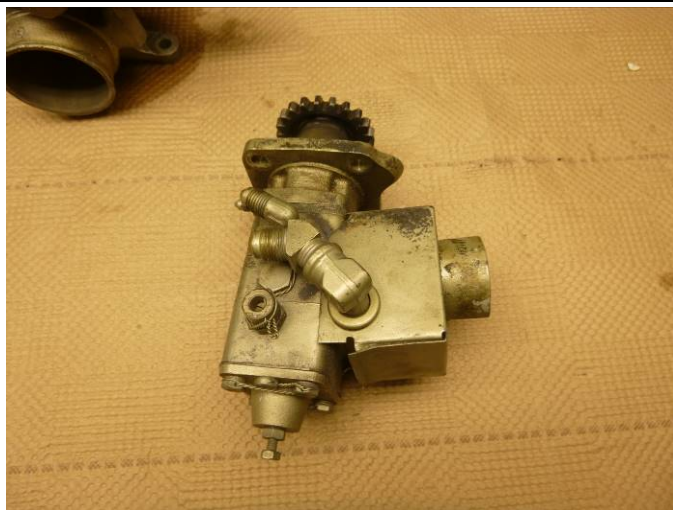
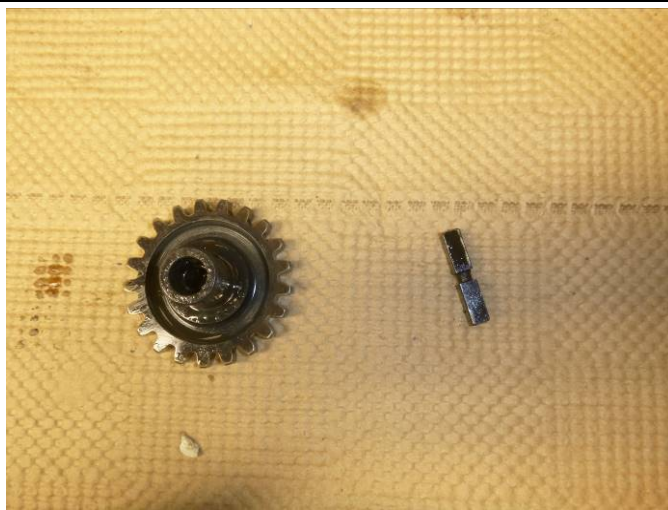
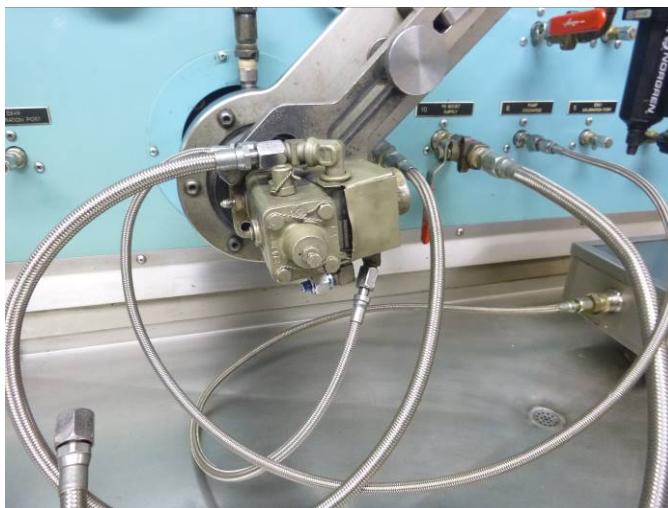
| Condition: | The fuel pump was intact and undamaged. It was noted that the fuel pump drive coupling remaining intact and the fuel pump drive coupling gear was undamaged. The fuel pump was placed on a test bench and was put through a production test cycle. The fuel pump operated normally and there were no anomalies noted. | | |

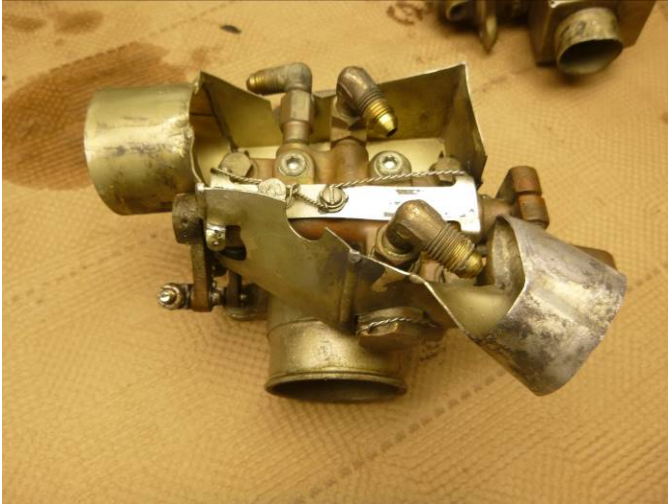
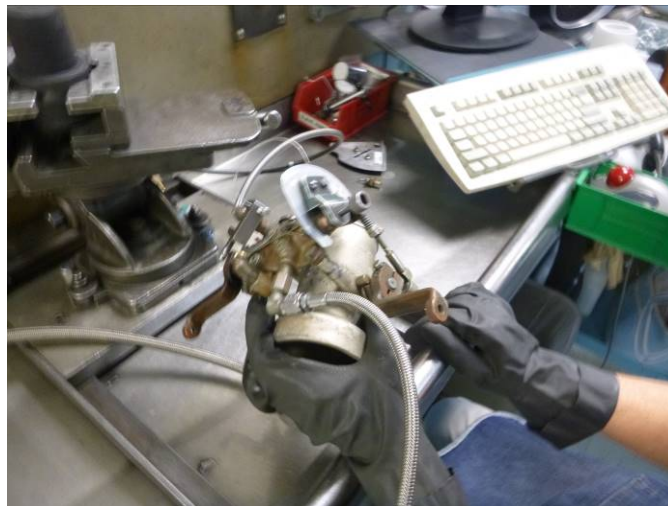
| Condition: | The fuel metering assembly remained intact and displayed impact damage to the heat shielding. The metering assembly was placed on a production test bench; no adjustments were made to the fuel metering assembly. It was noted that the observed flow at the 2.0° was set significantly higher than specifications for a new component. It was noted that the metering assembly was capable of flowing fluid at all throttle angles. | | |

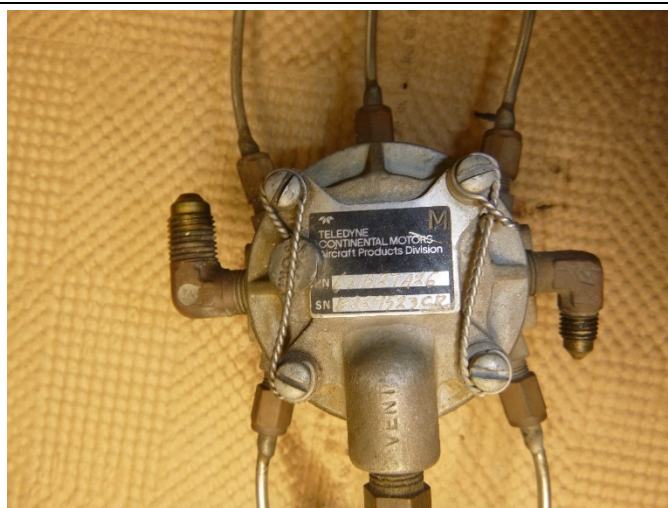
| Condition: | The fuel manifold valve remained intact and undamaged. The manifold valve was installed on a production test bench with all of the fuel nozzles installed. The fuel manifold valve operated normally on the test bench and was capable of flowing fluid normally. | | |
| Condition: | All of the nozzles were installed on their fuel lines going to the fuel manifold valve. The nozzles were used during the fuel manifold valve production test cycle and all of the nozzles operated normally. | | |
