## **NATIONAL TRANSPORTATION SAFETY BOARD**

### **APPROACH and GPS INFORMATION**

**WPR16LA093**

Accident Date: April 17, 2016

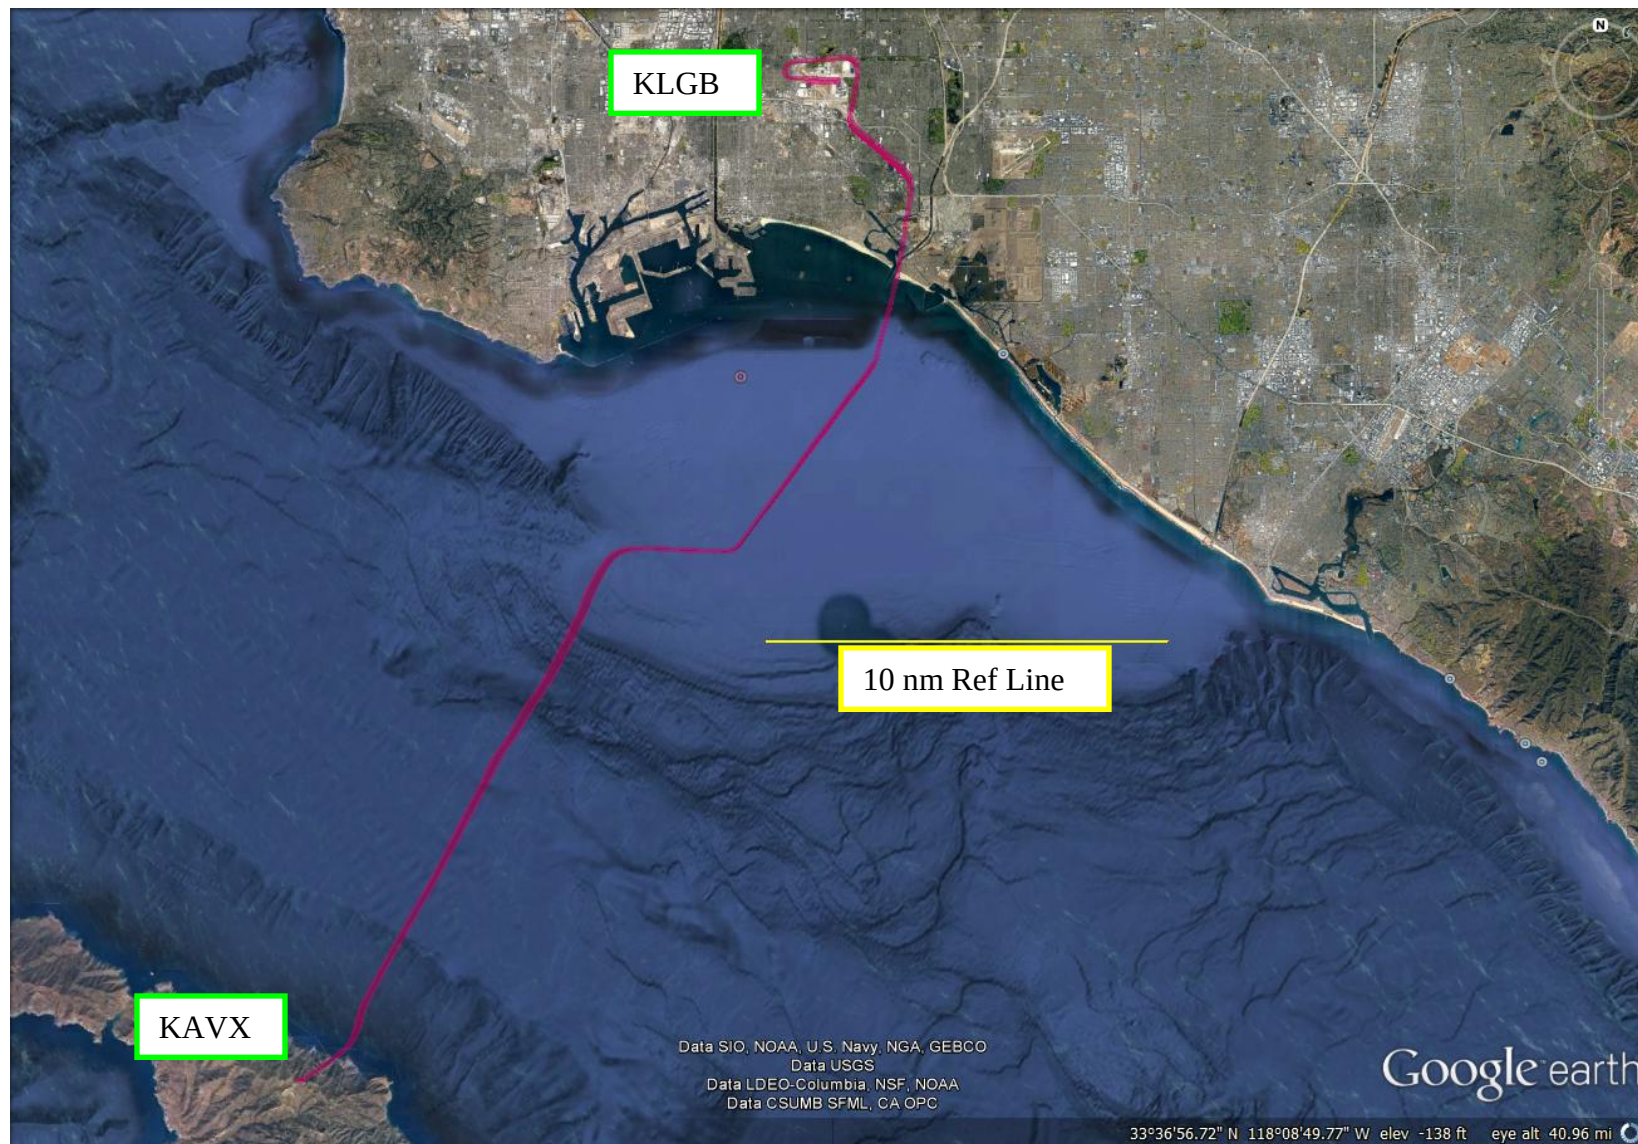
**Figure 1 - Entire Flight**

The GPS data file for the flight began when the airplane was parked in its spot at Long Beach Airport (LGB), Long Beach, CA, and ended at the accident location. The data is consistent with the pilot stopping to conduct an engine run-up, and then departing on runway 25R. The airplane flew a right downwind leg until it was just east of LGB, and then turned approximately south towards AVX.

The pilot reported that he utilized air traffic control (ATC) flight following services, and that they assigned him some headings and altitudes enroute for traffic avoidance purposes. When the airplane was about 10 miles from the mainland shore, it began an essentially straight and direct track towards AVX. When the airplane was approximately 2.5 miles from the AVX runway 22 threshold, the track turned more southbound, and then southwest to join the extended runway centerline about 1.4 miles from the threshold. The airplane then tracked directly towards the runway until the pilot attempted to go-around, when he deviated to the right. Flight duration from takeoff to accident was approximately 24 minutes.

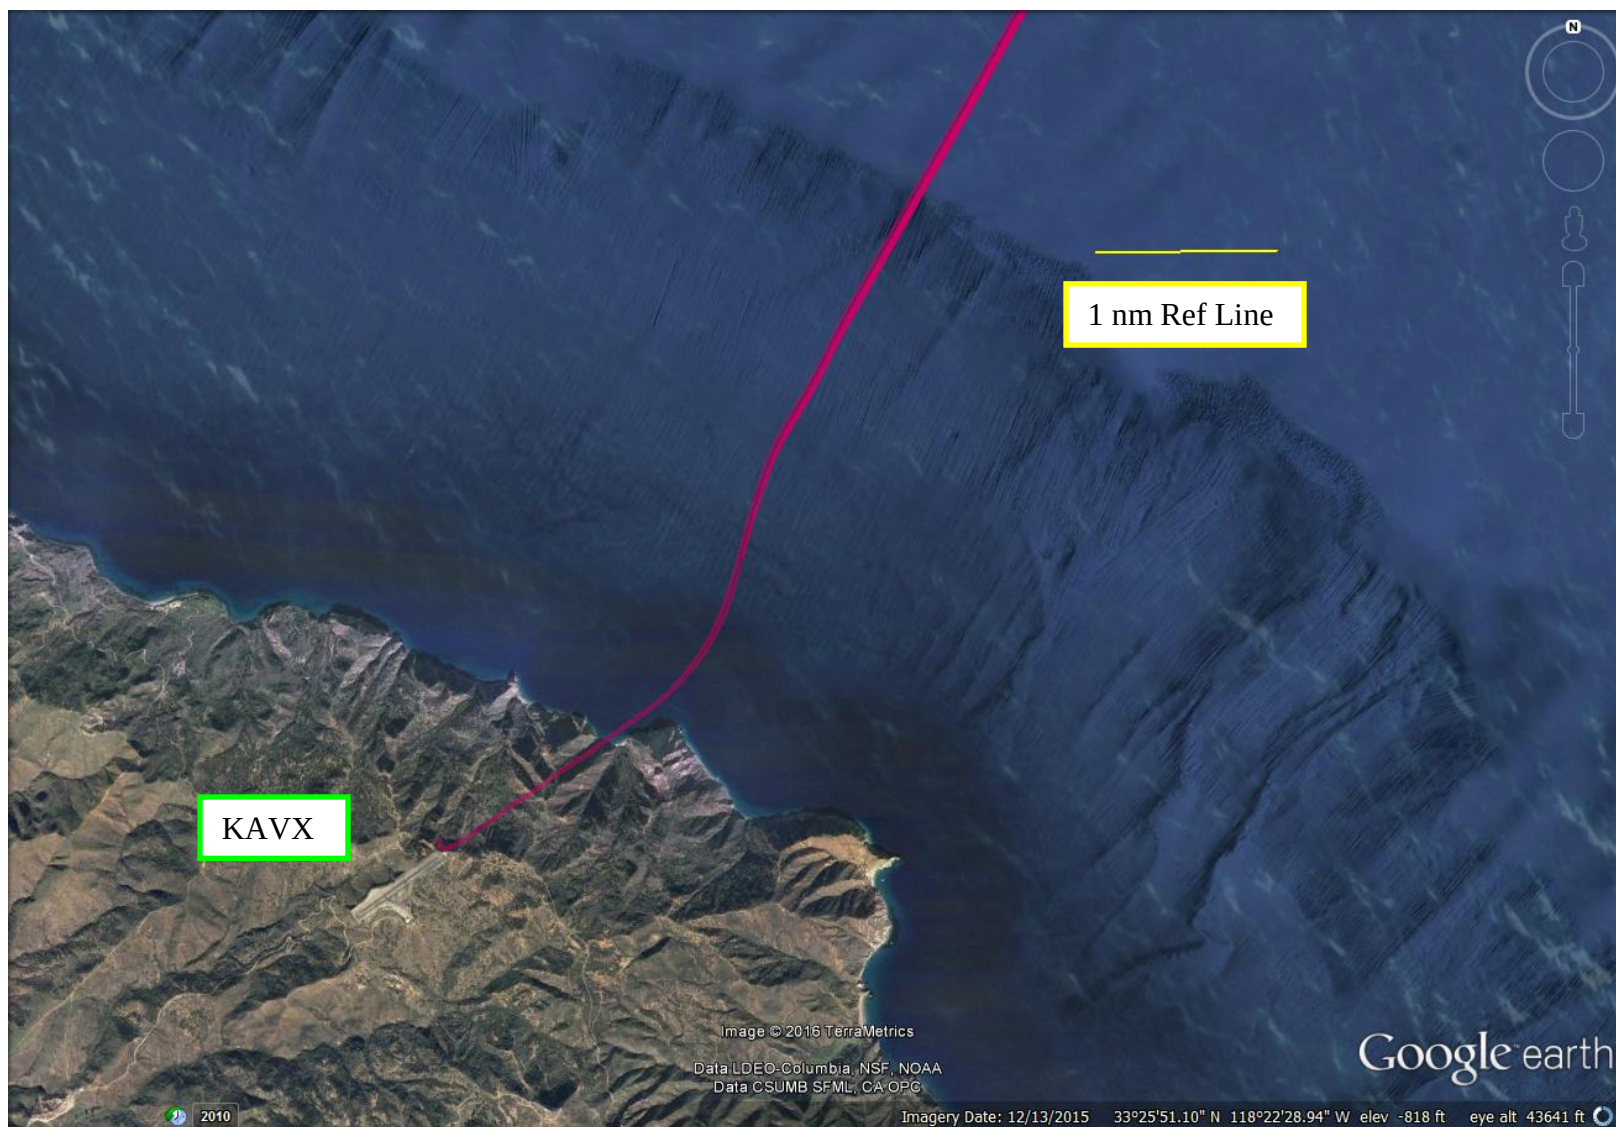
Figure 2 - Track with Final Approach Course Alignment Correction

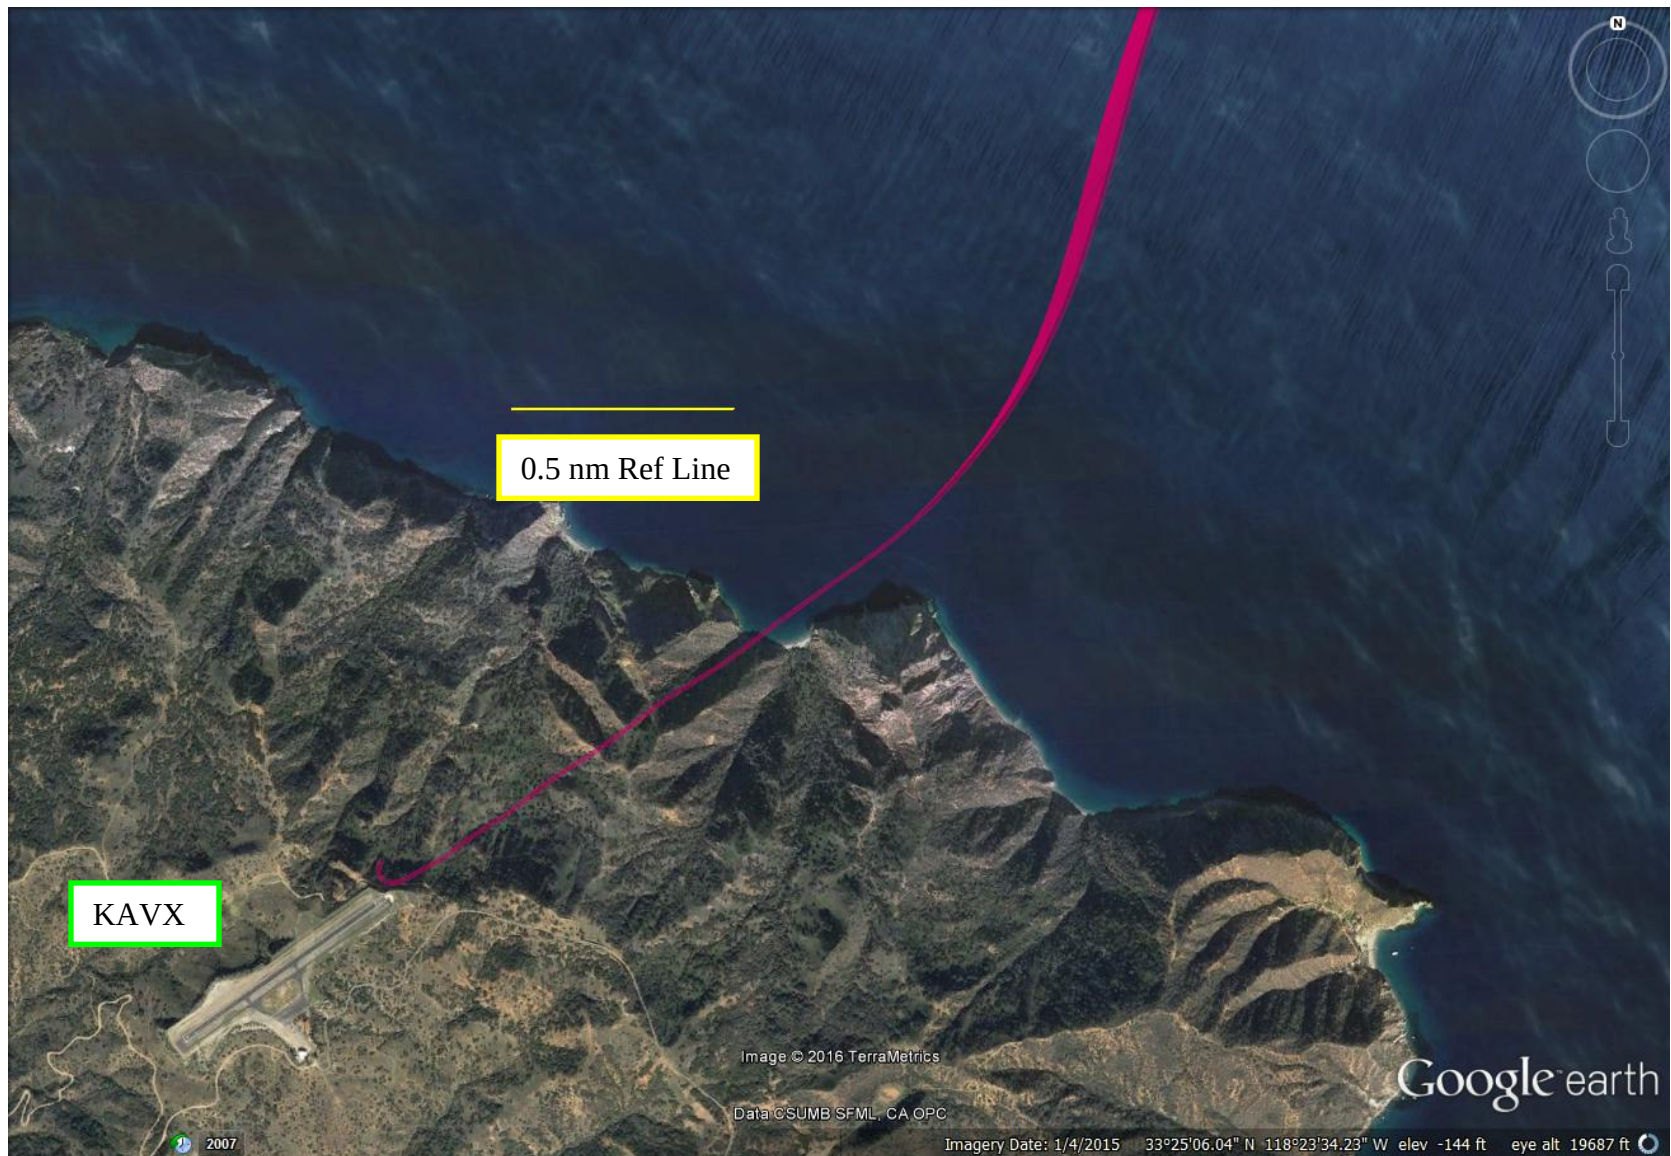
**Figure 3 - Final Approach Segment**

About 70 seconds prior to the accident, the airplane joined the final approach course, at a GPS altitude of about 2,000 feet. At that location, the PVASI nominal approach path altitude was approximately 2,100 feet, and the airplane was in the zone where the pilot would have seen the pulsating red light, indicating that he was well below the desired approach path. The airplane descended away from the nominal approach path, and the rest of the approach remained in the flashing red light zone. For the final mile of the approach, the airplane was situated approximately 150 feet below the nominal PVASI approach path.

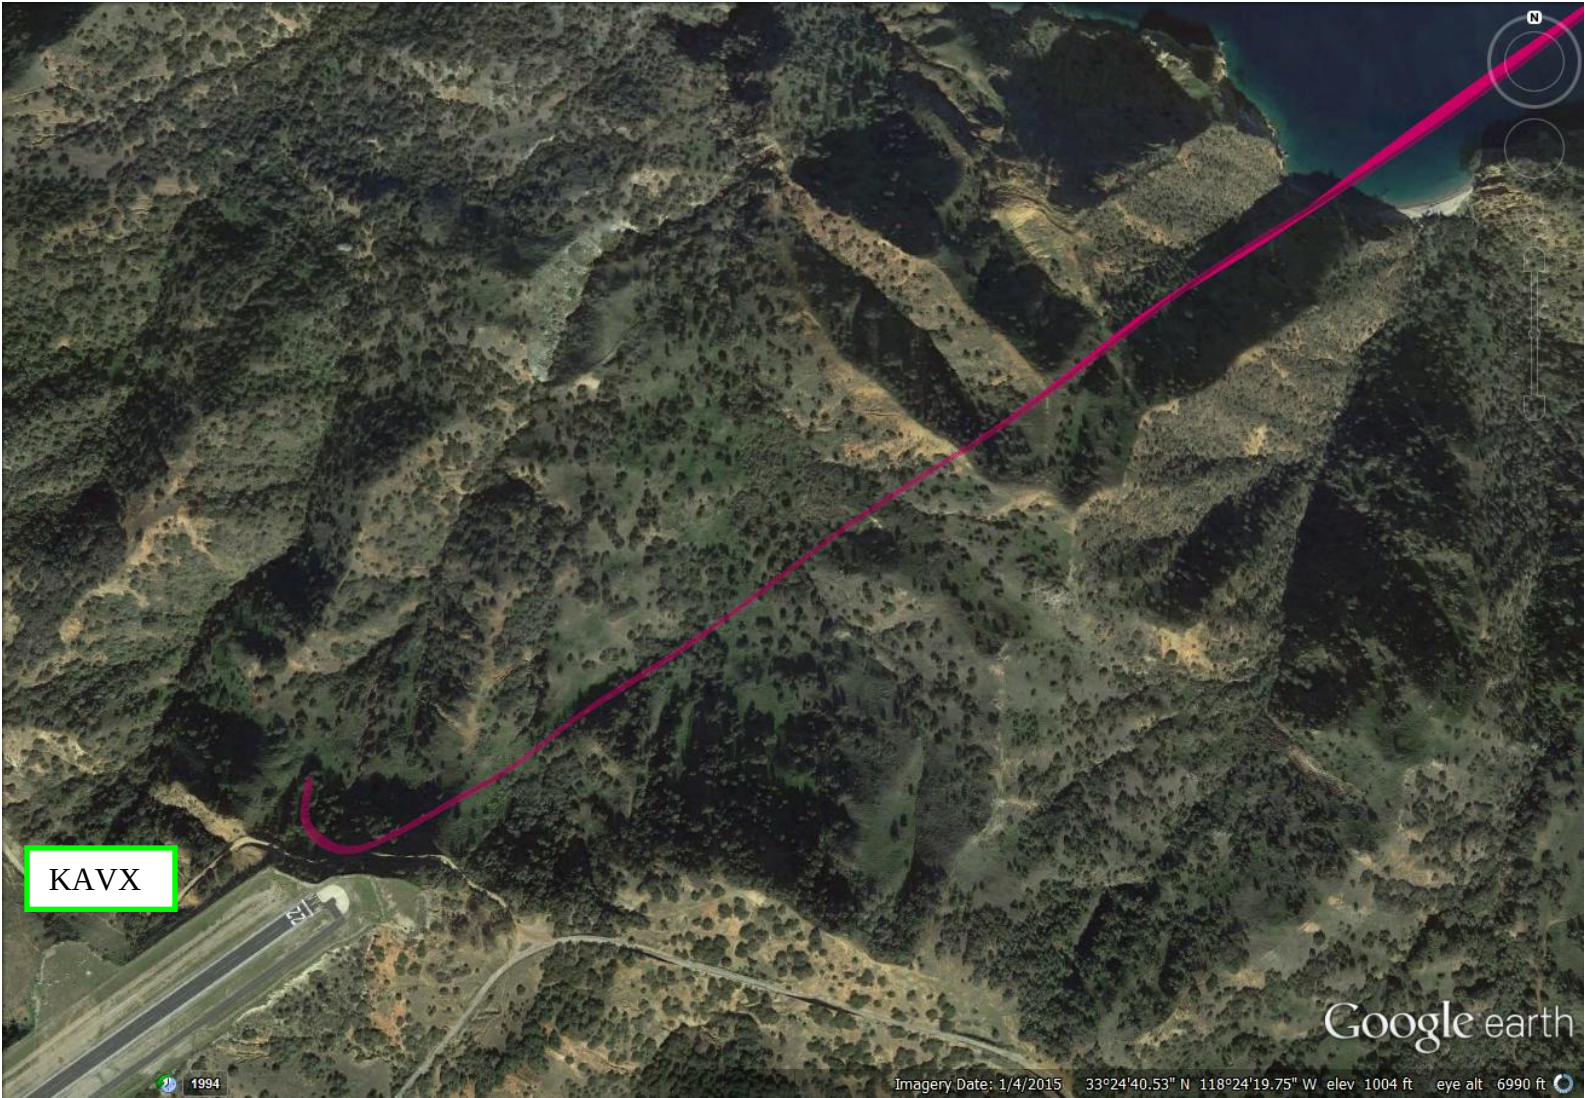
**Figure 4 - Final and Missed Approach Segments**

The GPS-derived groundspeed of the airplane was about 100 knots when it joined the final approach course. The groundspeed decreased steadily to about 35 knots, until about 8 seconds prior to the accident, when it began increasing steadily to about 55 knots, reached immediately before the accident. The speed increase was approximately coincident with the airplane descending below the runway 22 threshold elevation, and the deviation to the right of the approach course, which is consistent with the pilot's description of his attempted go-around.

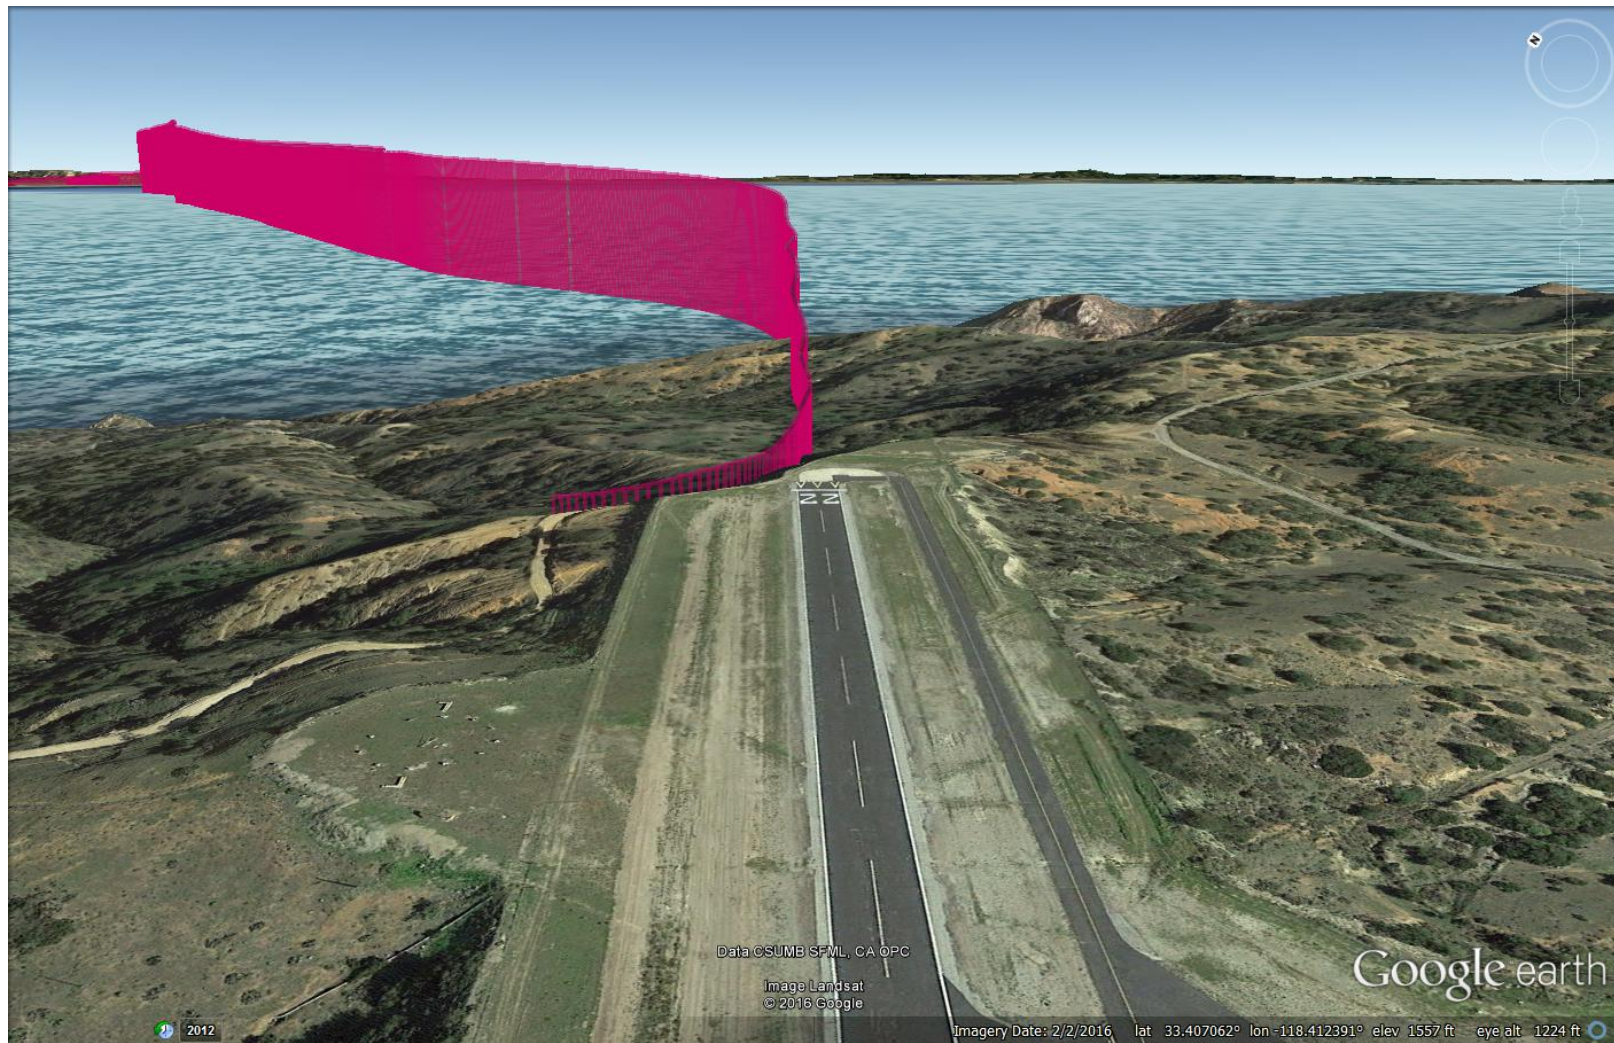
**Figure 5 - View Up Approach Path**

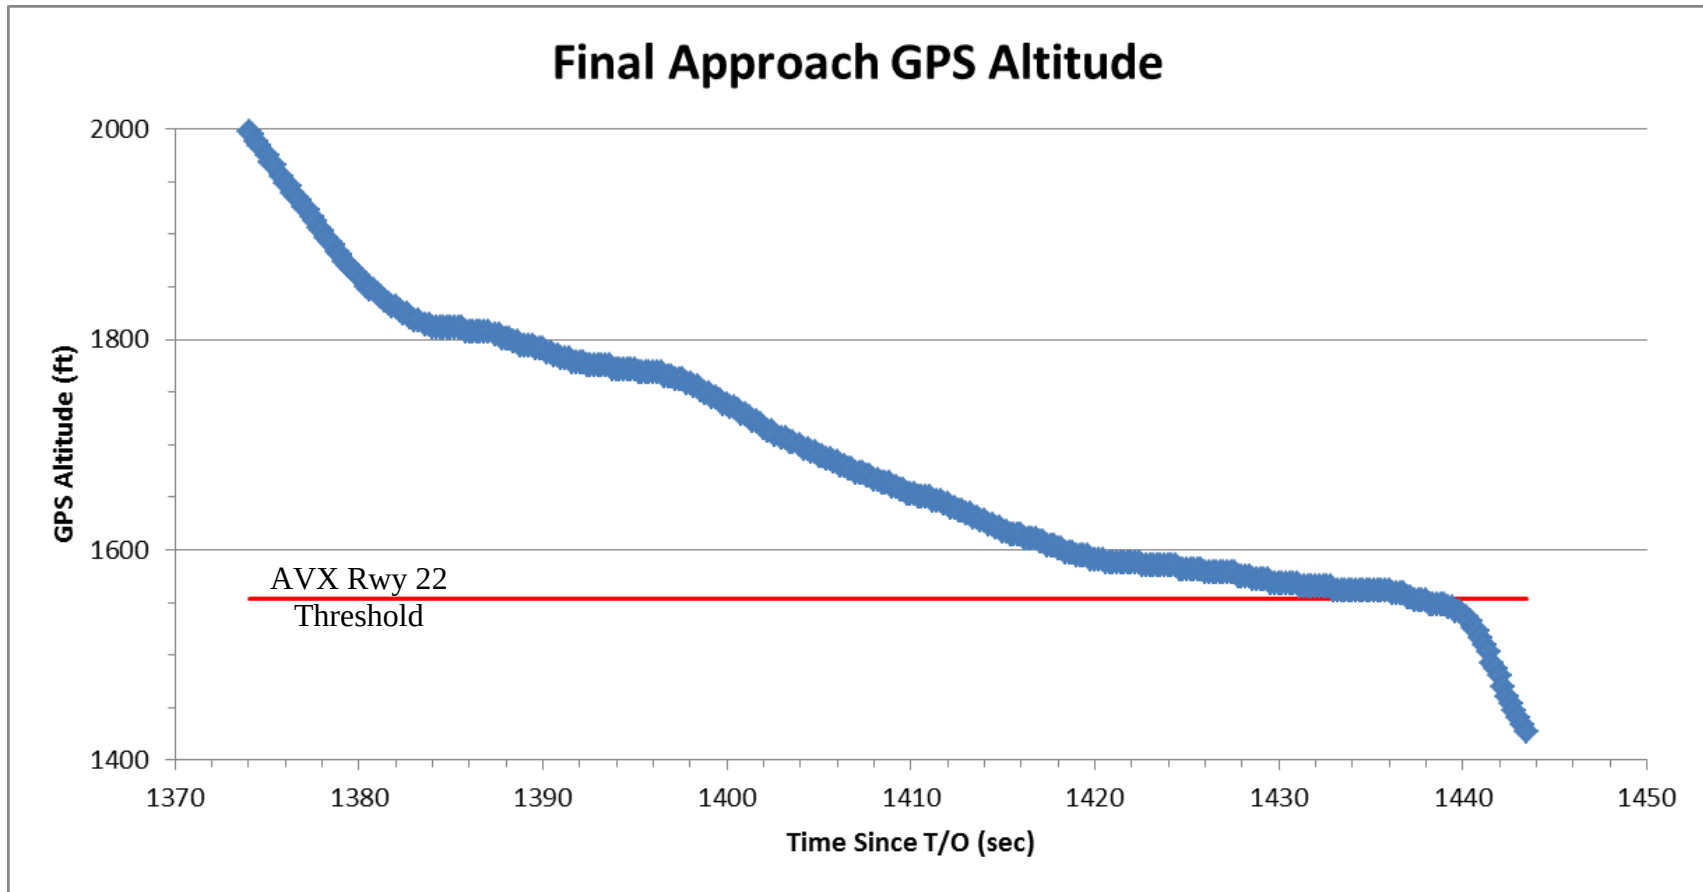
Figure 6 - GPS Altitude and Runway Elevation

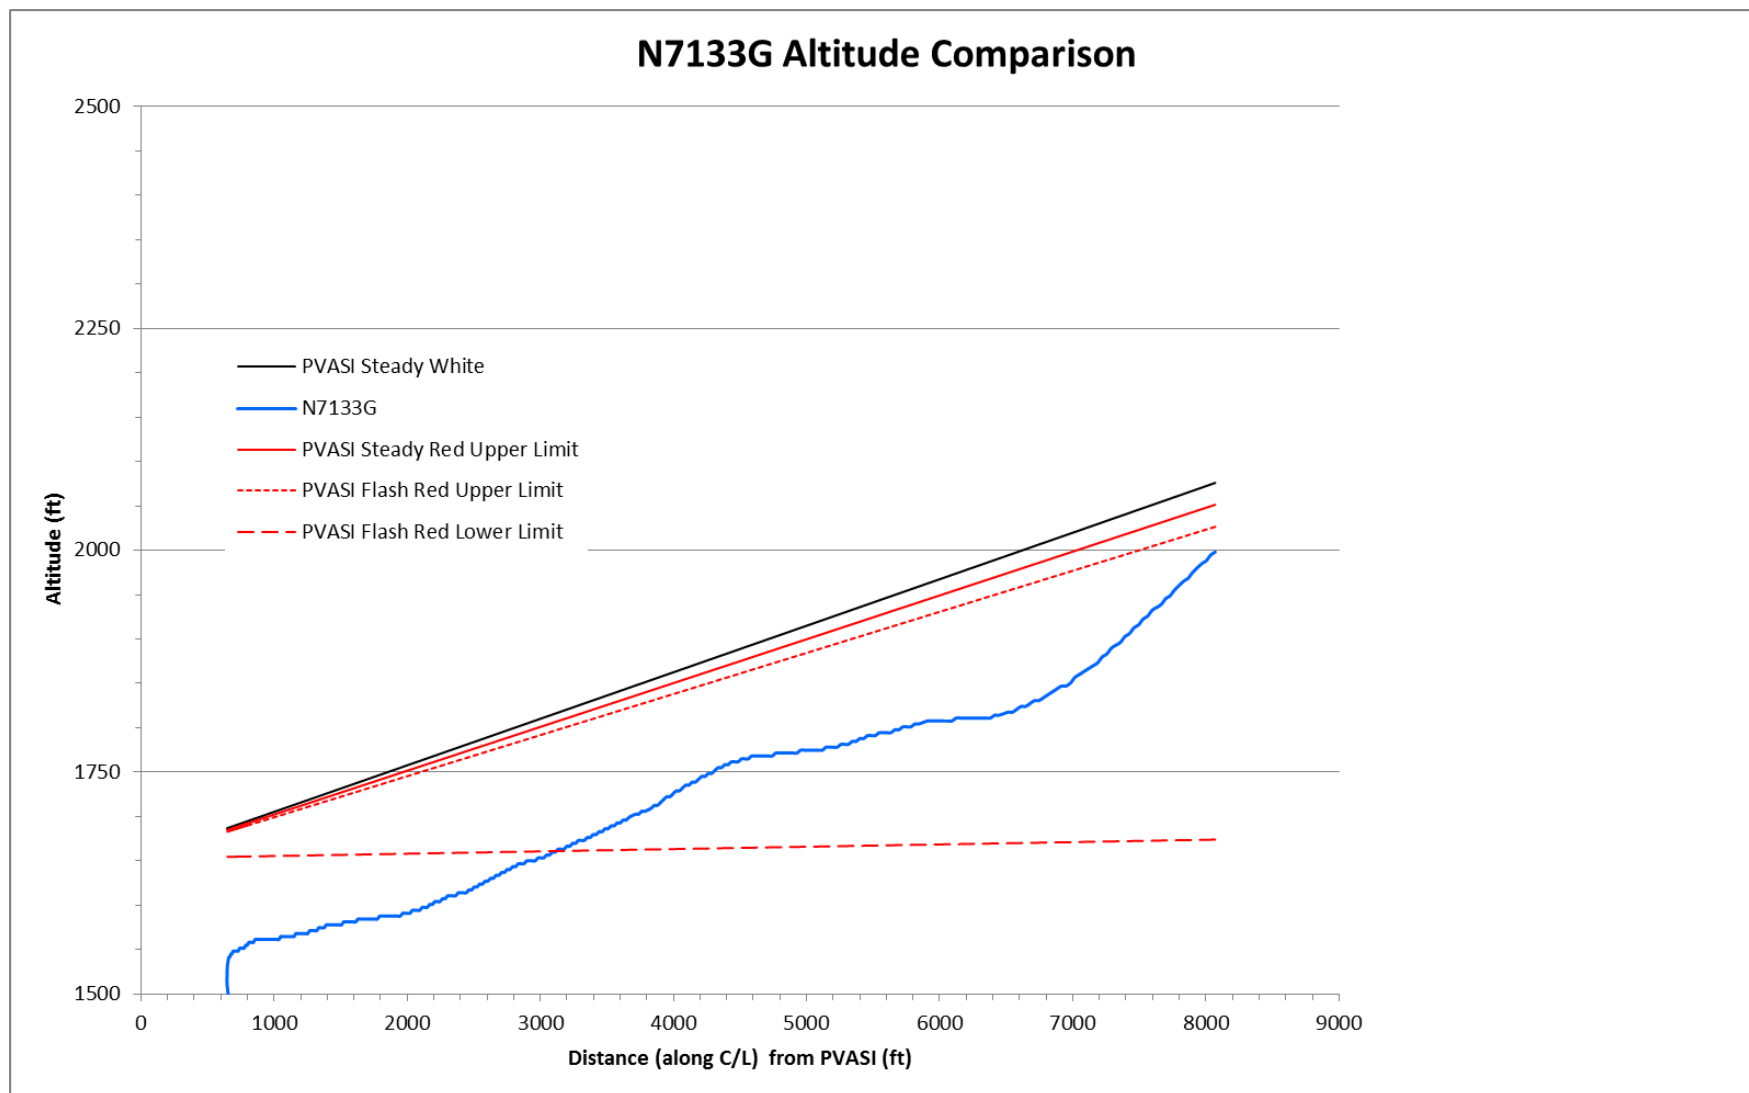
Figure 7 - Flight Track and PVASI Indication Zones

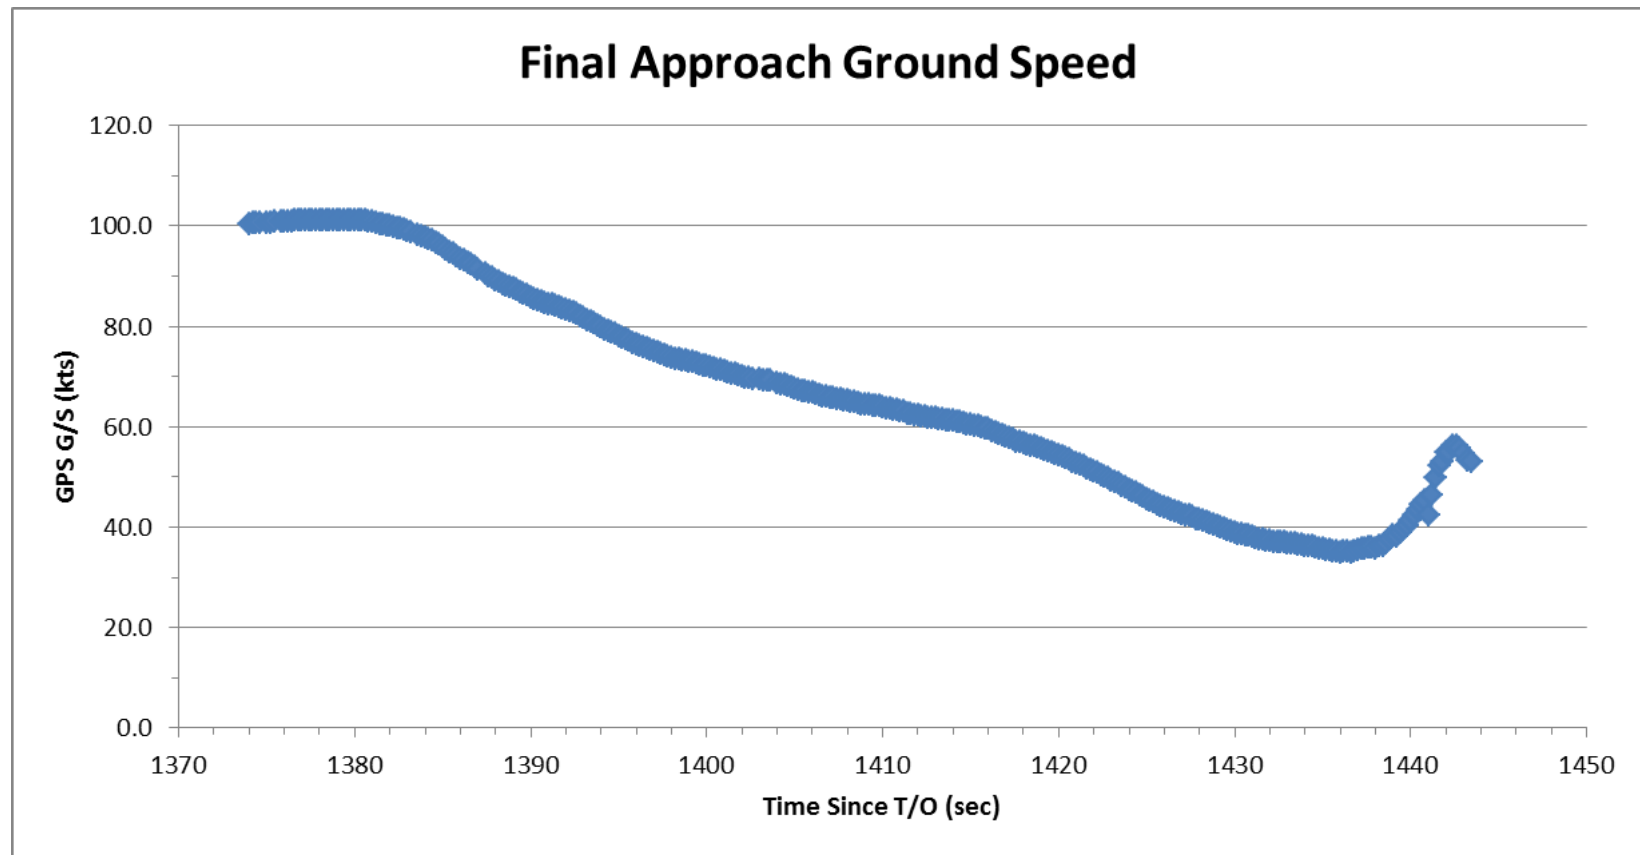
Figure 8 - Ground Speed
