## **NATIONAL TRANSPORTATION SAFETY BOARD**

### **ACCIDENT SITE IMAGES**

**WPR16LA093**

Location: Avalon, CA  
Date: April 17, 2016  
Aircraft: Cessna 172K, N7133G, Serial # 17258833  
NTSB IIC: Michael Huhn

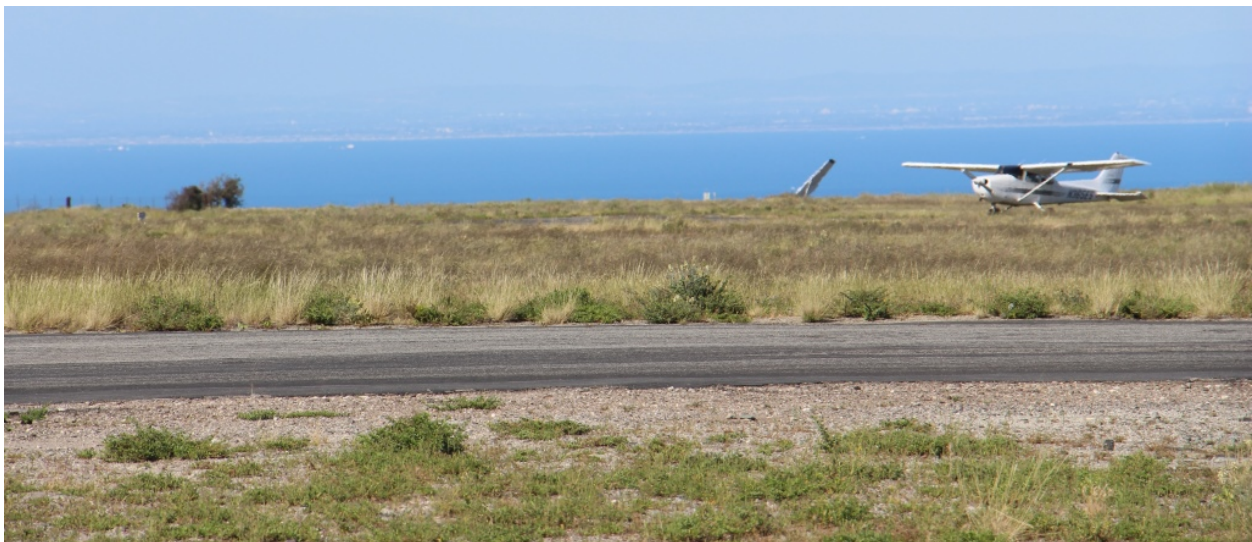
**Figure 1 - Left Wing of Still-Airborne N7133G (airplane approx 700 feet prior to AVX Rwy 22 threshold)**

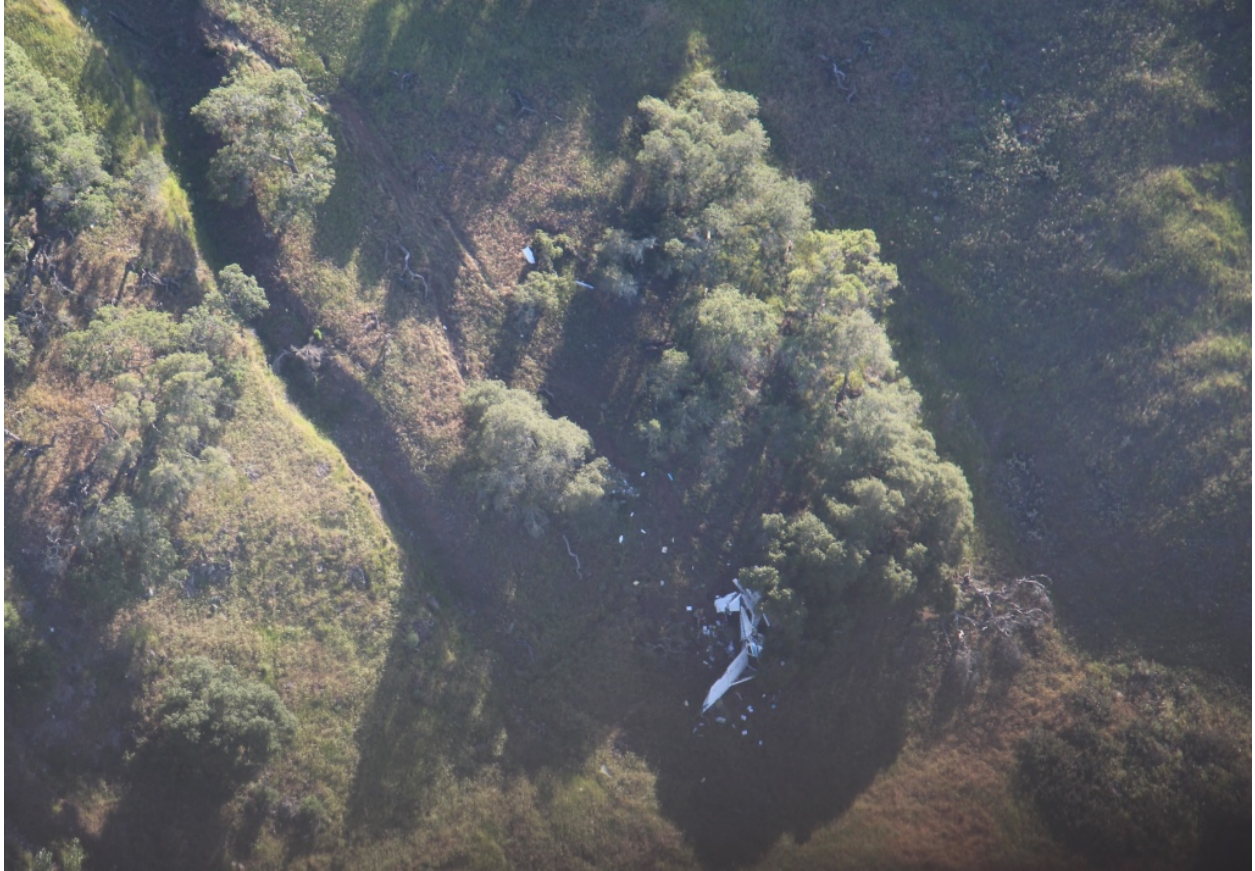
**Figure 2 - Aerial View Shortly After Accident**

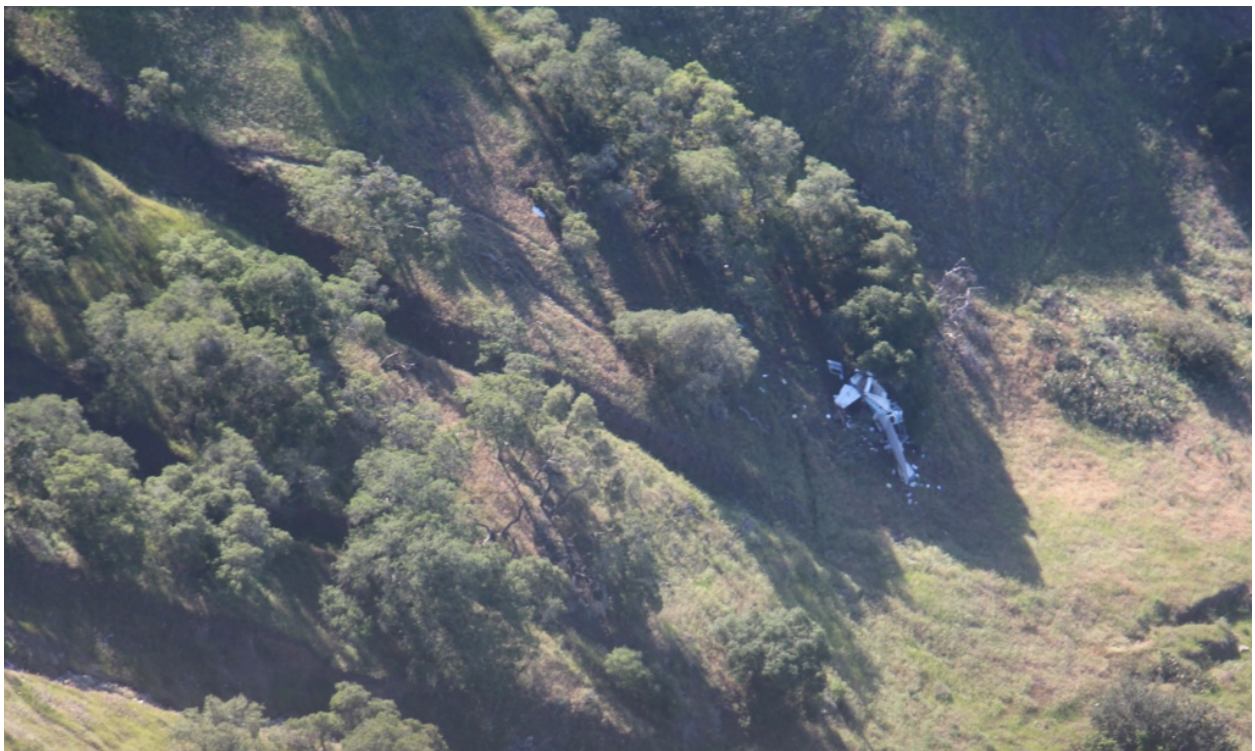
**Figure 3 - Aerial View Shortly After Accident**

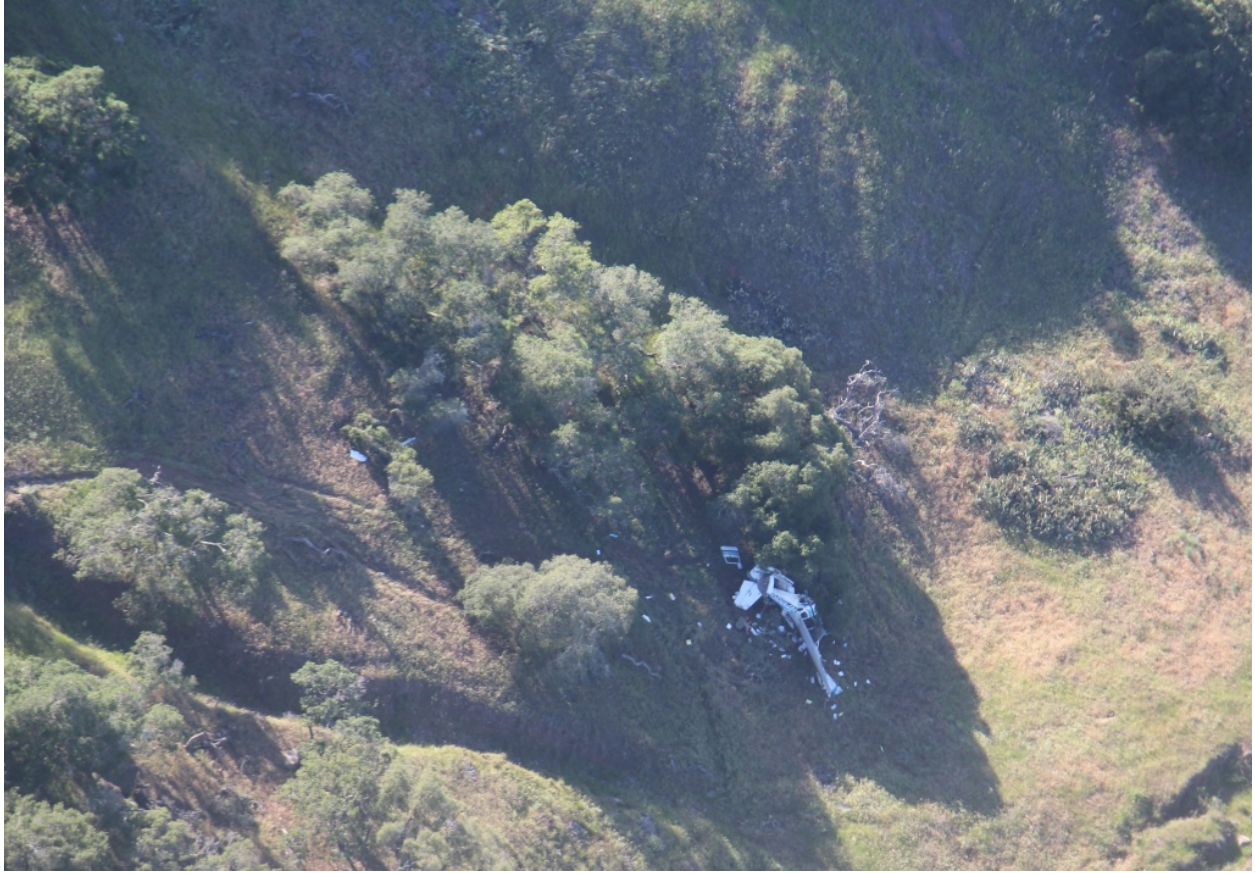
**Figure 4 - Aerial View Shortly After Accident**

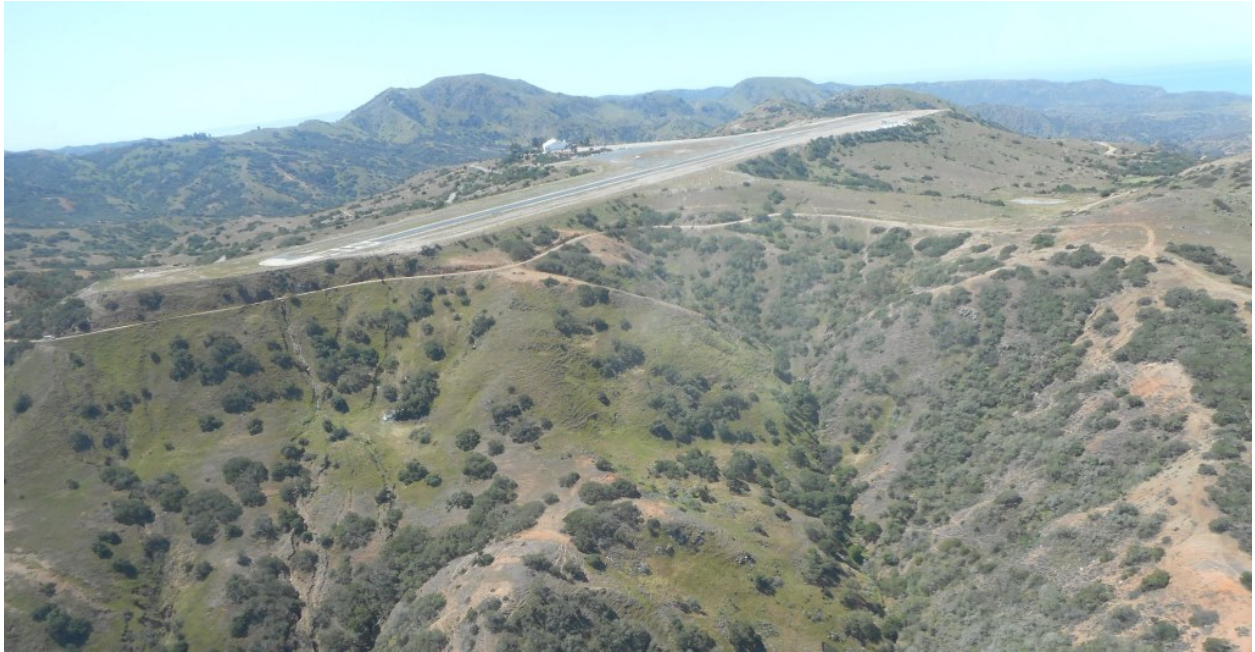
**Figure 5 - AVX Rwy 22 Approach End and Accident Site**

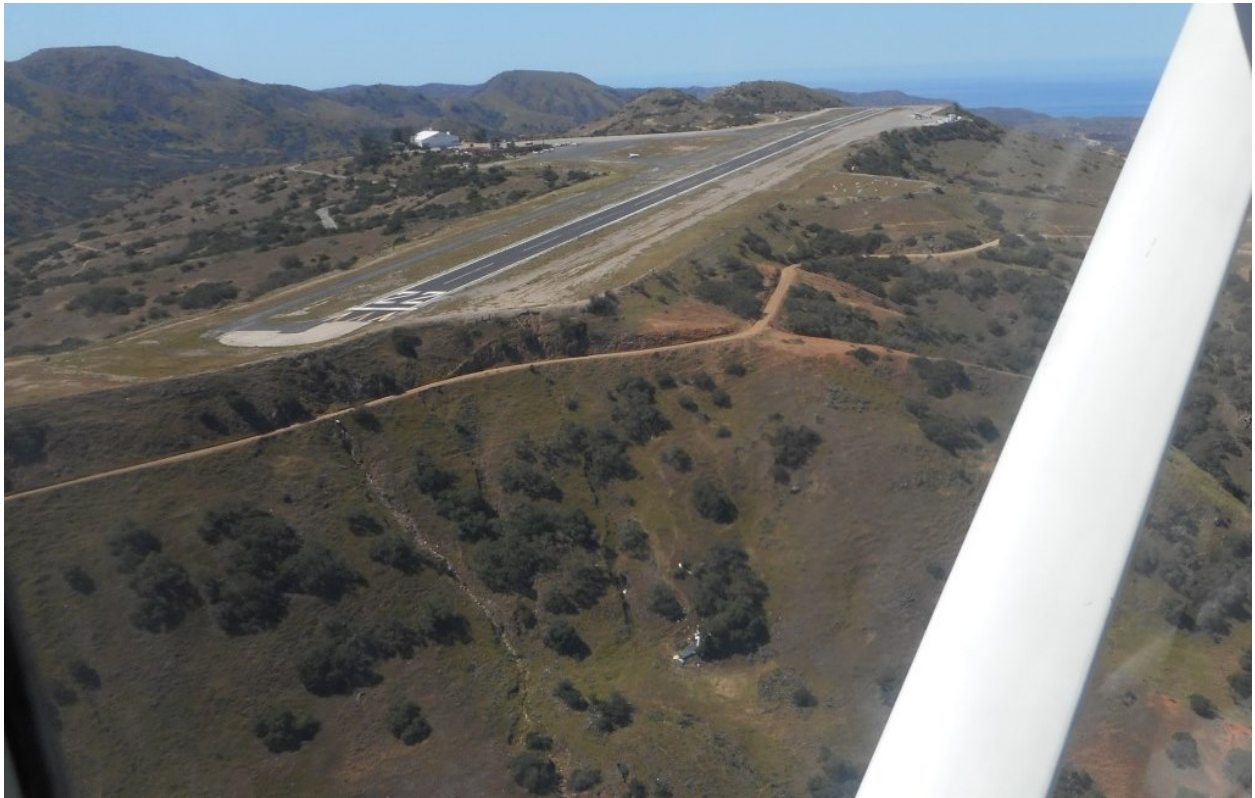
**Figure 6 - AVX Rwy 22 Approach End and Accident Site**

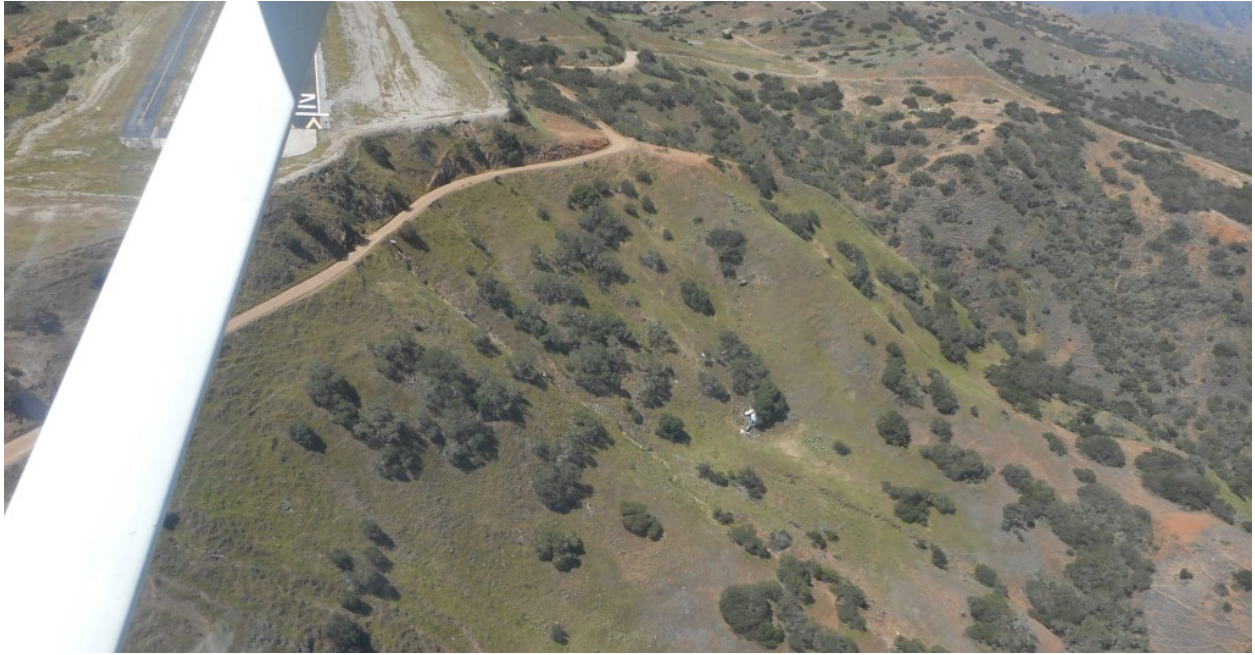
**Figure 7 - AVX Rwy 22 End and Accident Site**

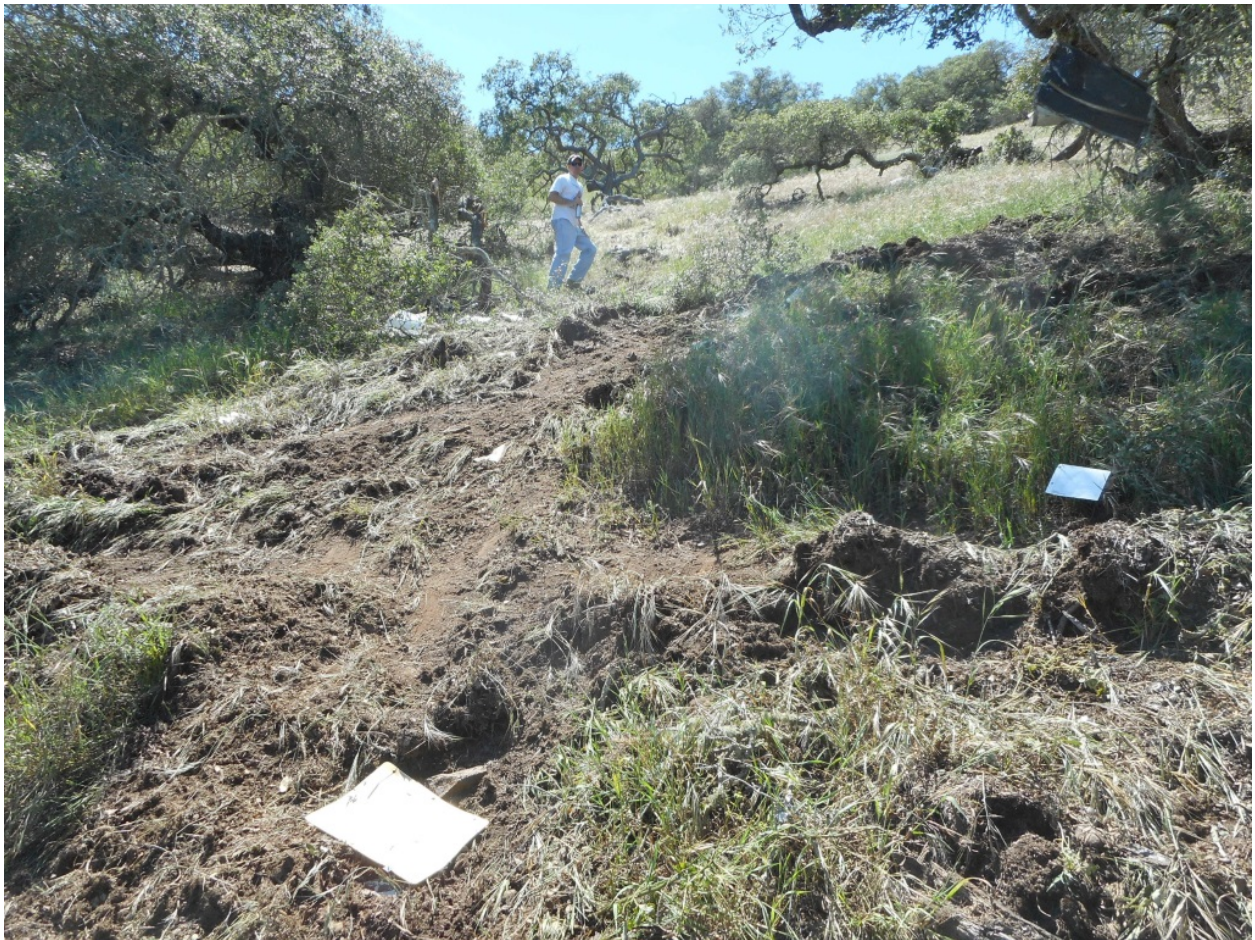
Reports from on-scene personnel, as well as ground scars and the debris field, indicated that the airplane struck steep terrain, traveled in that direction for about 50 feet, and then slid and tumbled downhill about 100 feet. That descent was arrested by large bushes and/or small trees. The wreckage came to rest approximately 400 feet north-northwest of, and 150 feet below, the runway 22 threshold.

**Figure 8 - Initial Impact Location (view in direction of flight)**

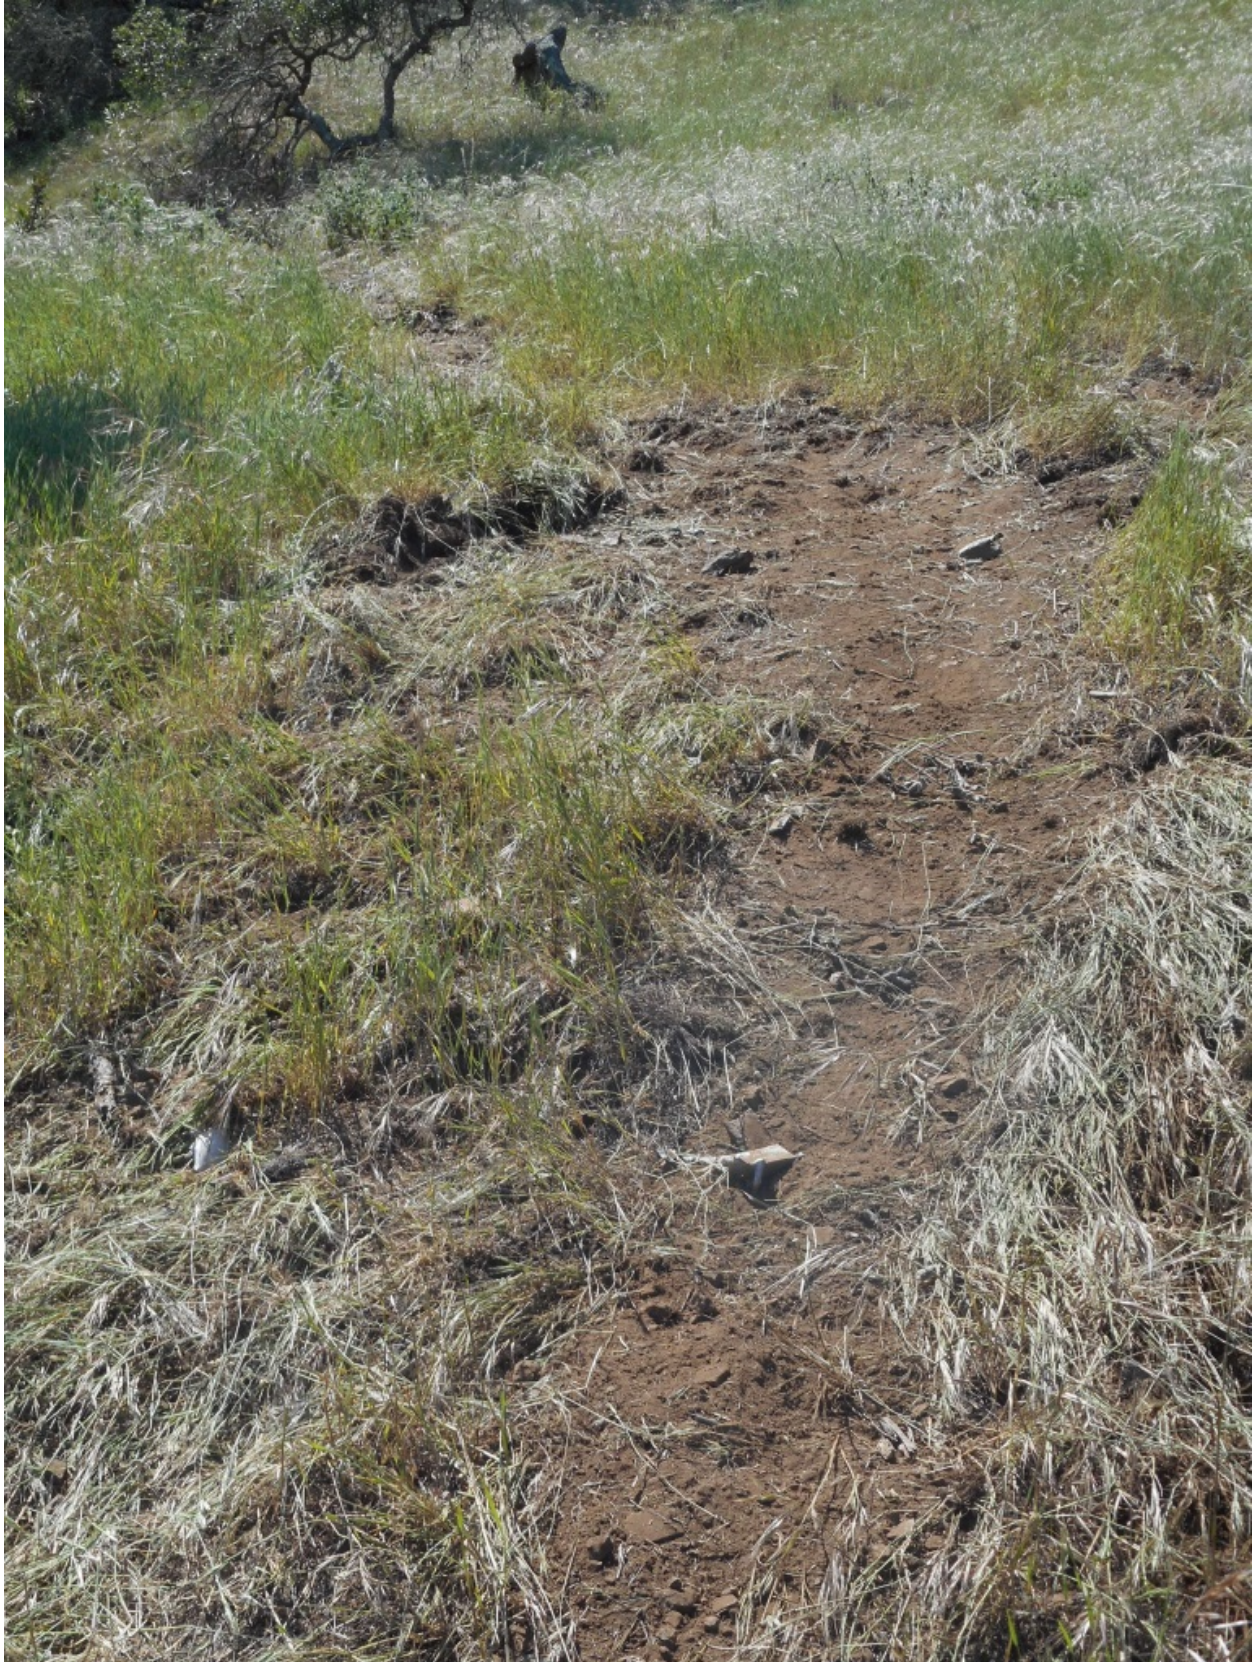
**Figure 9 - Initial Impact Location (view in direction of flight)**

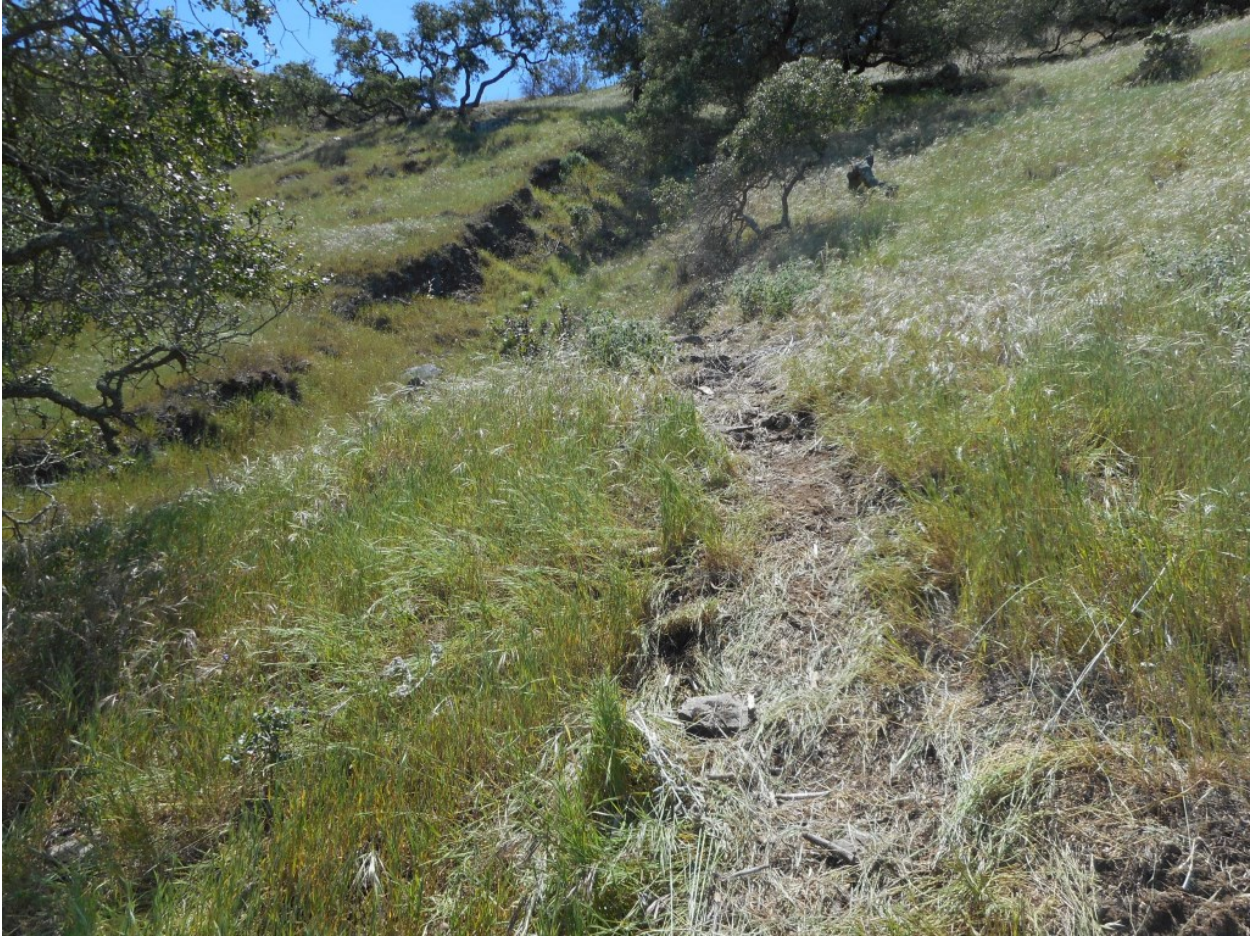
**Figure 10 - Ground Scar from Downslope Travel**

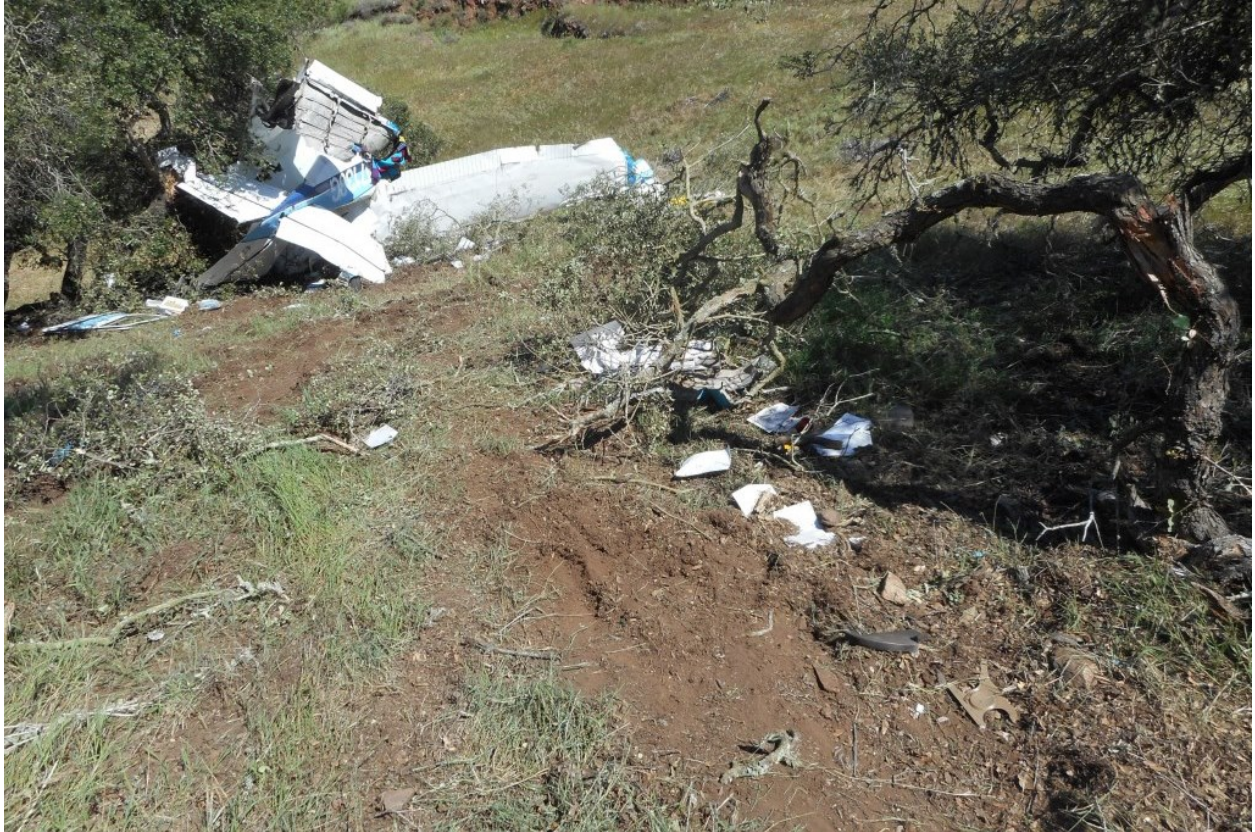
**Figure 11 - Main Wreckage**

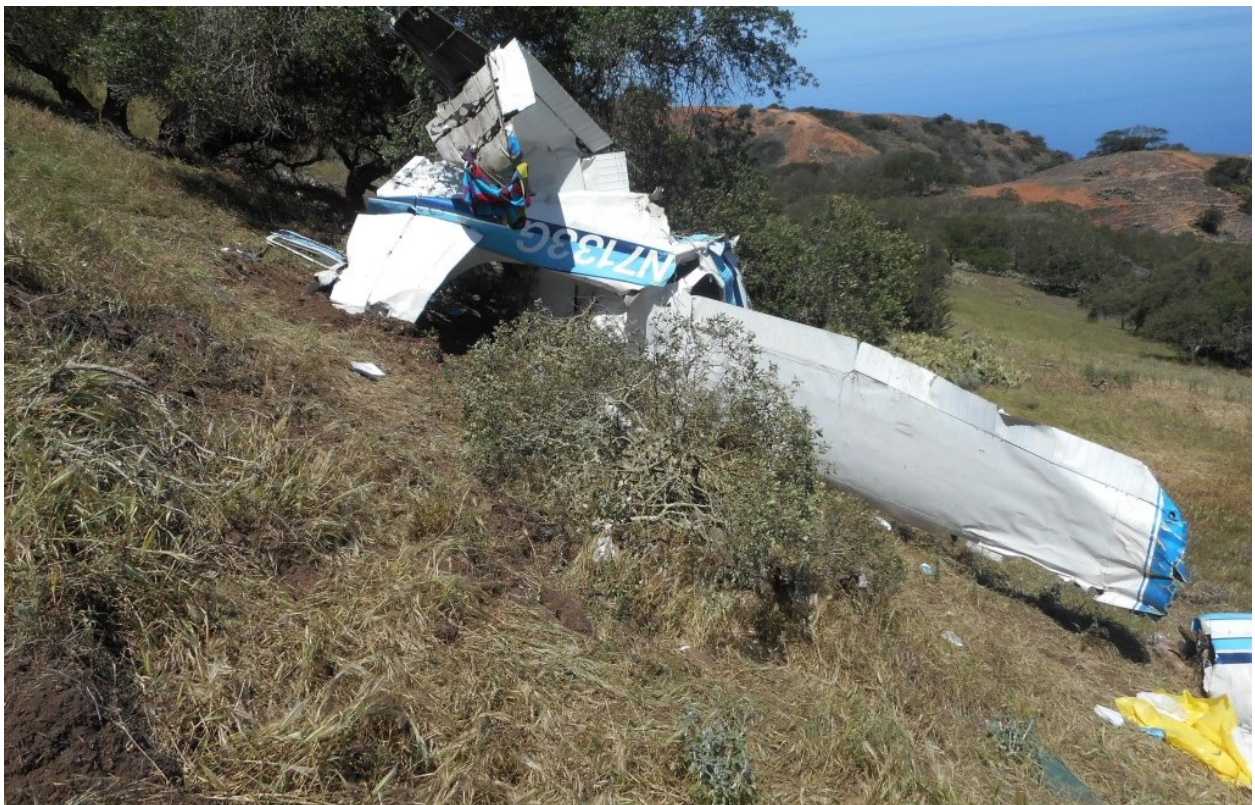
**Figure 12 - Main Wreckage**

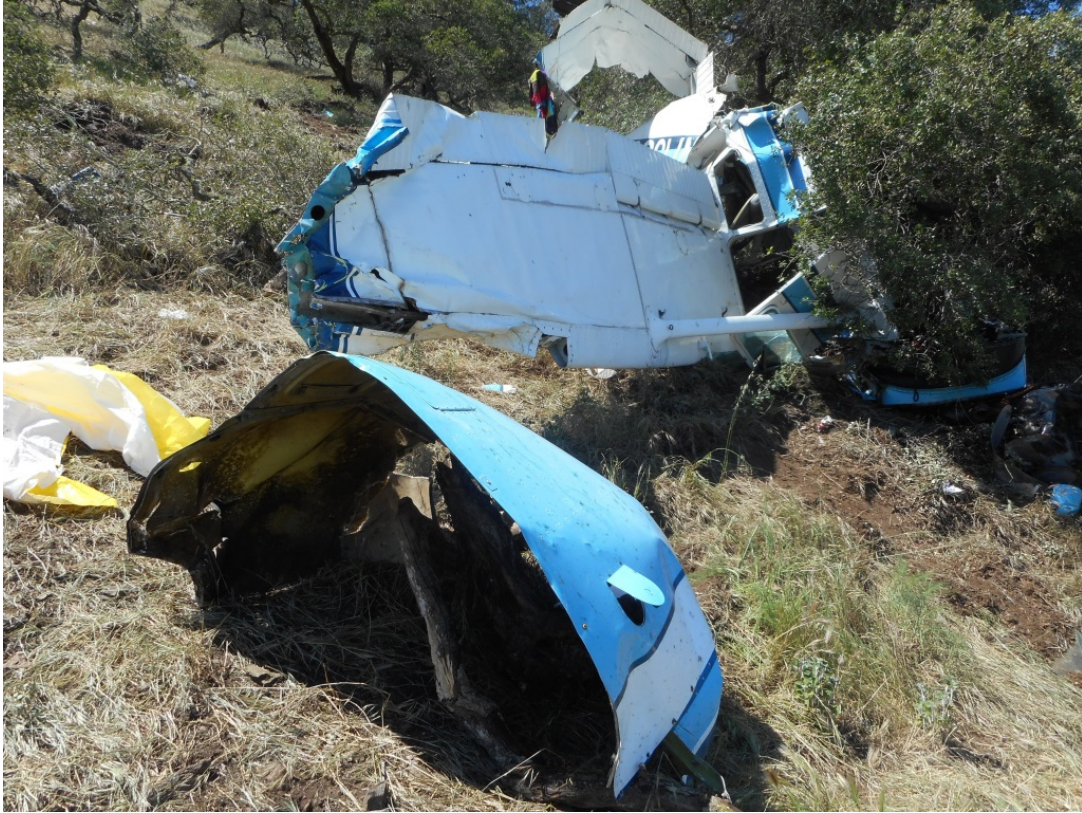
**Figure 13 - Cowl and Left Wing**

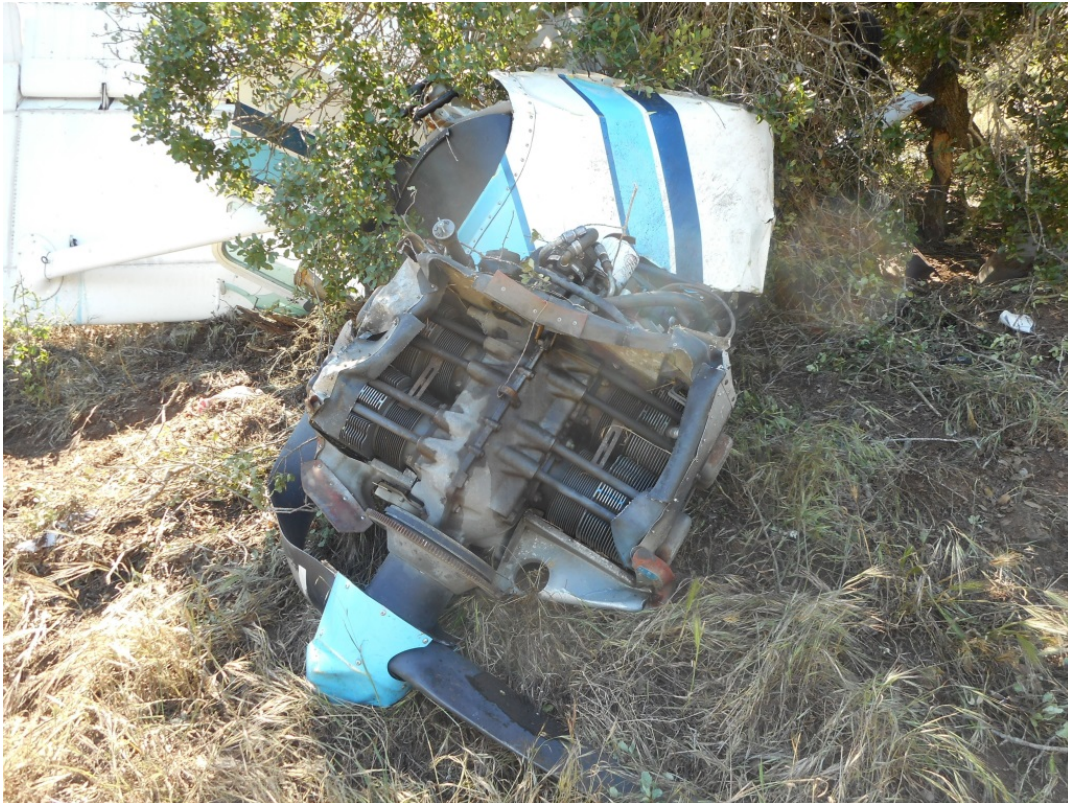
**Figure 14 - Engine and Propeller**

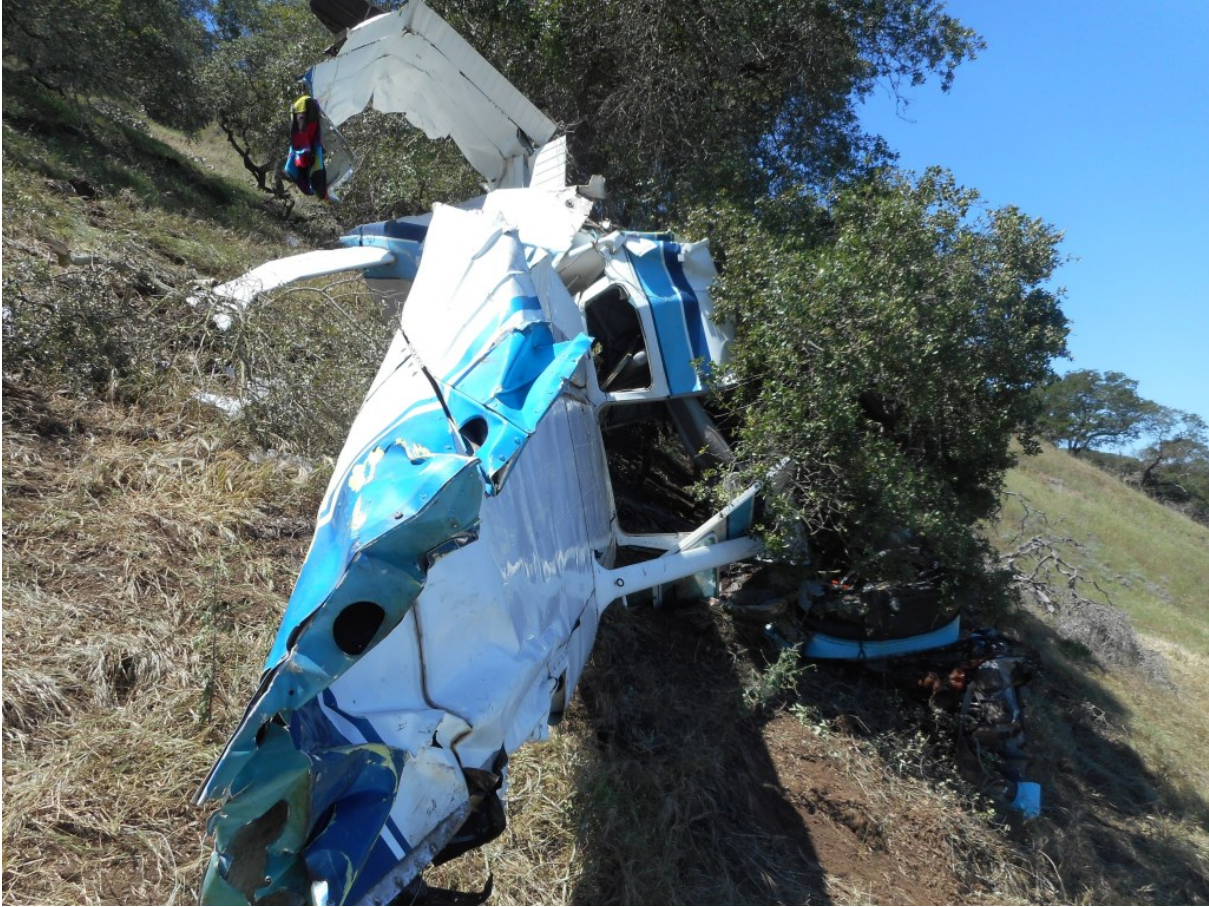
**Figure 15 - Left Wing and Cabin**

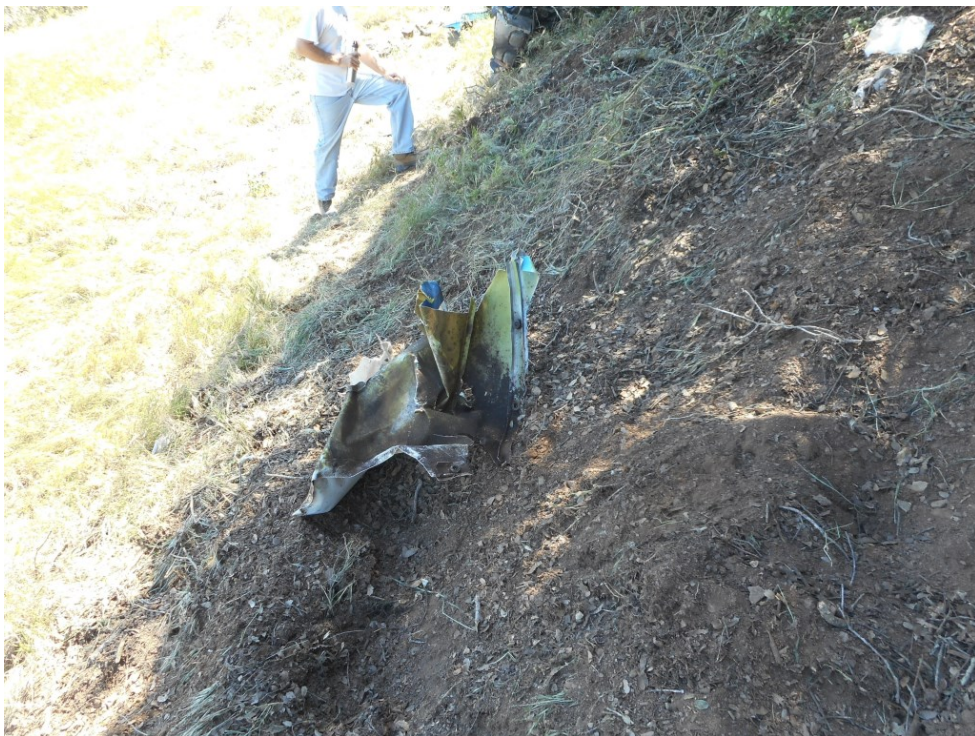
**Figure 16 - View Demonstrating Terrain Slope Steepness**
