## RECORD OF COMMUNICATION

**Date: May 17, 2016**  
**Person Contacted: Mr. Elliot Seguin (Pilot)**  
**NTSB Accident Number: WPR16LA110**

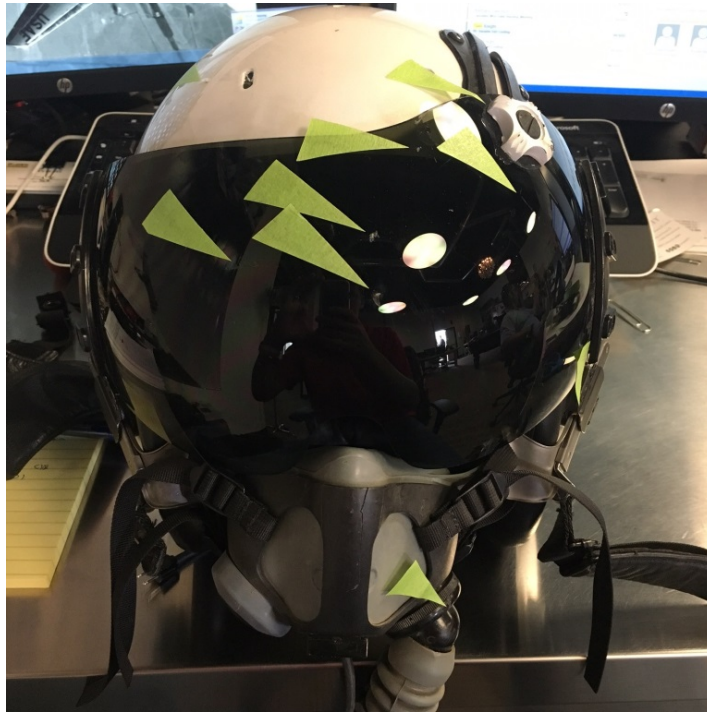
**Figure 1 - Helmet**

The pilot also included several photographs of the helmet; he marked the damage sites with green paper triangles (below).

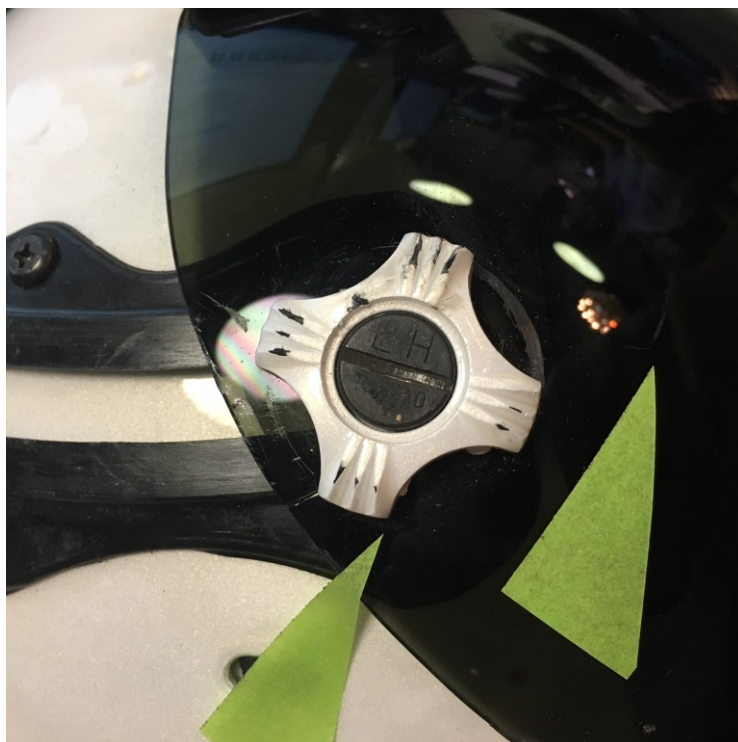
**Figure 5 – Helmet Visor Knob**

The helmet is here with me in Chino. I was taking it in to be inspected today, so I am glad I got this email before that. My natural flinch pose puts my left eye forward. Which presents the friction knob on the helmet to the crash. Something in the crash caught the friction knob (there are marks on the knob and the visor is cracked right there) and pulled it open, presenting my eye to the crash.
