**FAA Photo 1 – Main Wreckage**

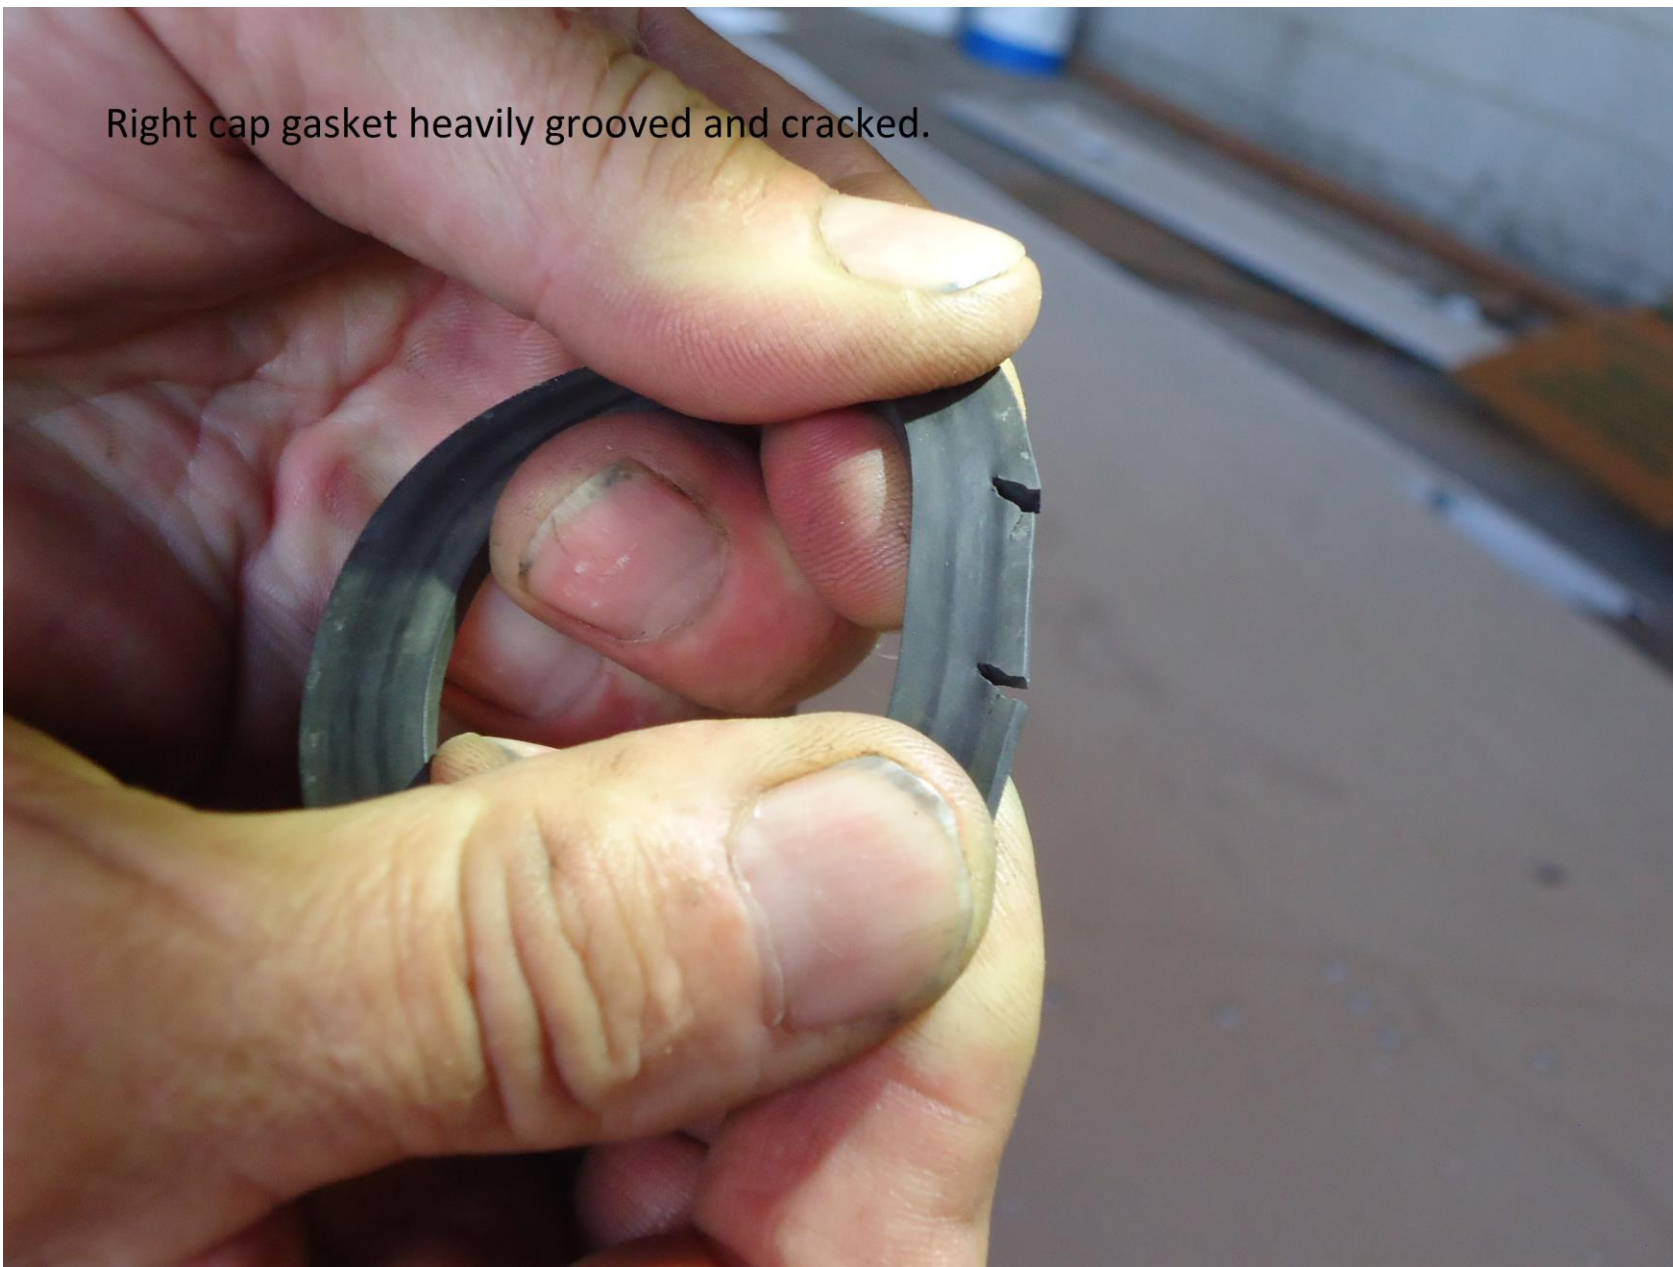
**FAA Photo 3 – Right Wing Tank Cap Seal**

Right cap gasket heavily grooved and cracked.
