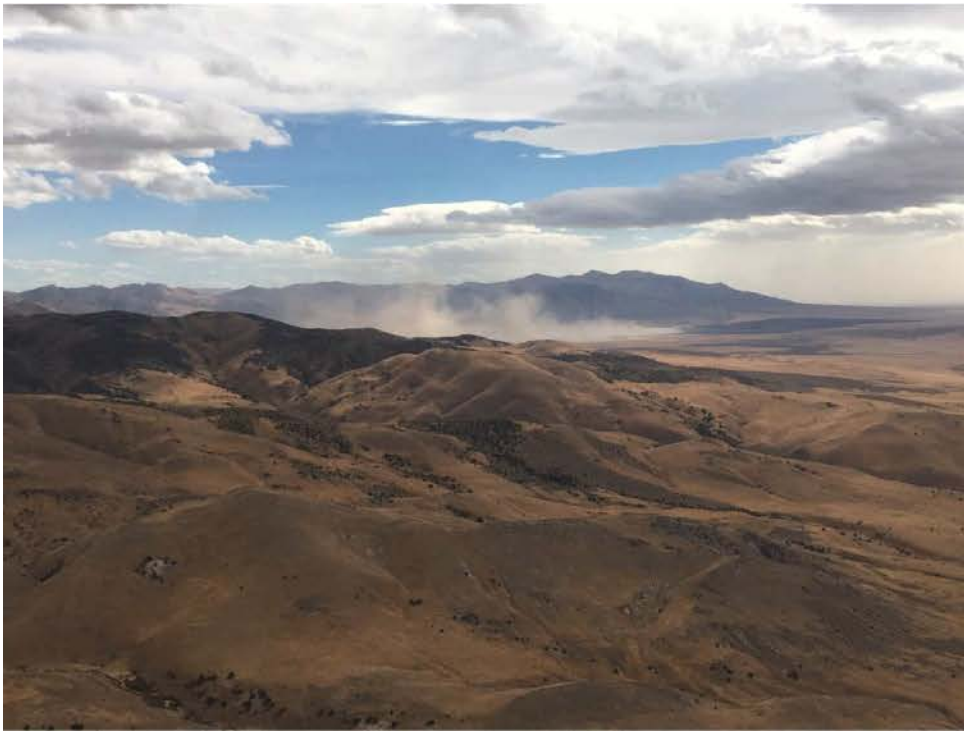
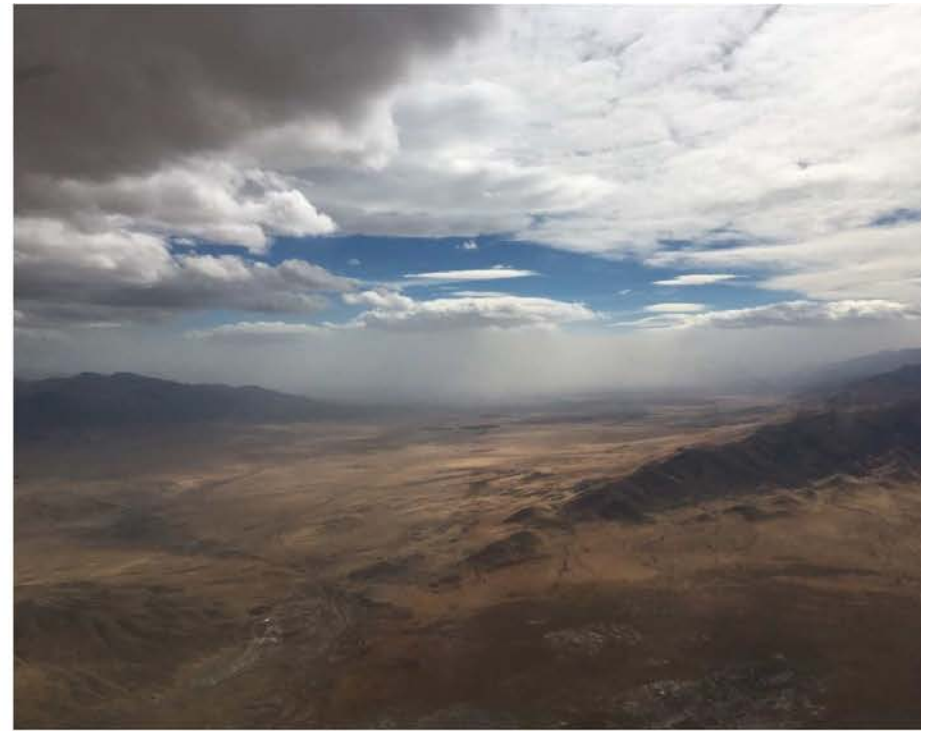
**Figure 1, 2 – Photographs Taken by the Pilot at 1329 (left) and 1336 (right).**

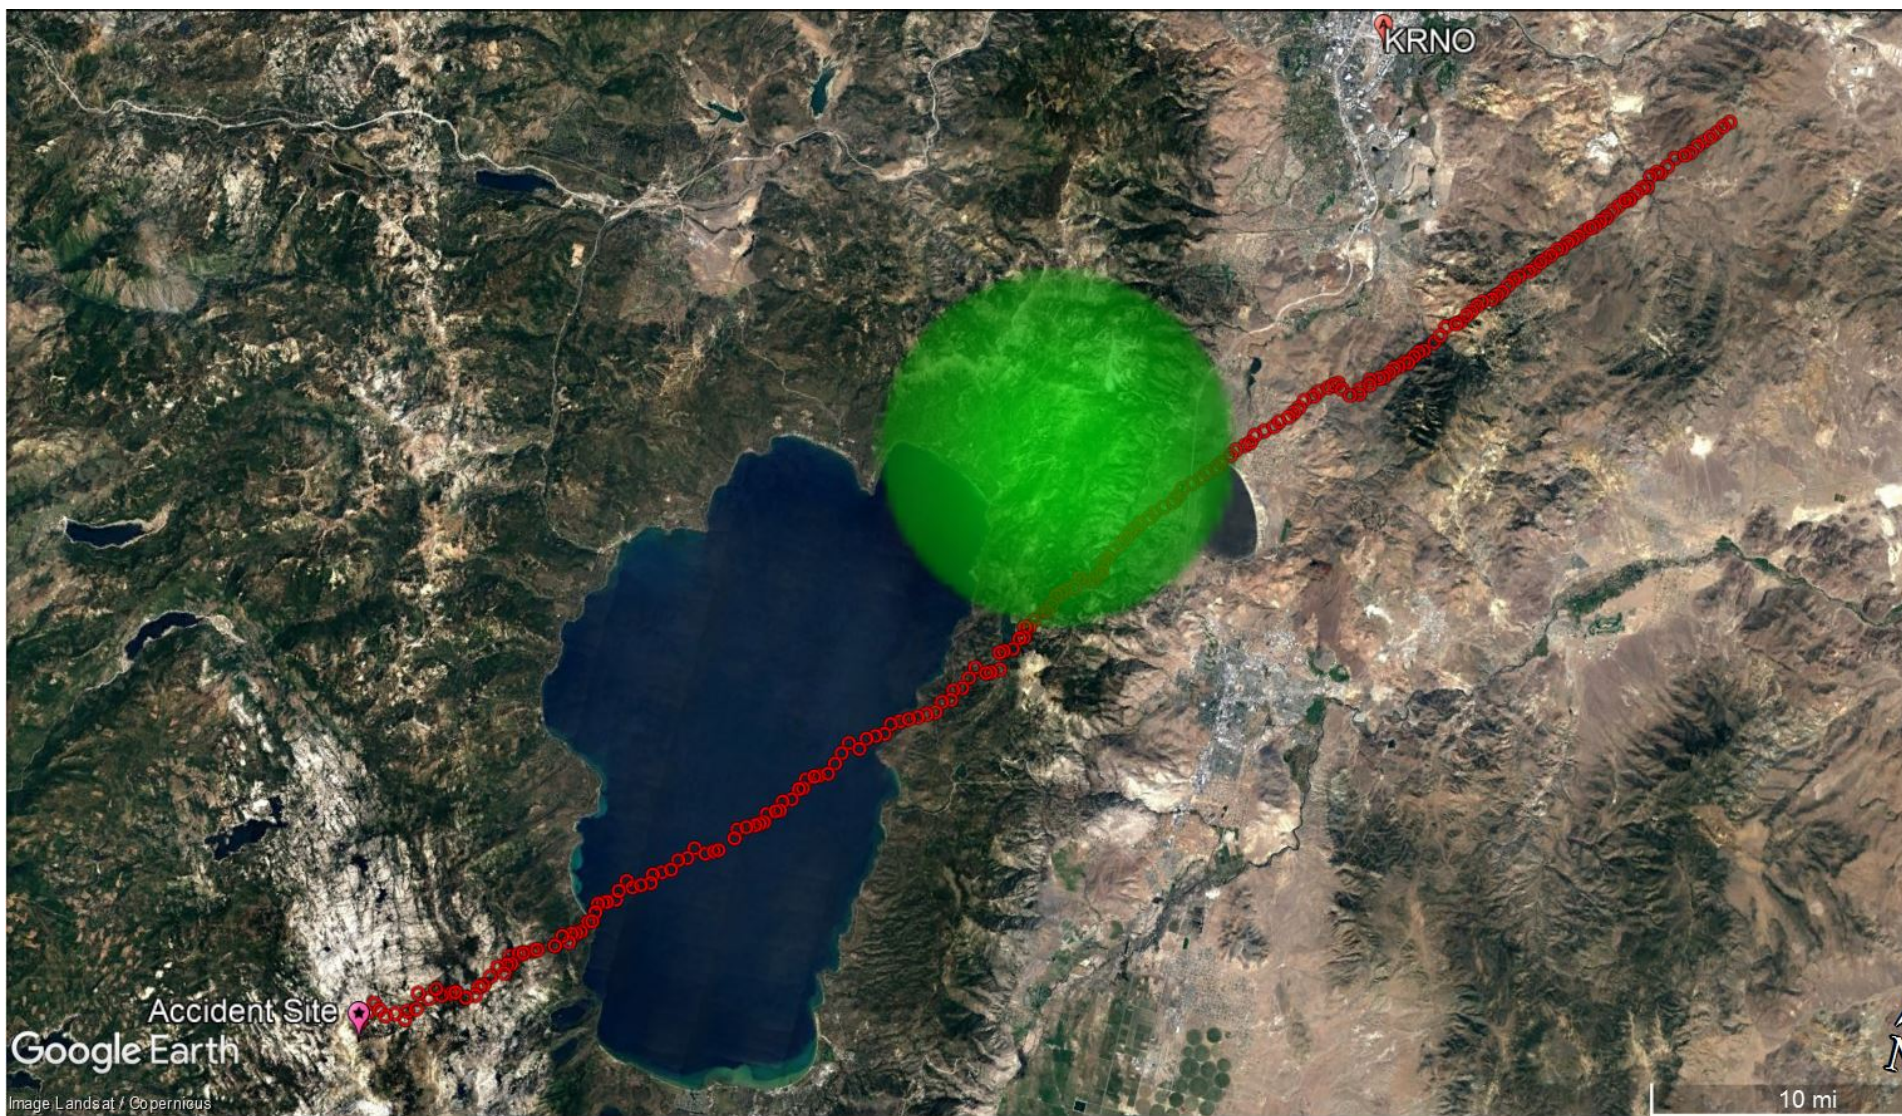
**Figure 3 - Temporary Flight Restriction (green) Underneath the Route of Flight**

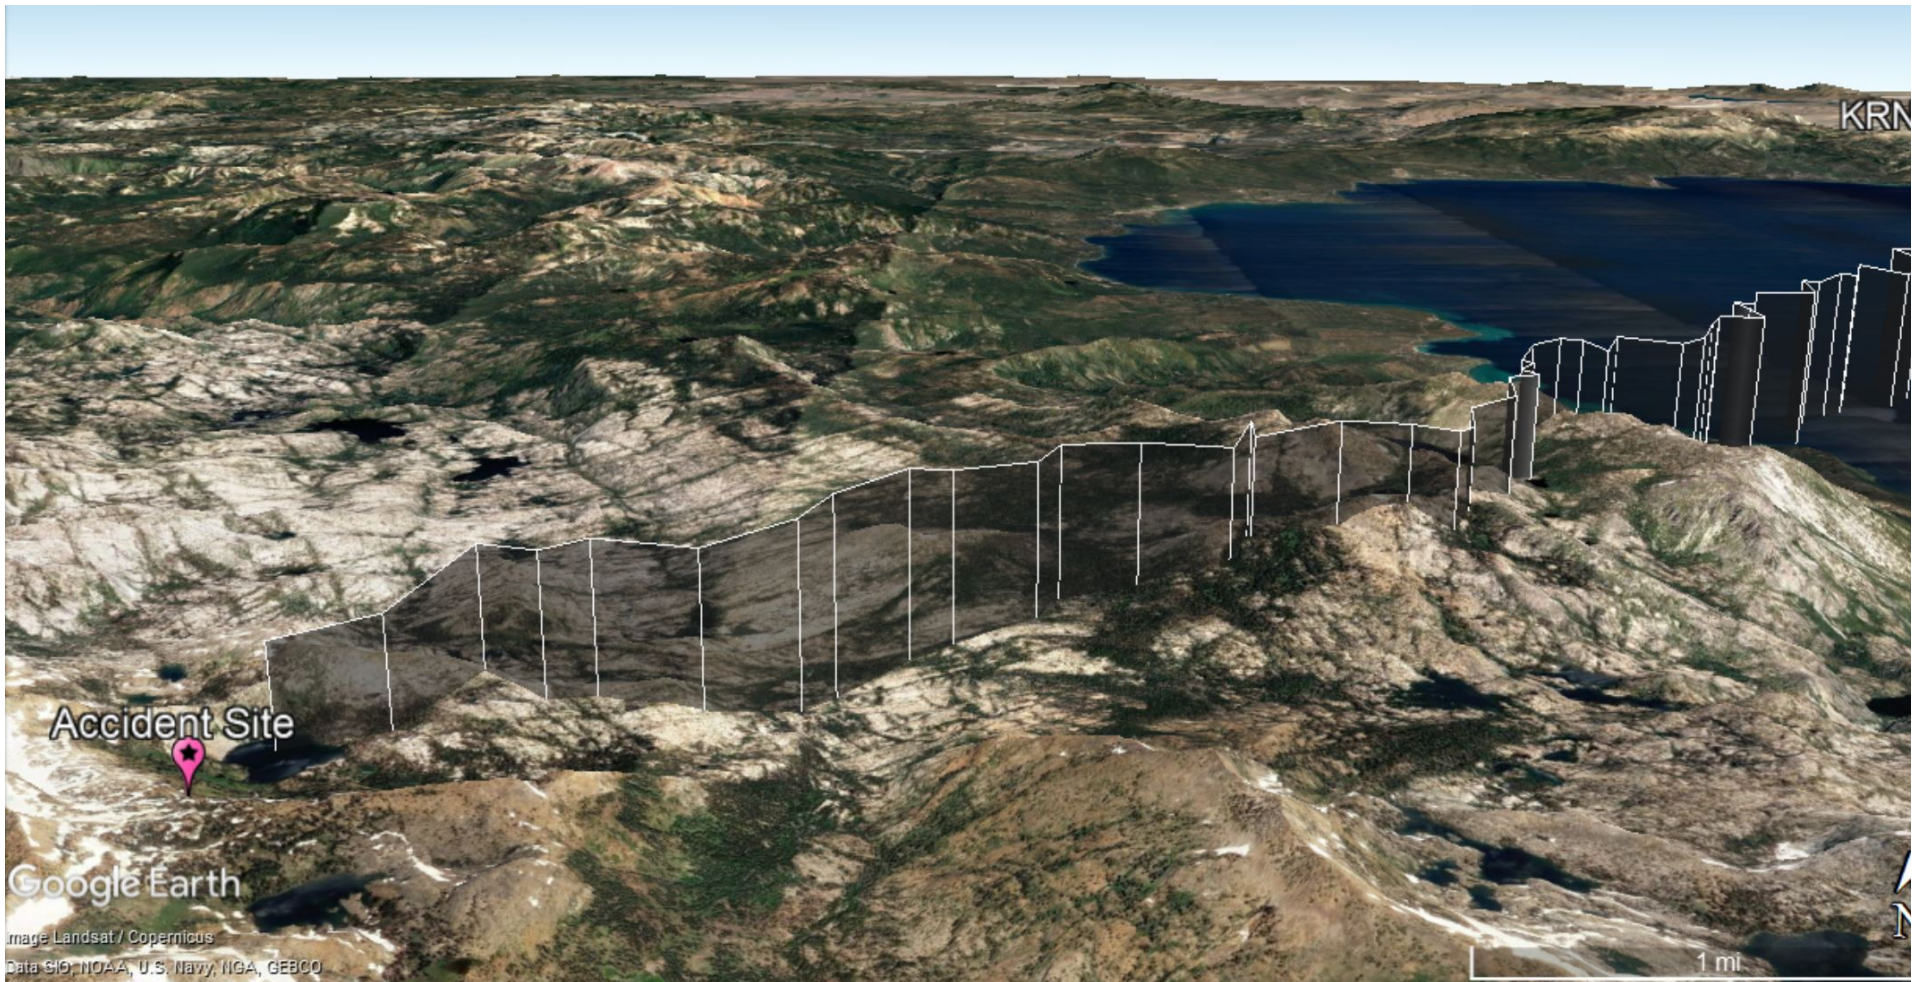
**Figure 4 - Flight Path During the Final Stages of Flight (the white lines are direct connections between each acquired radar target and do not represent the airplane's actual flight path between targets)**

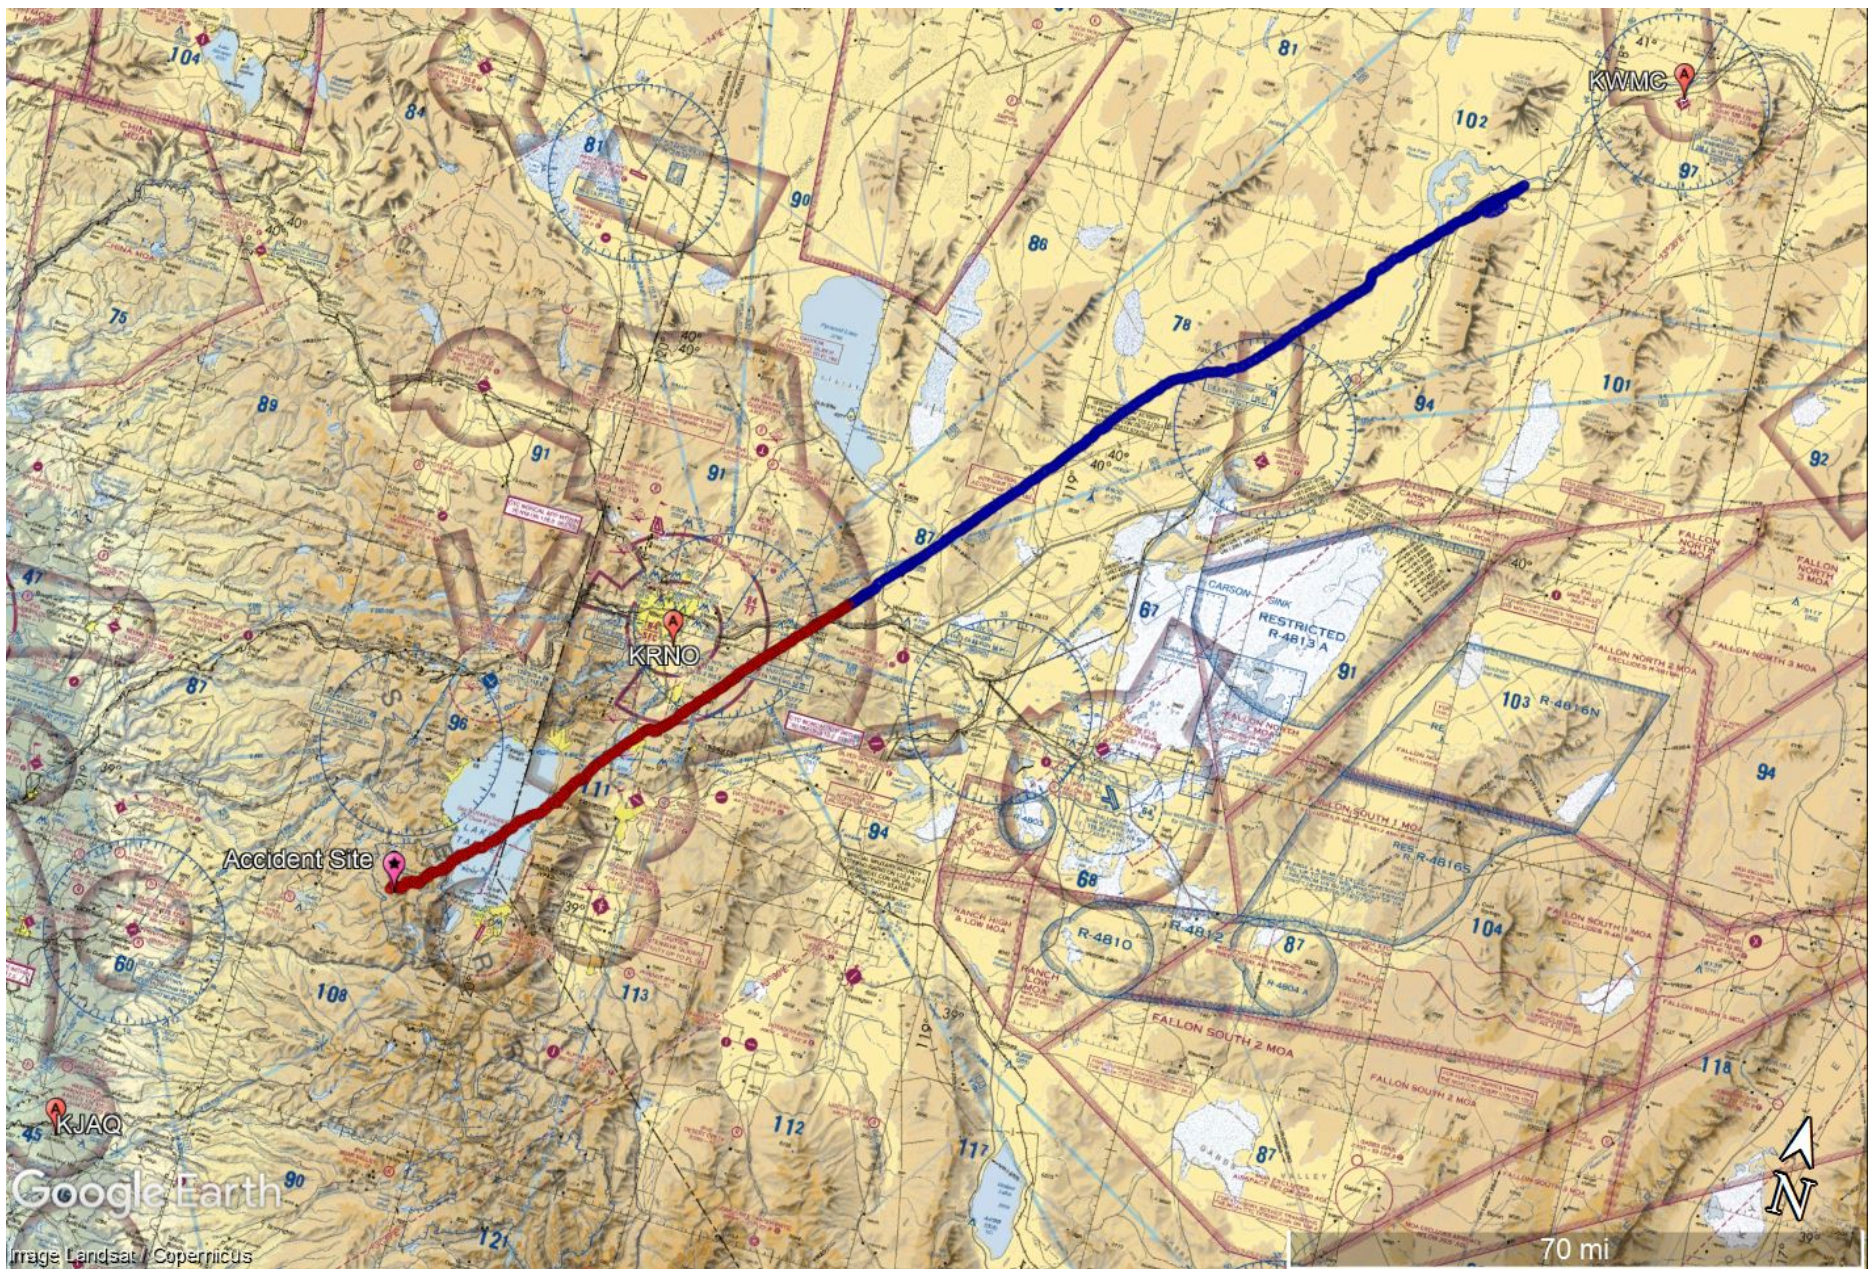
Figure 5 - Radar-acquired Route of Flight (blue indicates 1200 transponder code, red indicates 3726 transponder code)

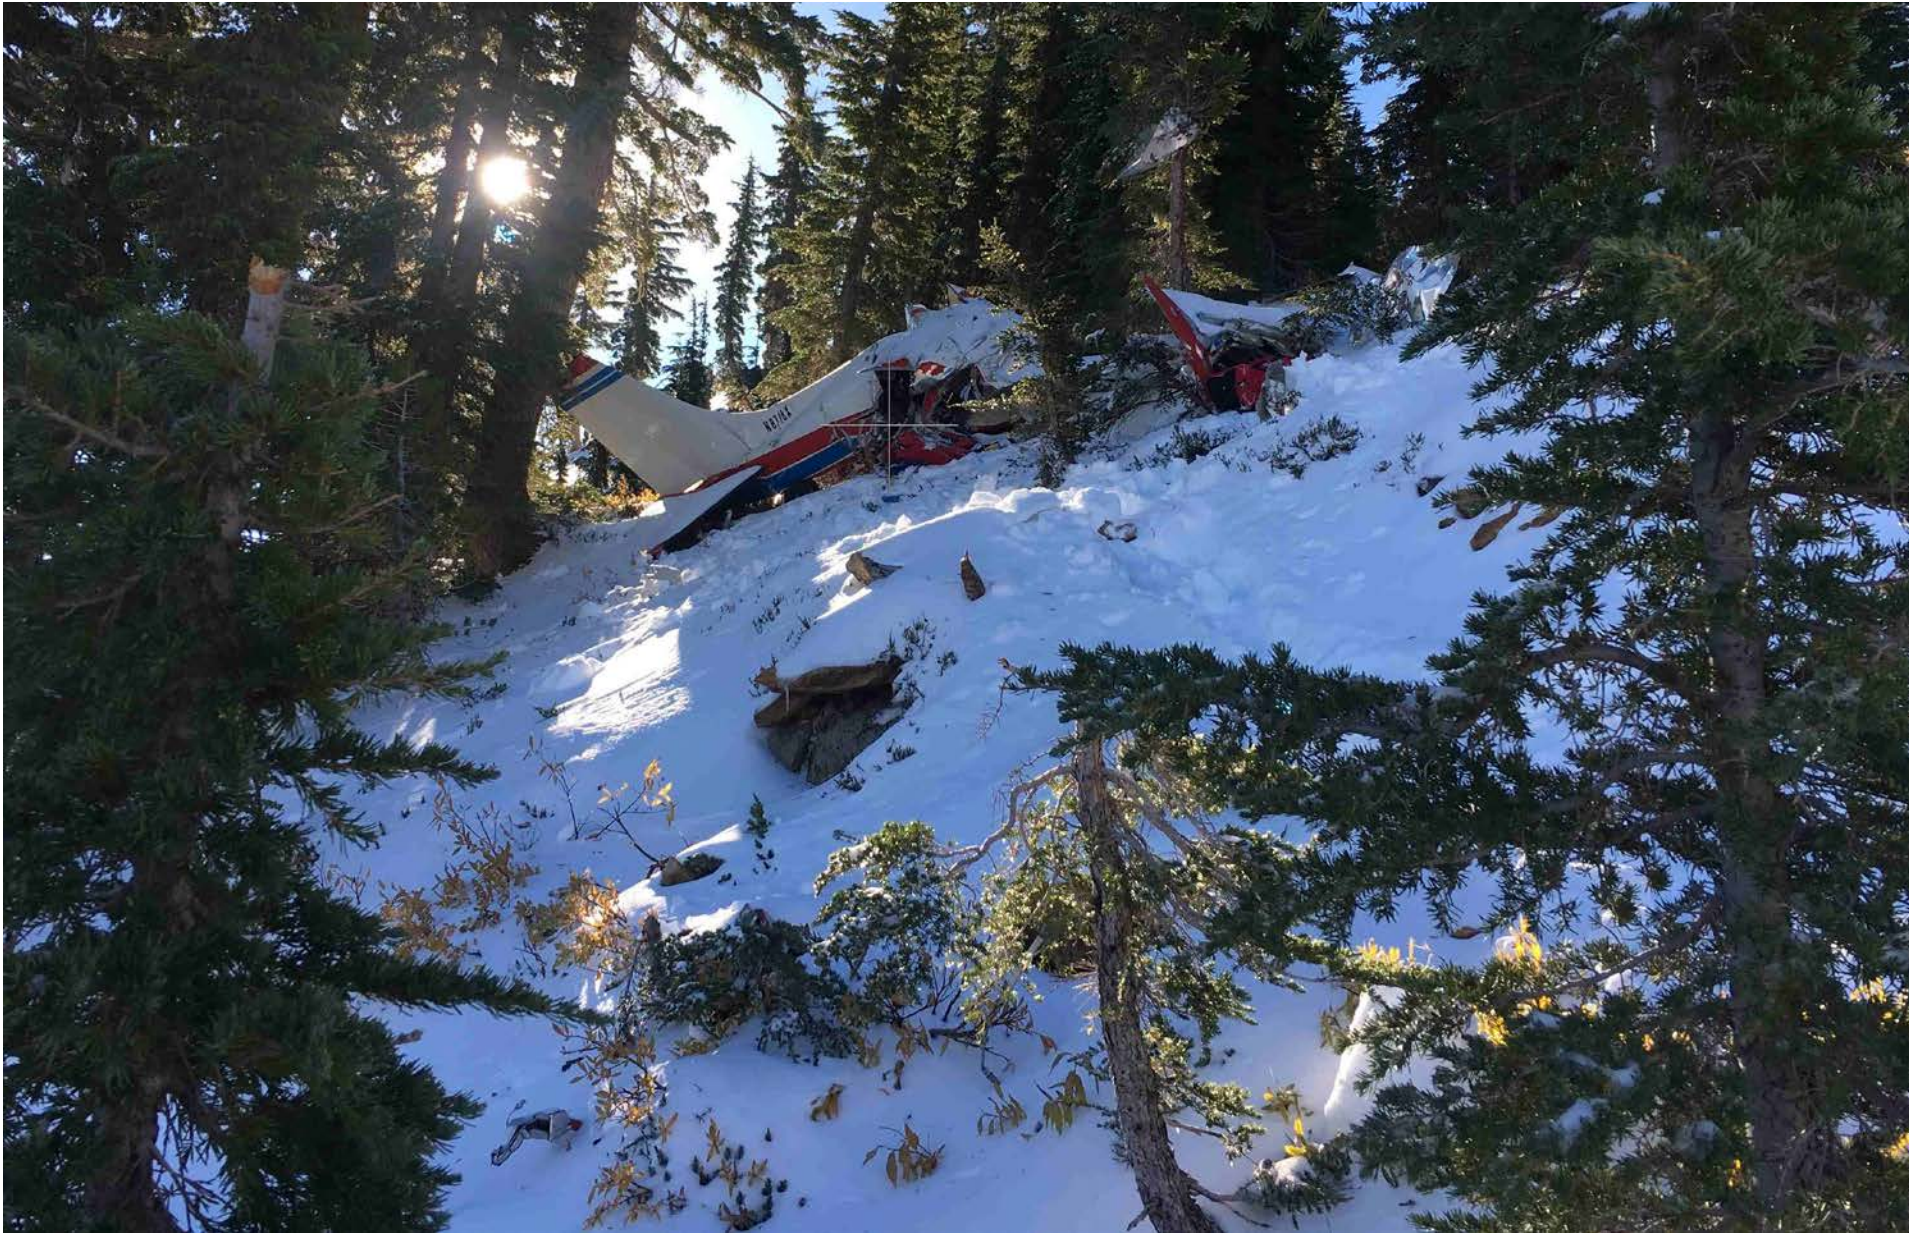
**Figure 6 - Airplane Wreckage at the Accident Site**
