## **NATIONAL TRANSPORTATION SAFETY BOARD**

### **Weather Study**

WPR17FA044

Location: Near Dabob, Washington  
Date: December 29, 2016  
Time: 1844 Pacific standard time  
0244 Coordinated Universal Time (UTC) on December 30  
Airplane: Cessna 182P, N52388

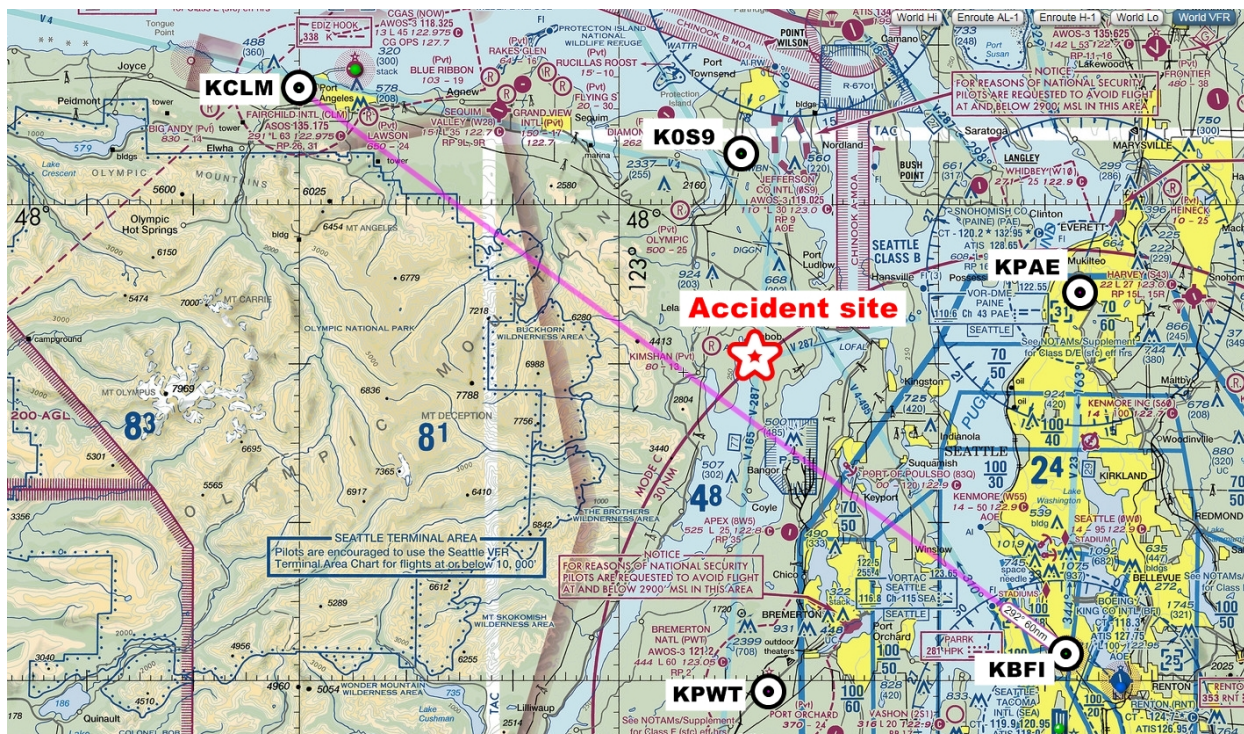
**Figure 8 – Sectional chart of accident area with the location of the accident site, surface observation sites, and a line between the departure airport and the intended destination airport**
