# **NATIONAL TRANSPORTATION SAFETY BOARD**

**MATERIALS LABORATORY FACTUAL REPORT**

**Report No. 19-021**

Place : Madras, Oregon  
Date : August 19, 2017  
Vehicle : Wheeler Express  
NTSB No. : WPR17FA185  
Investigator : Zoë Keliher

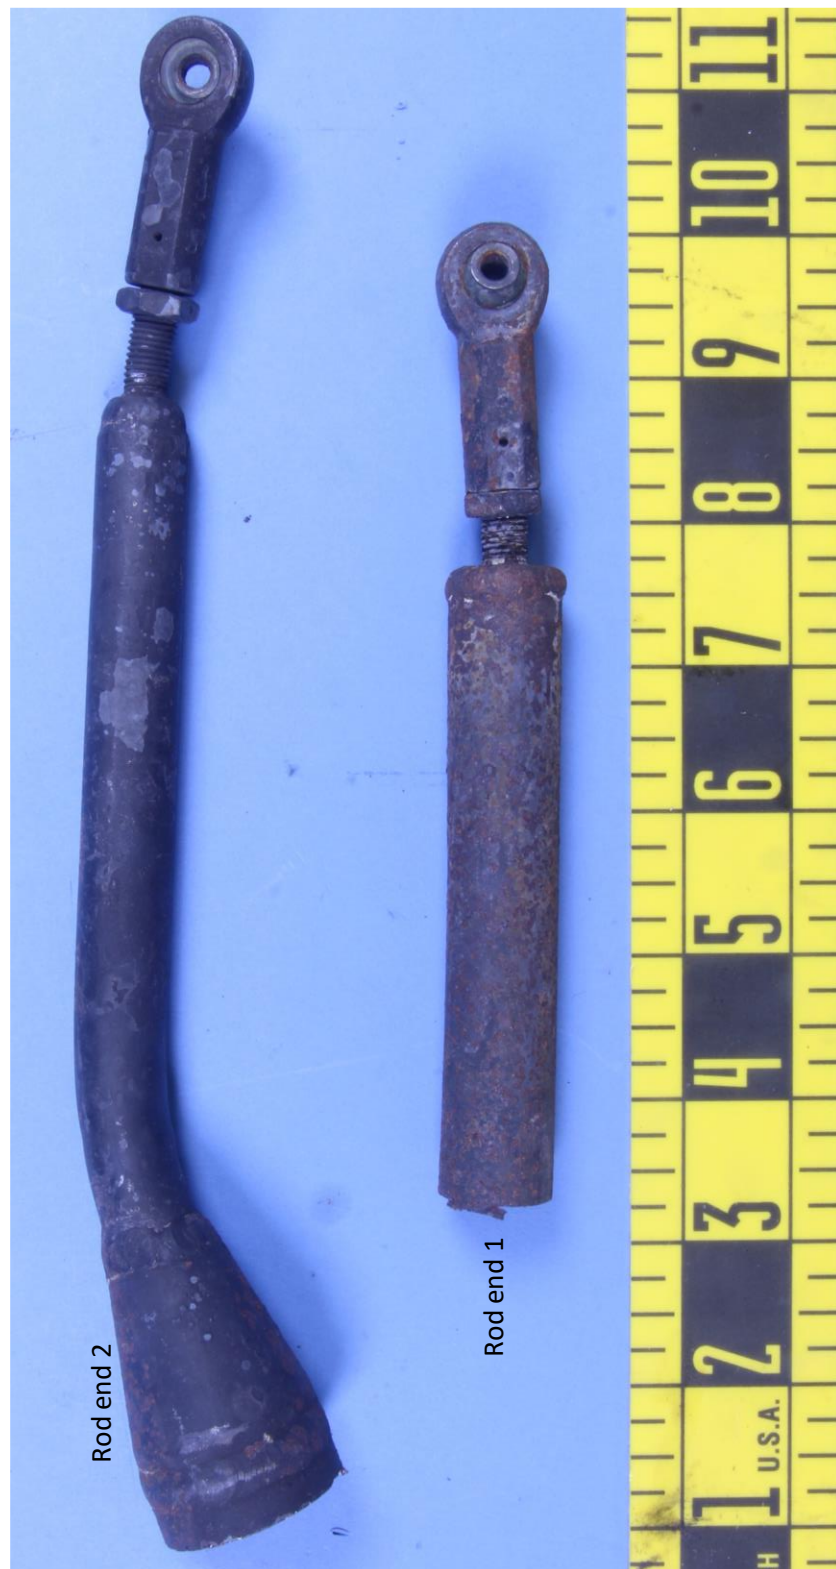
Figure 2 Views of the rod end bearings.

Two rod ends were submitted to the Materials Laboratory for examination of the surfaces of the internal bearing bore for any evidence of the installation of fastening hardware. The as-received evidence is shown in Figure 1. Closer views of the evidence are shown in Figures 2 -4. Digital microscope images of the inner bearing bores are shown in Figure 5. Using a 5X to 50X stereo-zoom optical microscope, no markings consistent with the presence of fastening hardware were observed in either bearing bore.

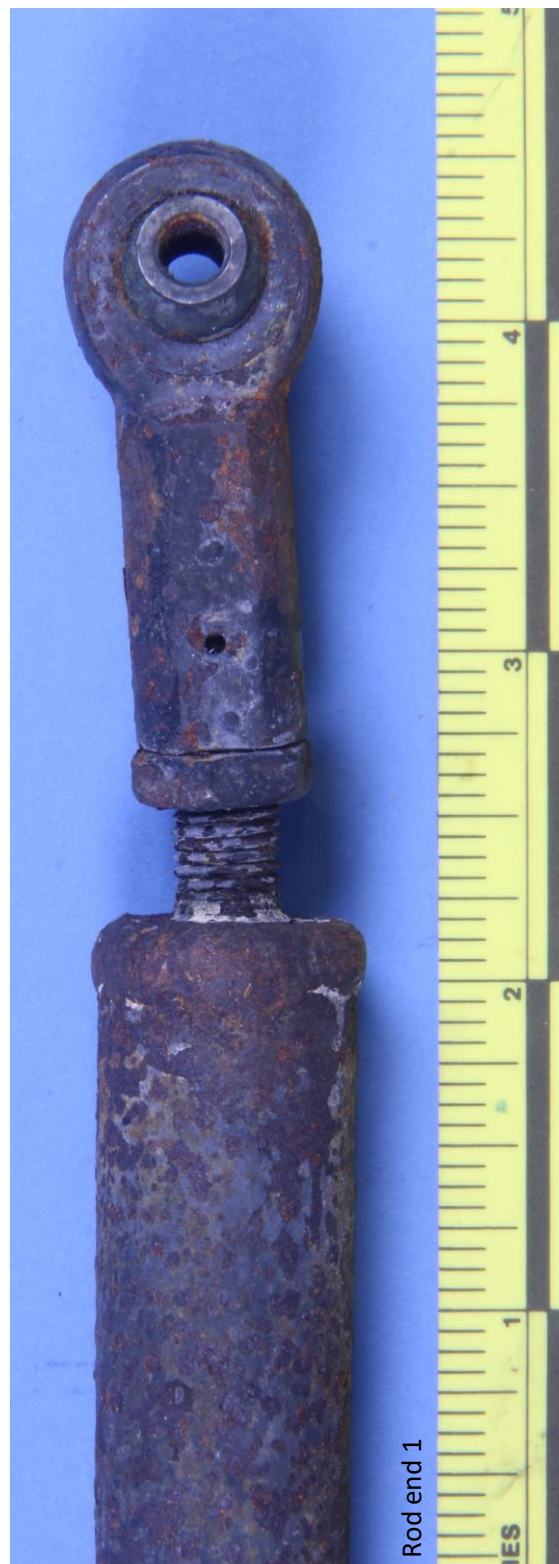
Figure 3 Closer view of rod end bearing 1.

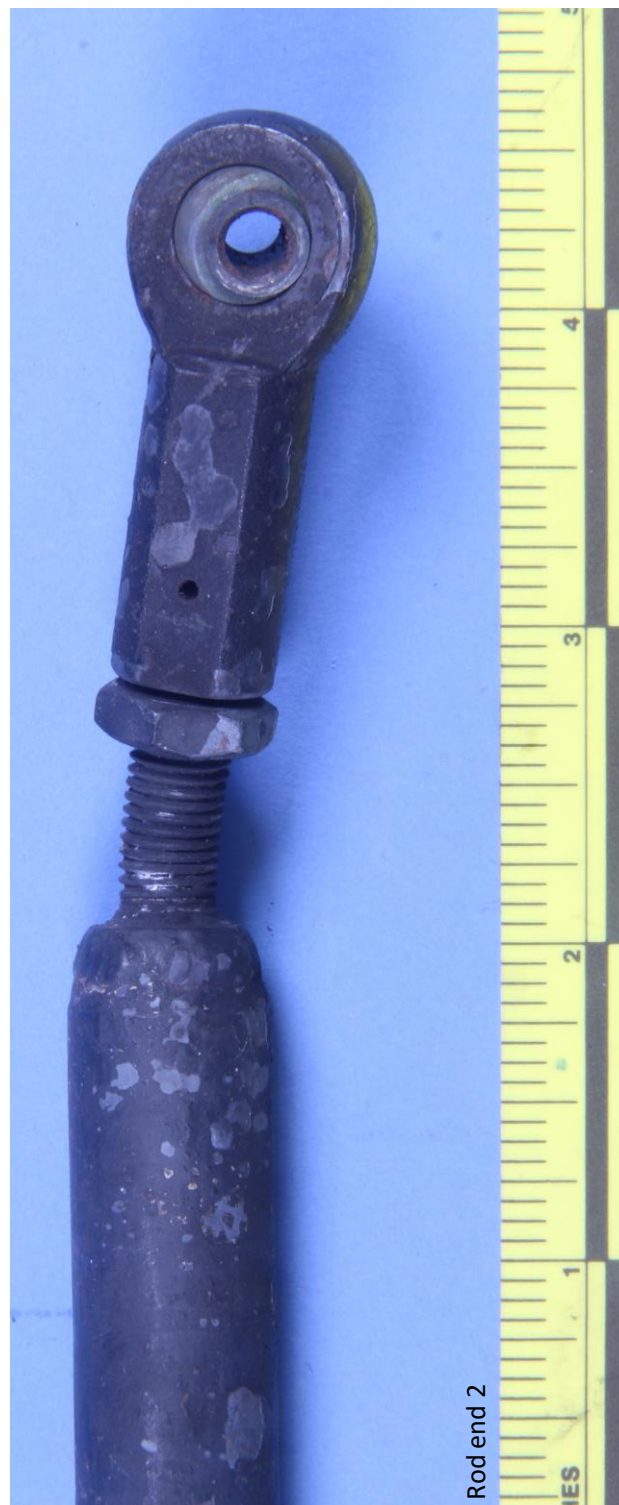
Figure 4 Closer view of rod end bearing 2

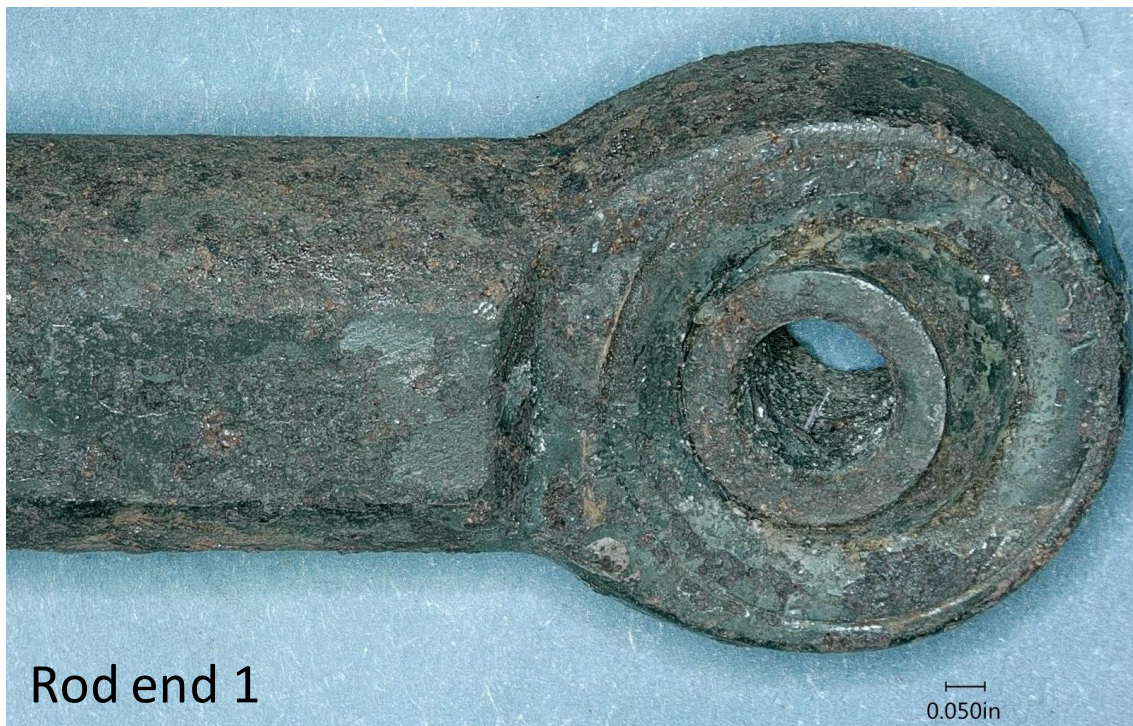
Figure 5 Close digital microscope views of the rod end bearing bores.
