# NATIONAL TRANSPORTATION SAFETY BOARD

Vehicle Recorder Division

### Specialist's Factual Report

Location: Brinnon, Washington  
Date: September 29, 2017  
Aircraft: Piper PA-28-140  
Registration: N9549W  
Operator: Private  
NTSB Number: WPR17FA215

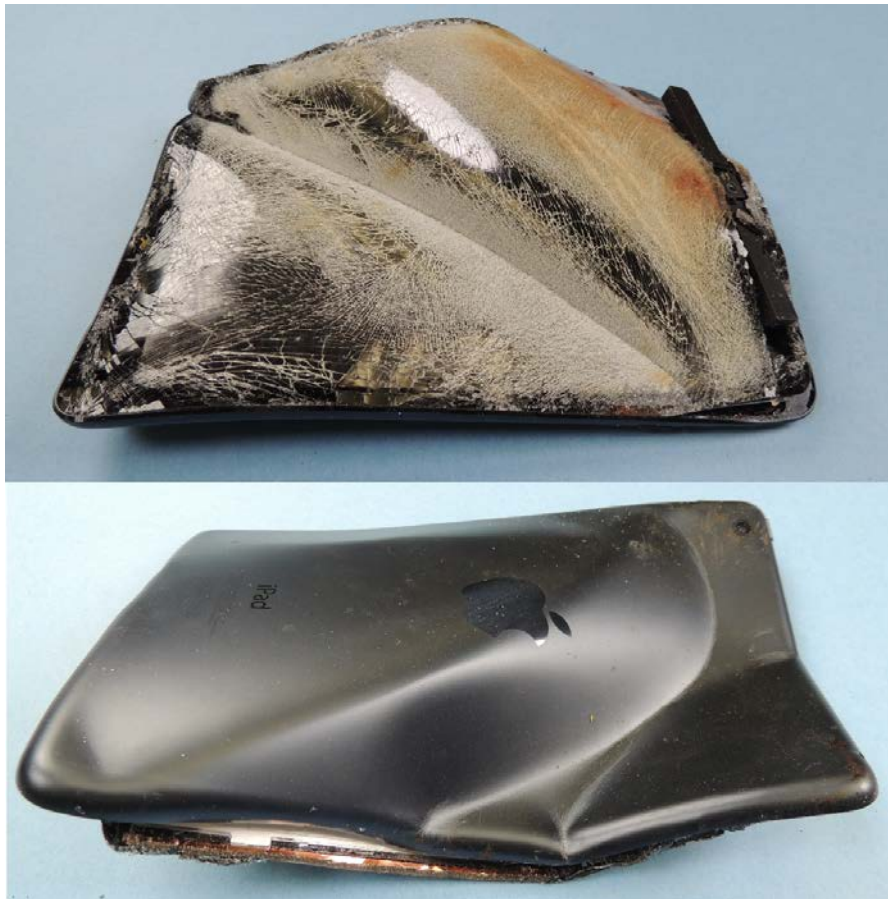
Upon arrival at the Vehicle Recorder Division, an exterior examination revealed the unit had sustained severe impact damage, as shown in Figure 1. The main board was removed and installed in a surrogate device. The surrogate device powered on normally.

**Figure 1.** Front and back of the iPad Mini as received.

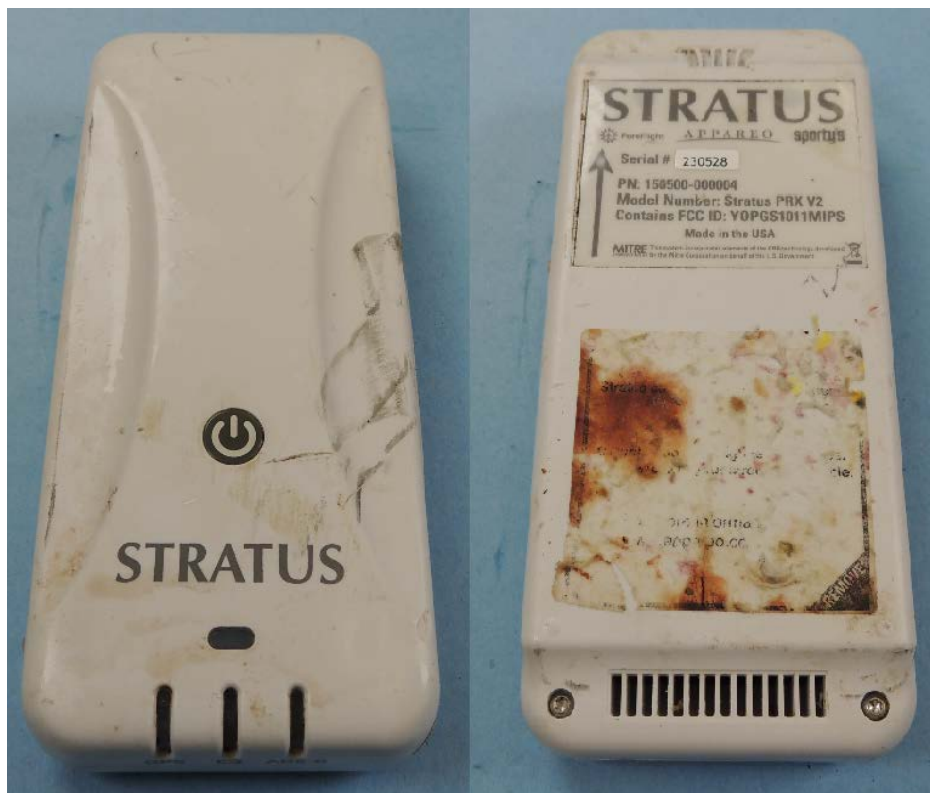
Upon arrival at the Vehicle Recorder Laboratory, the device appeared undamaged externally as shown in Figure 3. The unit, however, did not power on normally. The device was opened and an examination revealed damage to the circuit boards. The device's internal memory chip was identified and removed. The chip was cleaned and read with the appropriate model reader. A binary image was obtained of the internal memory and laboratory software tools were used to convert the binary data to engineering units.

**Figure 3.** Front and back of the Appareo Stratus PRX V2 as received.

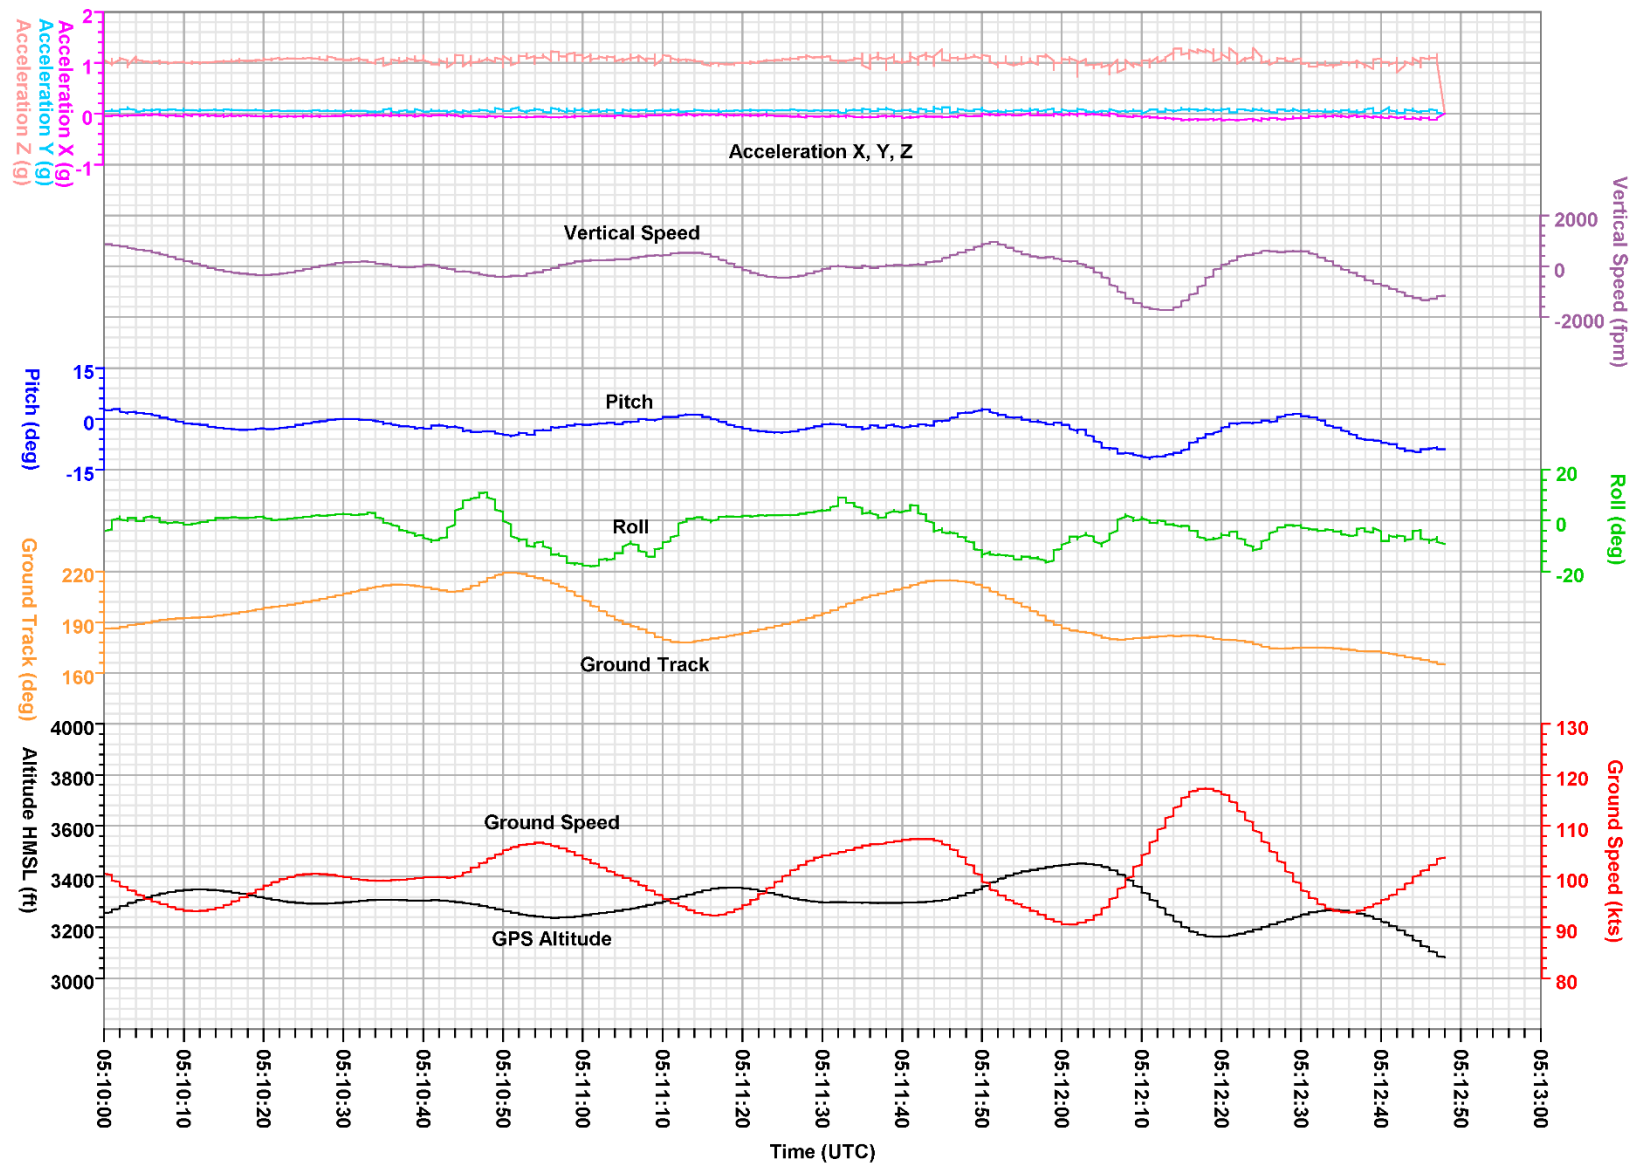
Figure 7 is a plot of basic parameters during the last portion of the accident flight. The time interval is 05:10:00 to 05:13:00 UTC.

Figure 7. Plot of basic parameters at the end of the accident flight.

Vertical Speed and Acceleration Z were found to be reversed when compared to other data. These data were inversed in the plotted information and tabular data provided in this report. It was unclear whether the device was mounted upside down by the pilot, or if there was a conversion error in the translation of the binary data to engineering units.

Tabular data used to generate figures 4 through 7 are included as Attachment 1. This attachment is provided in electronic comma separated value (.CSV) format.
