# NATIONAL TRANSPORTATION SAFETY BOARD PILOT/OPERATOR AIRCRAFT ACCIDENT/INCIDENT REPORT

The Pilot/Operator (Pilot) investigated, inspected and studied the emergency landing of helicopter, N311VT, at a certain site in the Kohala Mountains. The purpose was to determine its cause and to identify those results and experiences that will improve future safety, maintenance and operations.

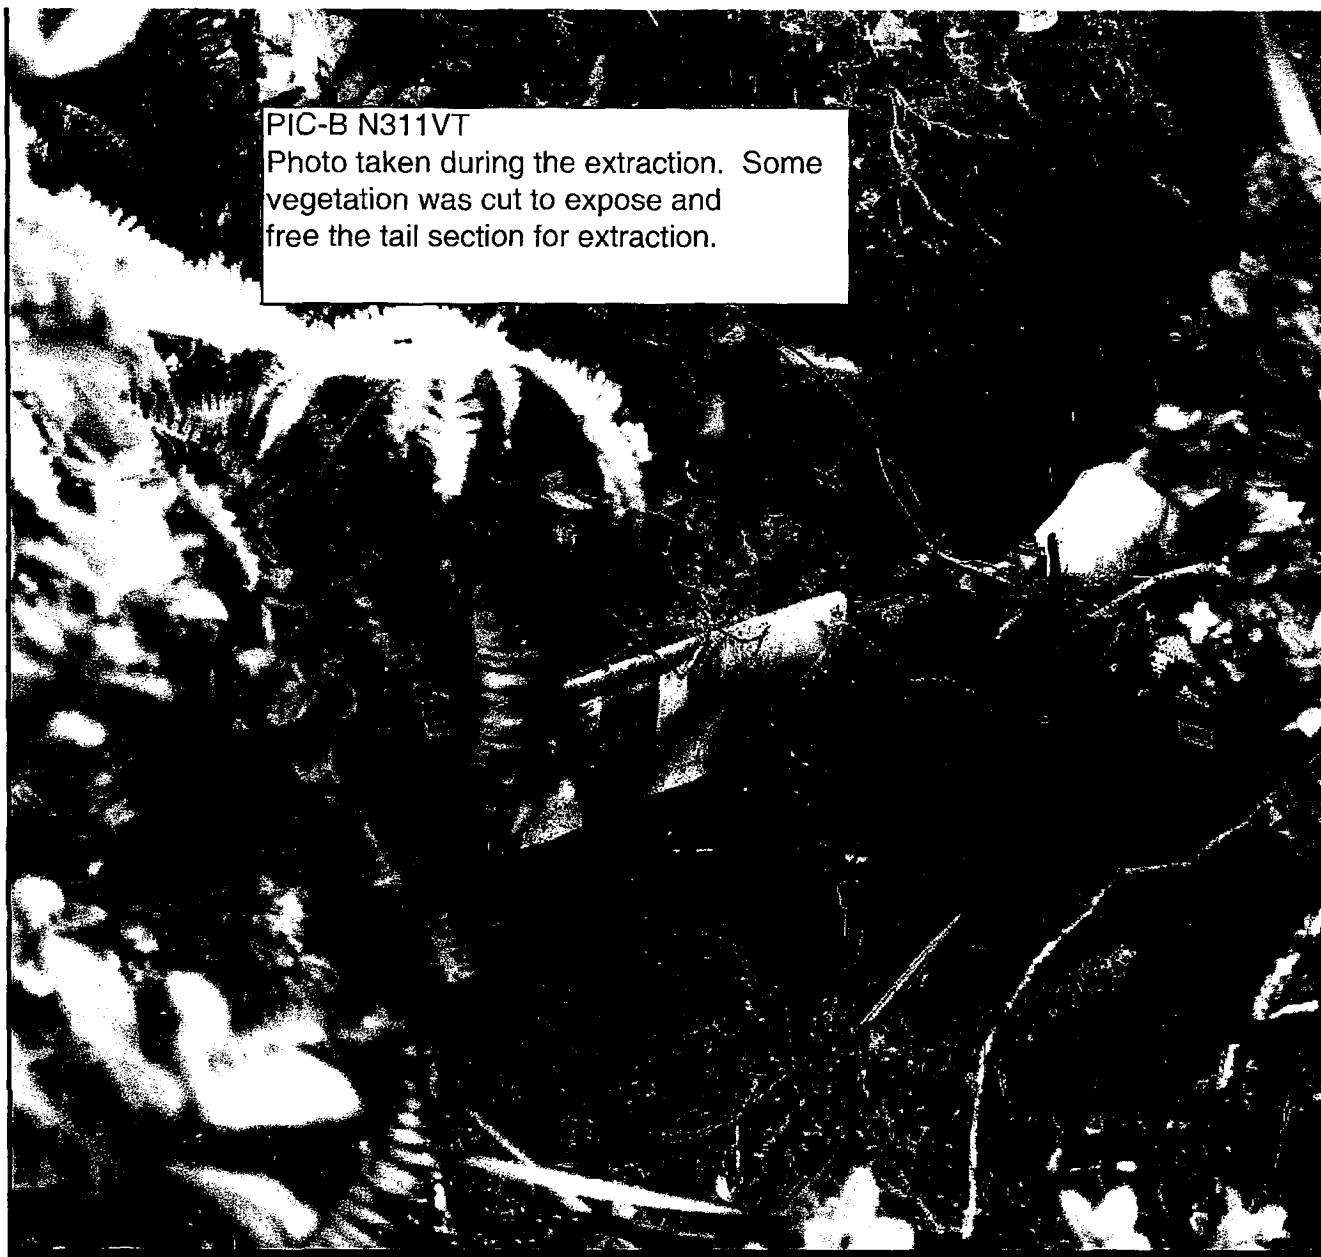
PIC-B N311VT

Damage - Tail Rotor Blades, Two (2), attached Photo #01 & PIC-B N311VT.  
Collateral Damage: Tail rotors damaged by bush and shrubbery during the touchdown of emergency landing.

Photo taken during the extraction. Some vegetation was cut to expose and free the tail section for extraction.
