Enviro Systems, Inc. Evaluation Test Report – Cabin Pressurization Control System

## Evaluation Test Report Cabin Pressurization Control System

**Enviro Part Numbers:**  
Controller – 52811-701  
Valves – 52812-701

The purpose of this evaluation test report is to document the condition of the pressurization control system as received by Enviro Systems. The system was removed from an accident aircraft that had a wind screen failure in flight. All unpacking and testing was witnessed by Mr. Gail Sober from the FAA Oklahoma City Flight Standards District Office

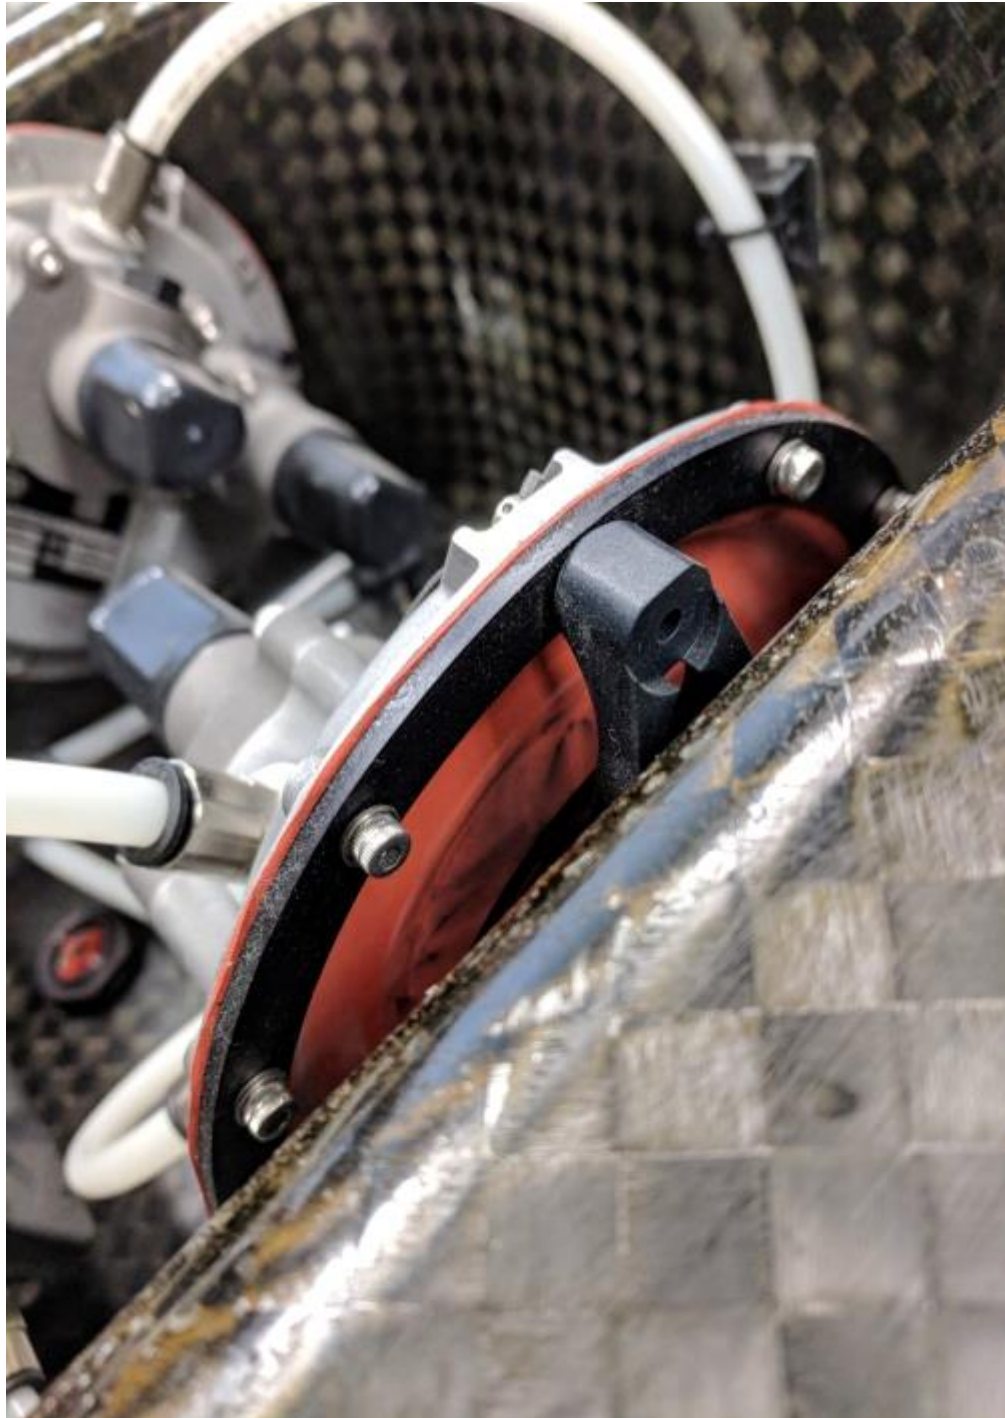
Visual inspection revealed the entire system was intact and with no damage. A functional Leak test on the static ports of the entire system revealed no leaks and the diaphragms remained in the normal fully open position. See Figure 1, Figure 3, Figure 8, Figure 9, Figure 10, and Figure 11 showing diaphragm position and leak test setup. The hardware securing each valve was properly fastened and the gasket was compressed and sealed in the normal condition. See Figure 2 showing installed outflow valve with compressed gasket. The controller installation only utilized two of the four mounting provisions. See Figure 12 and Figure 33 showing mounting hardware.

Figure 1 – Installed outflow valve showing diaphragm in open position

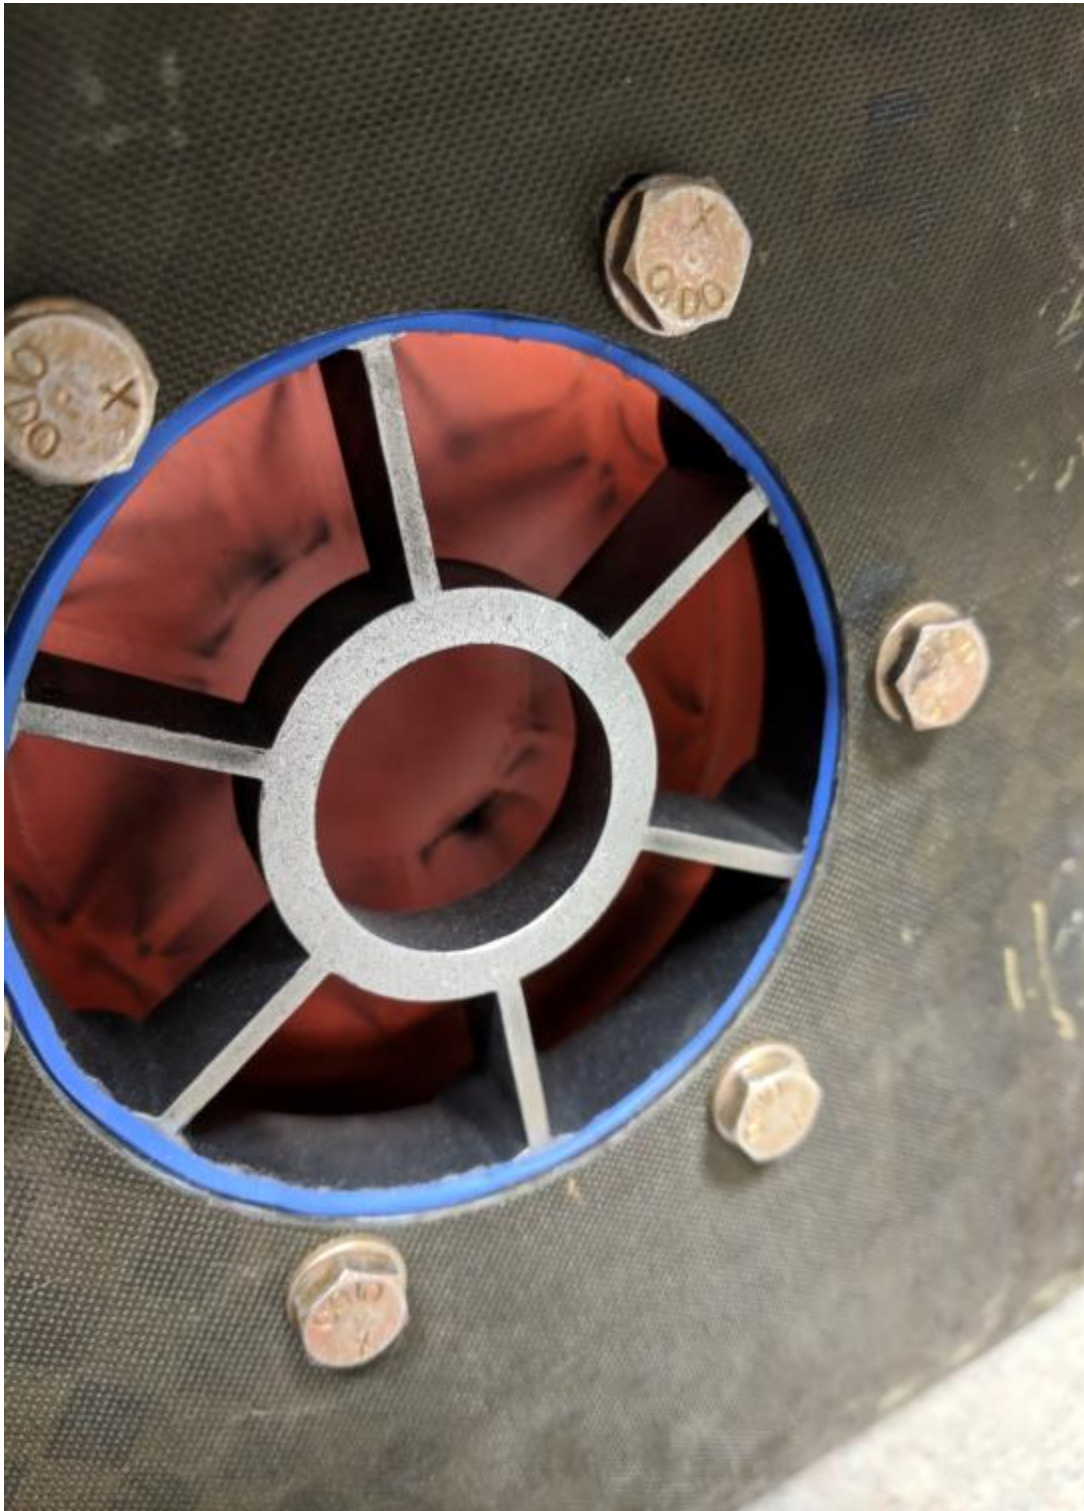
Figure 2 – Back side of outflow valve showing compressed gasket

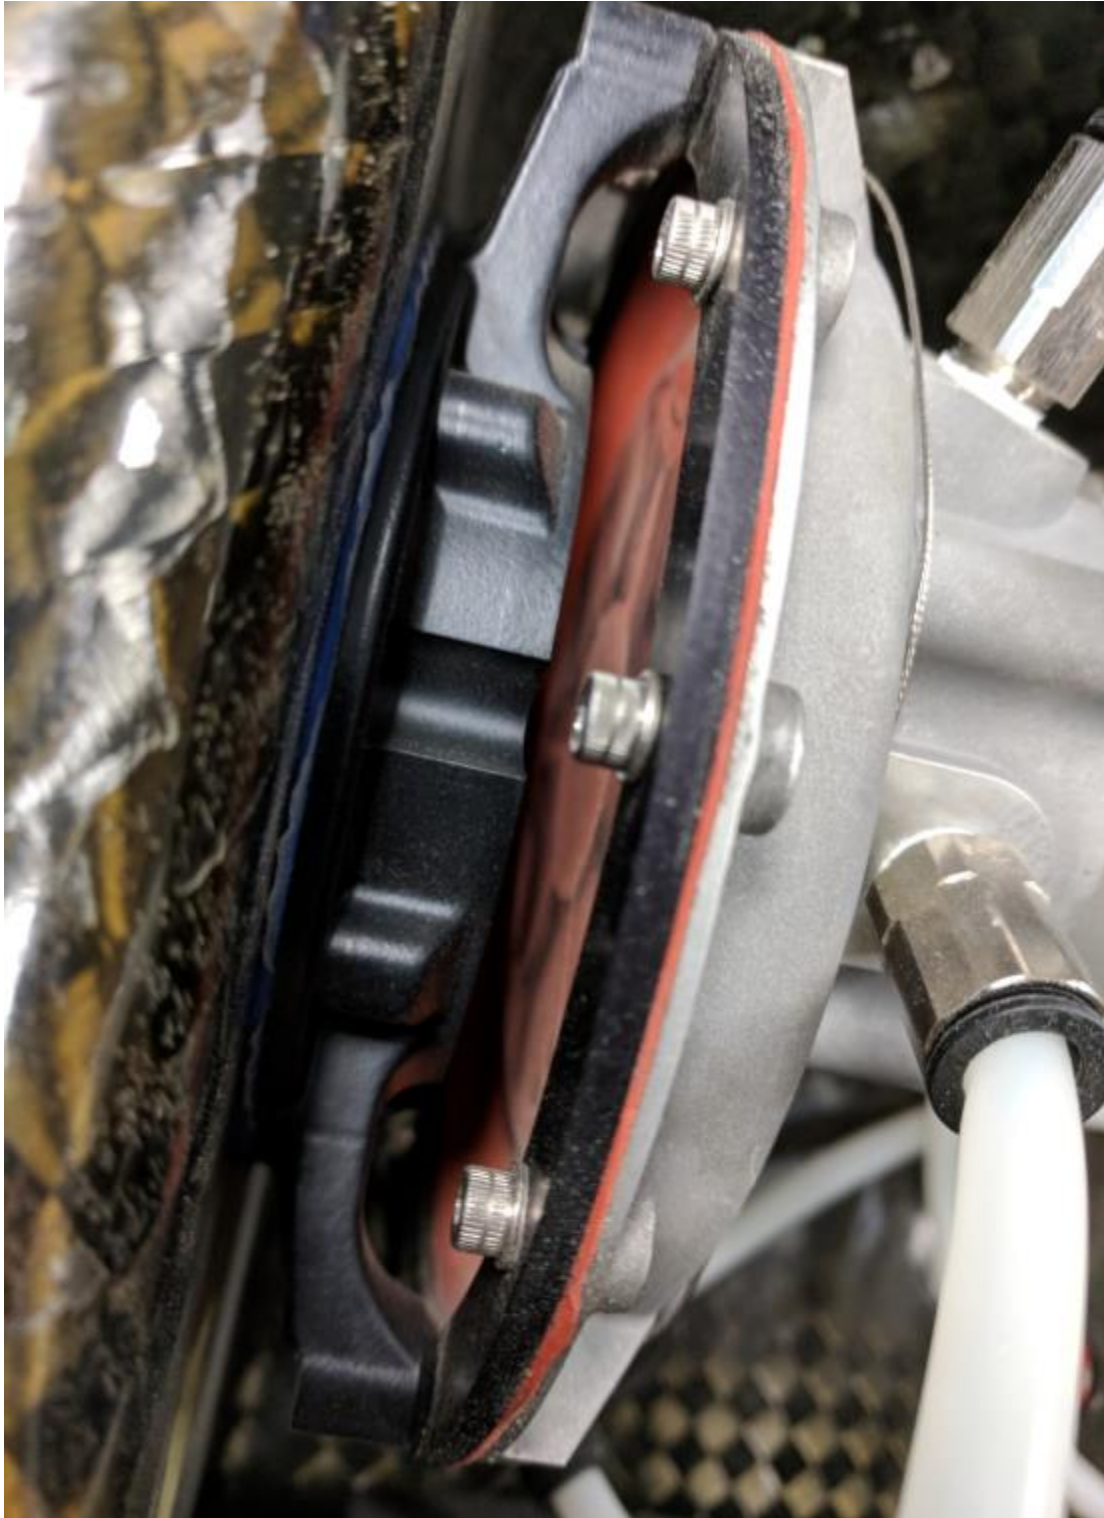
Figure 3 – Side view of outflow valve showing diaphragm in open position

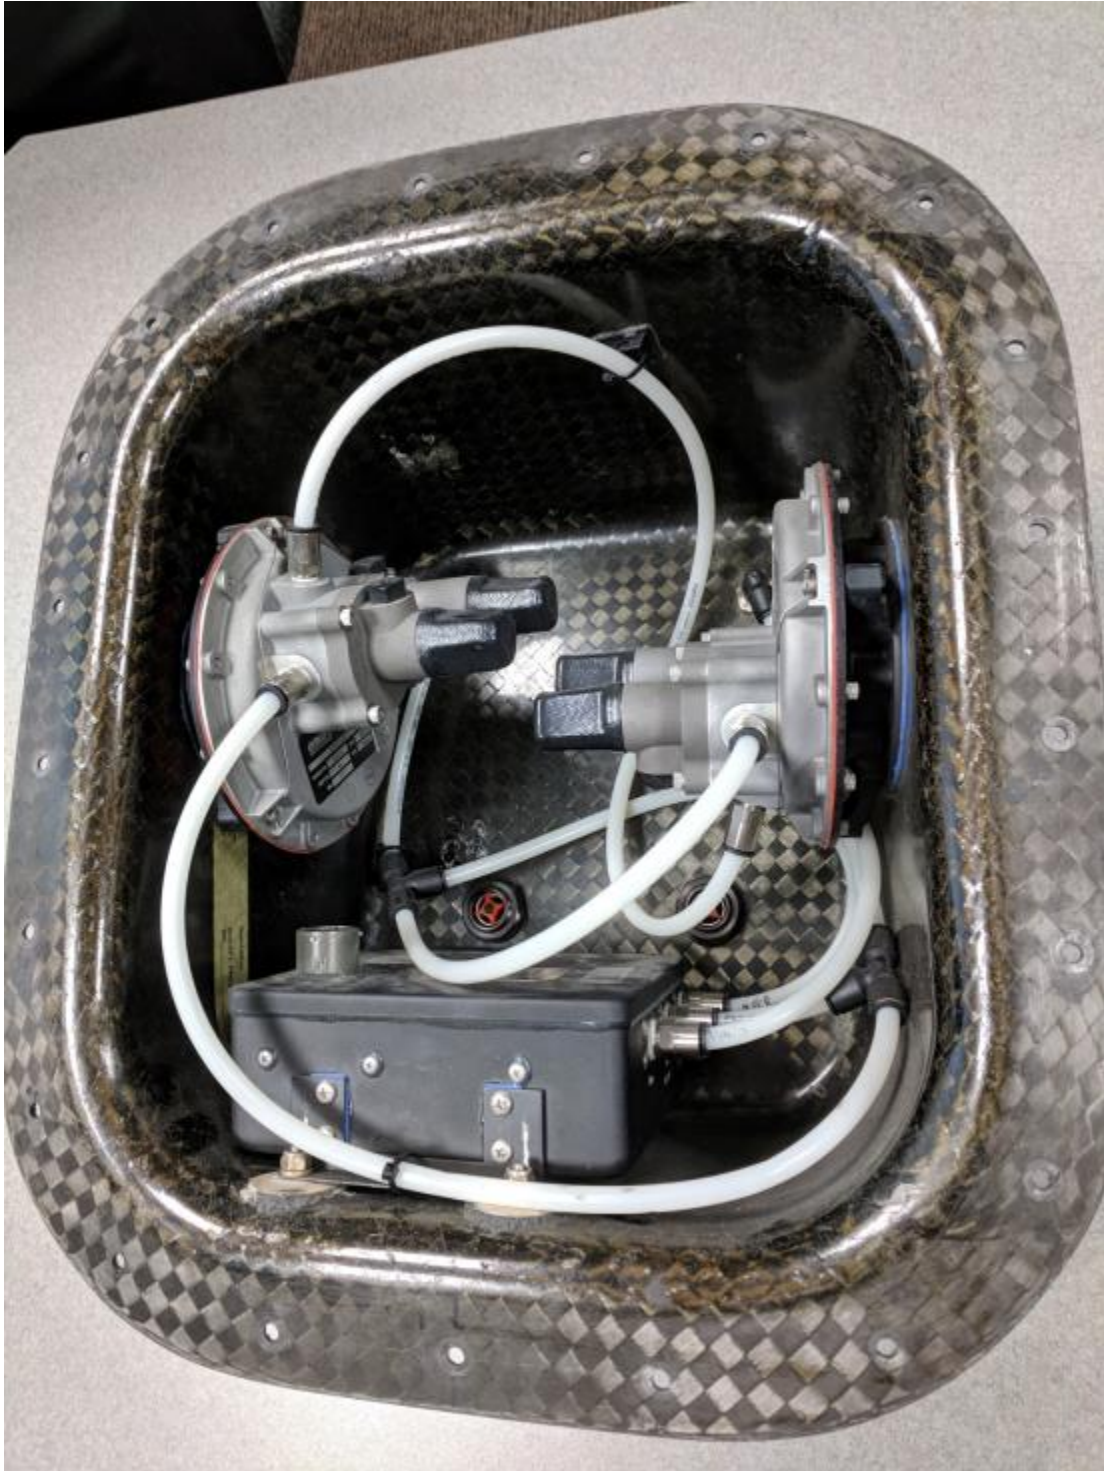
Assembly was returned to Enviro complete and installed in the Evolution Aircraft provided mounting assembly, see Figure 4. Evolution Aircraft provided hardware included composite housing and metal mounting assembly in black, mounting hardware for outflow valves and controller, all plumbing connecting the valves and controller together, and two additional valves not provided by Enviro Systems as shown in Figure 32.

**Figure 4 – Full pressurization assembly in Evolution Aircraft mounting as received**

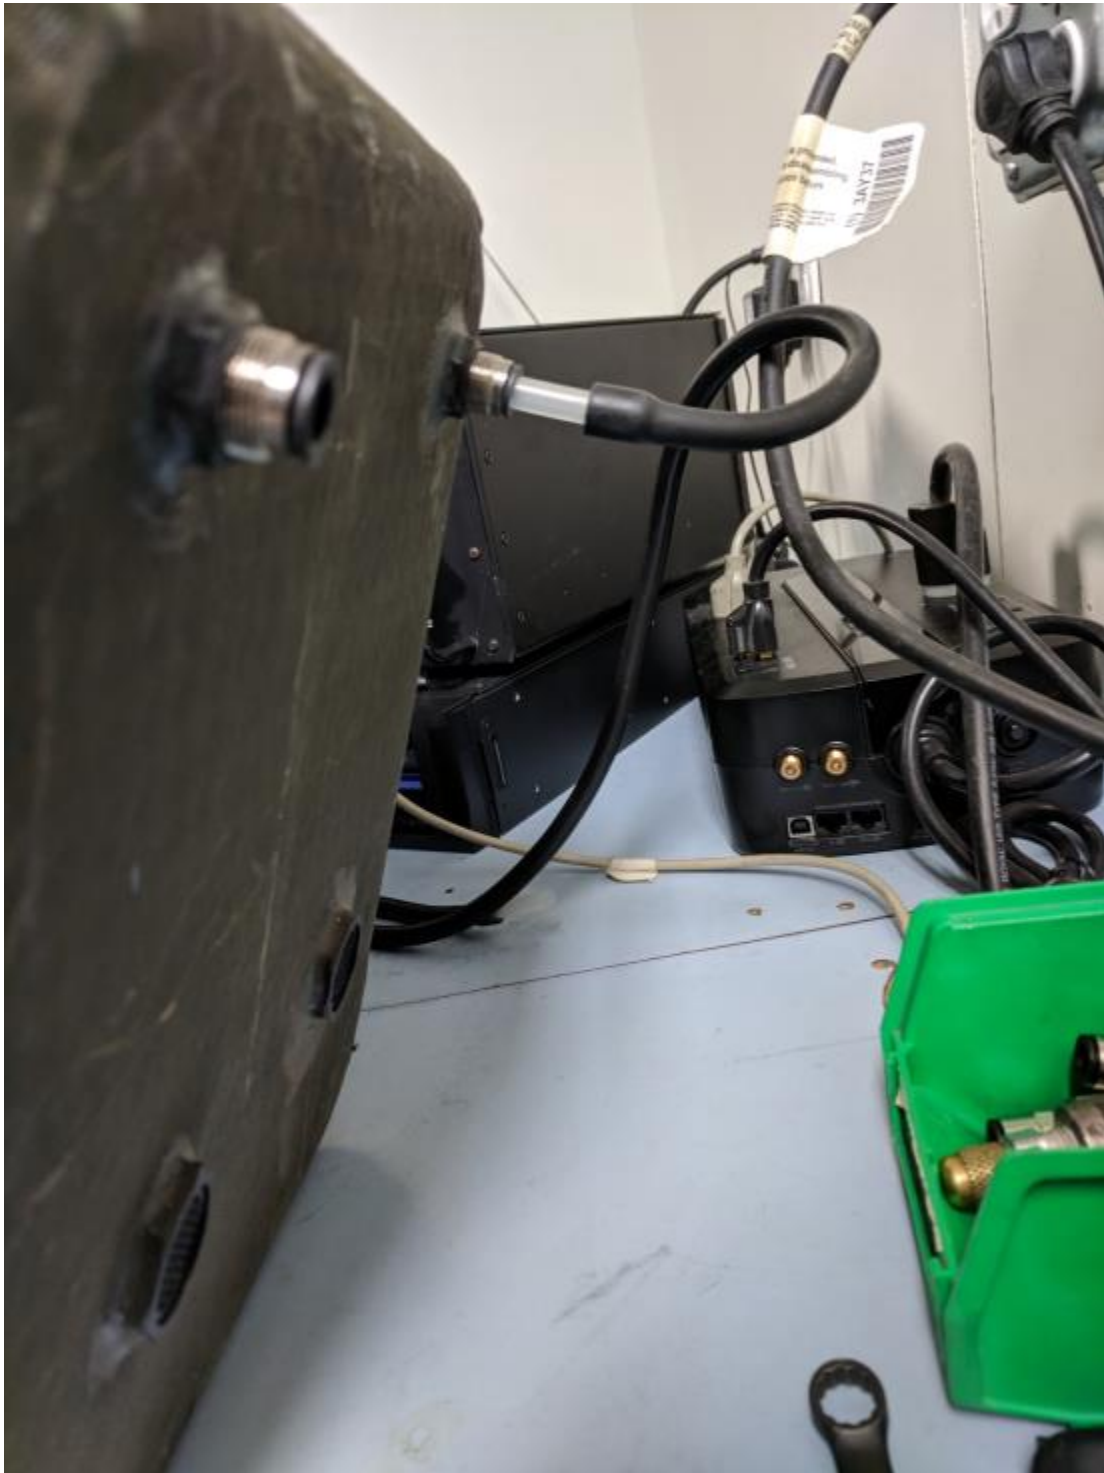
Figure 10 – Full system leak test on second static port

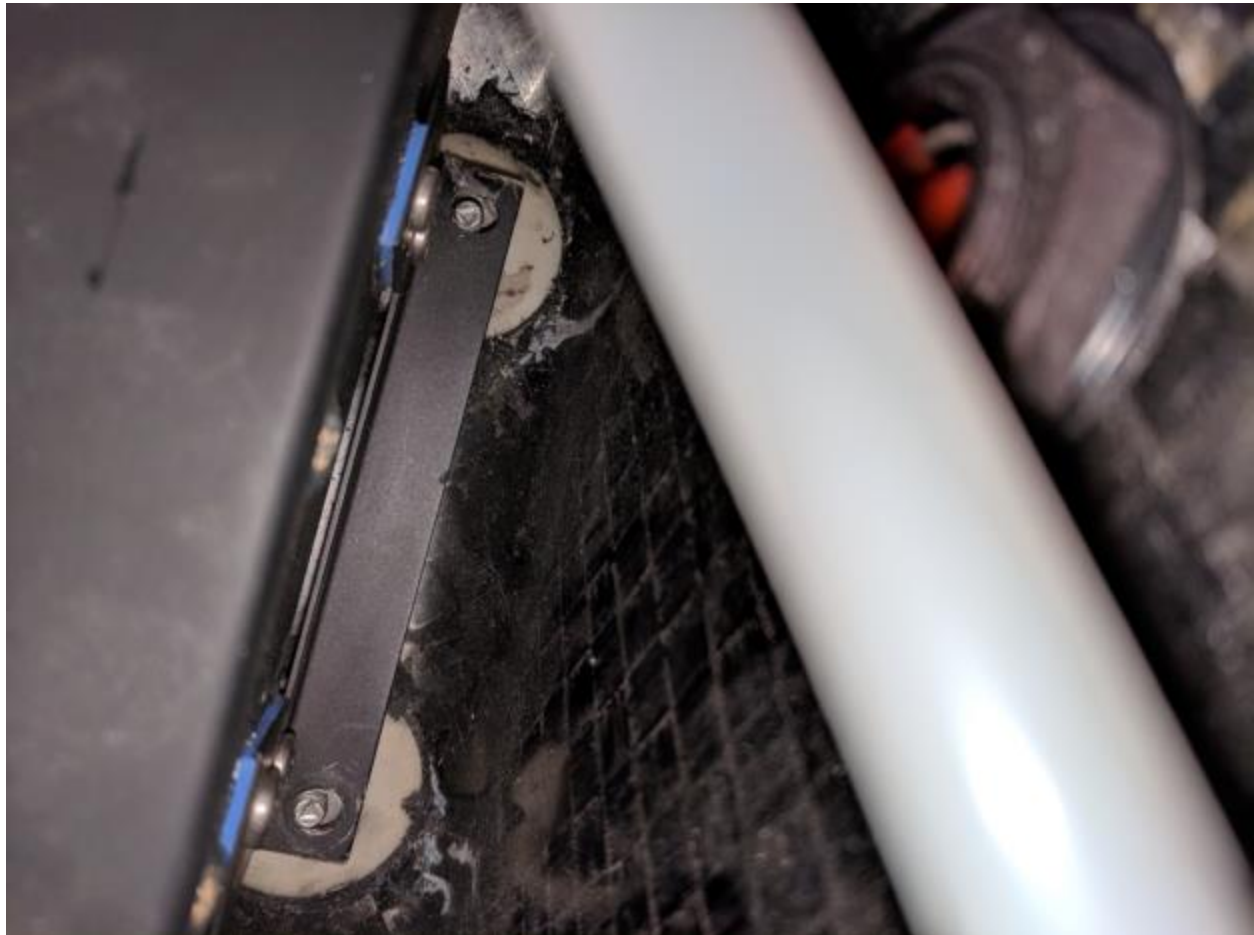
**Figure 12 – Rear mounting brackets missing hardware as received**

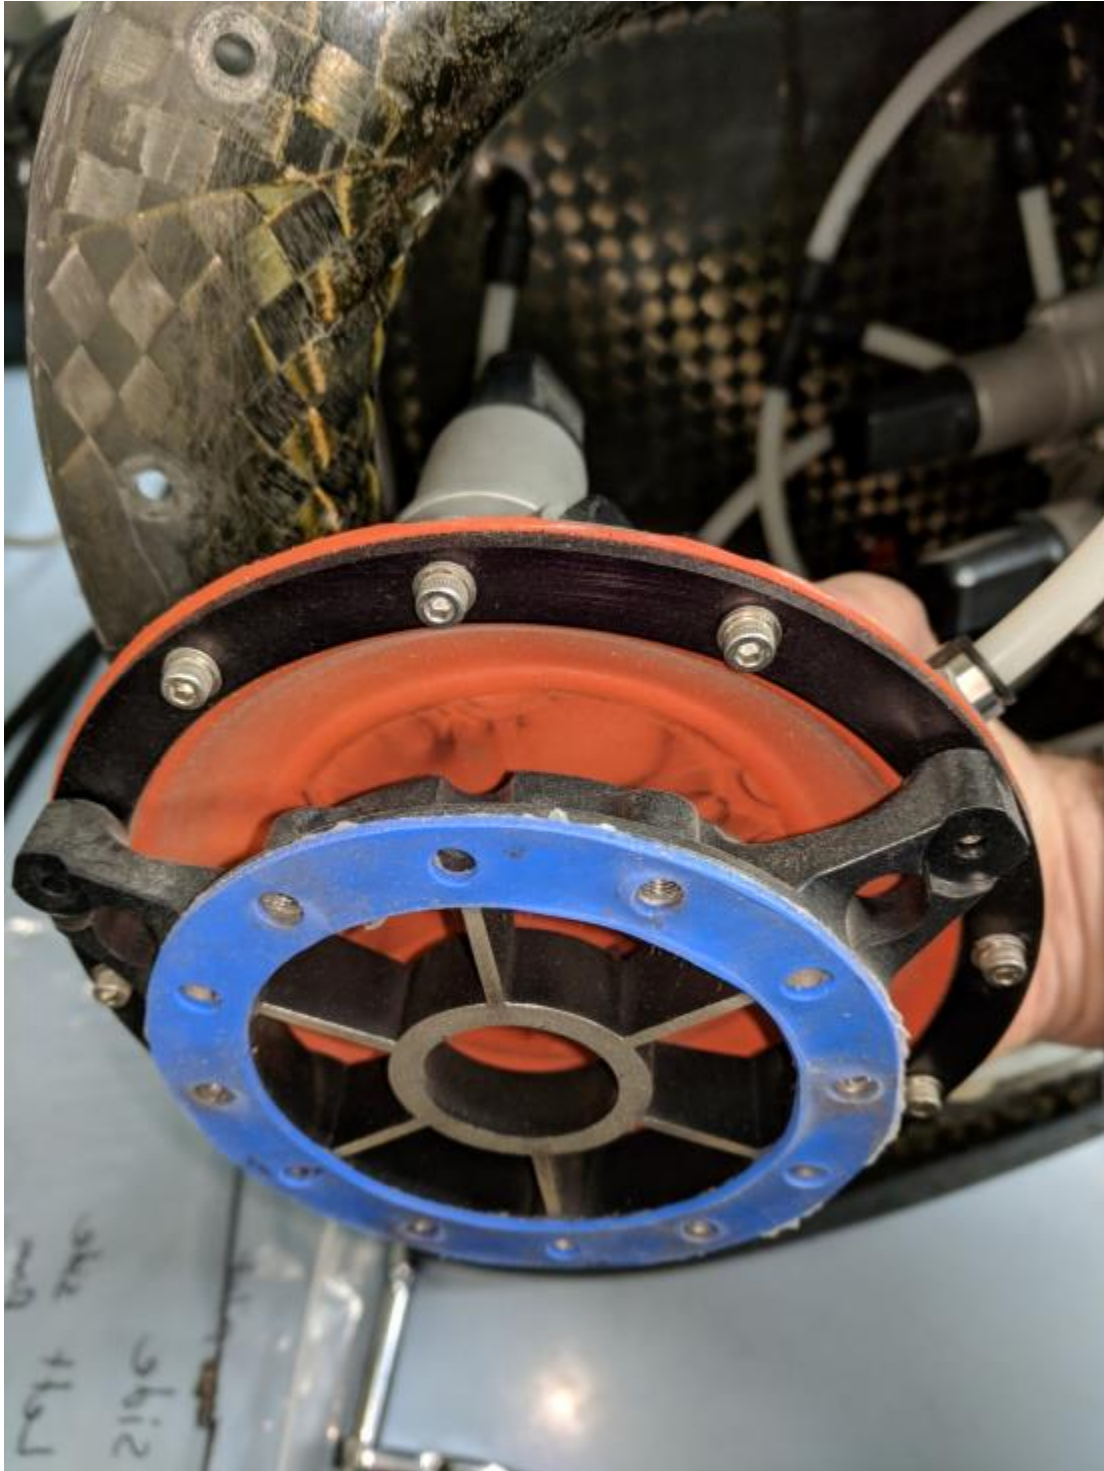
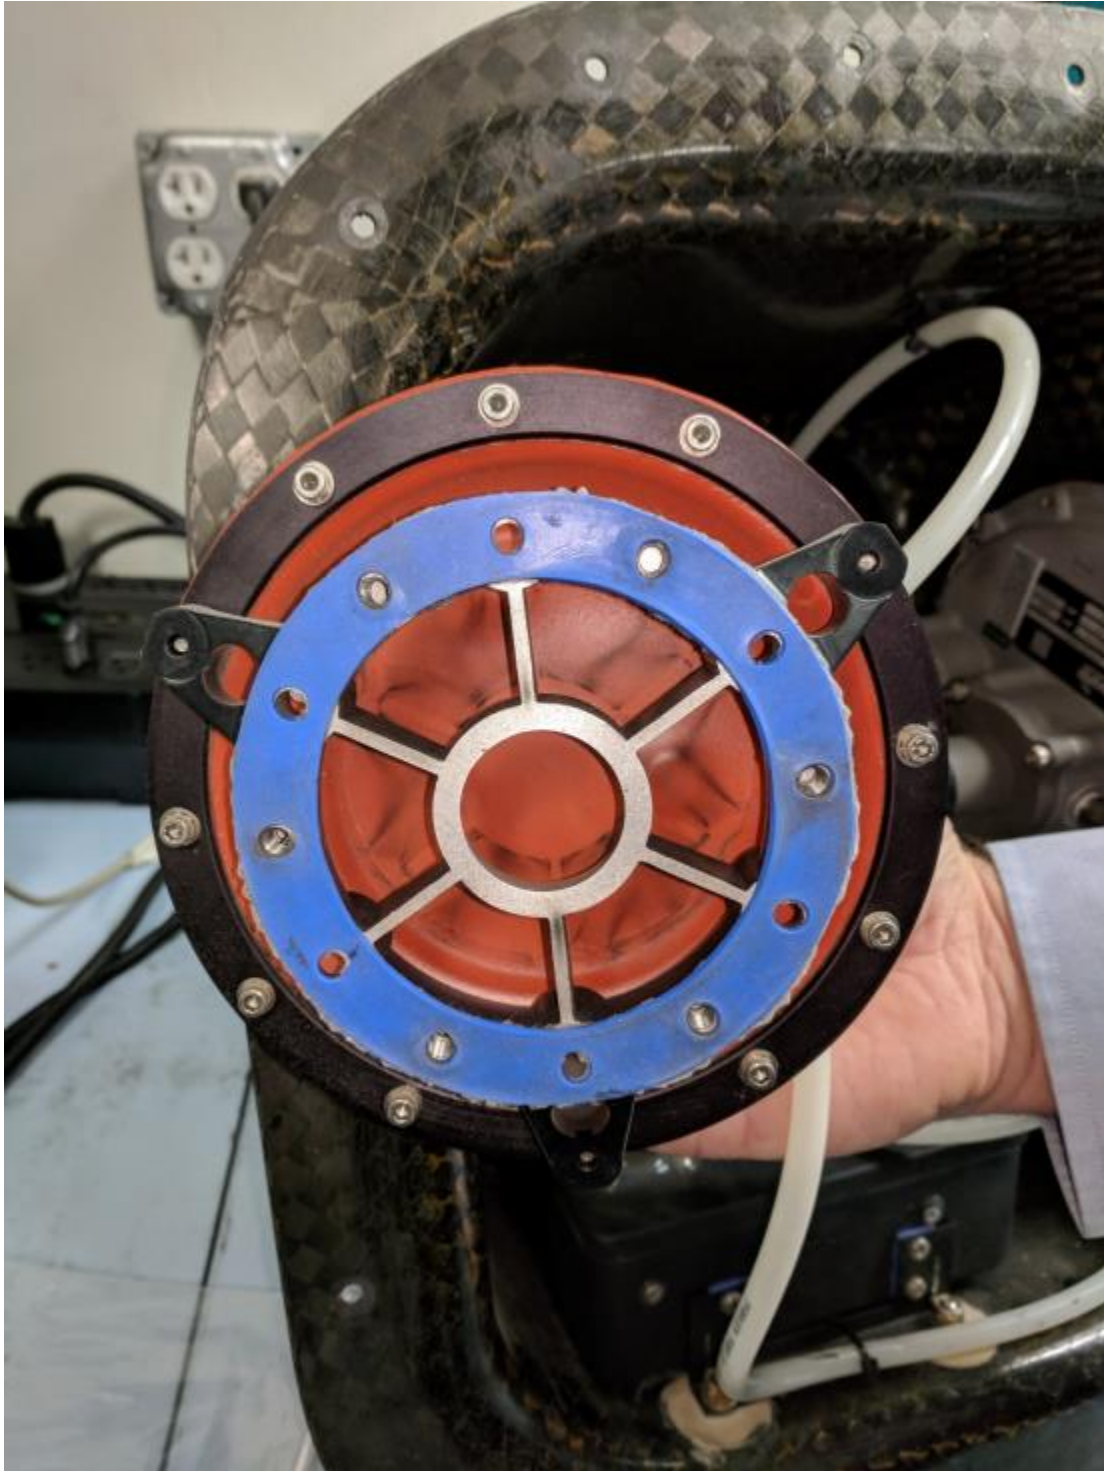
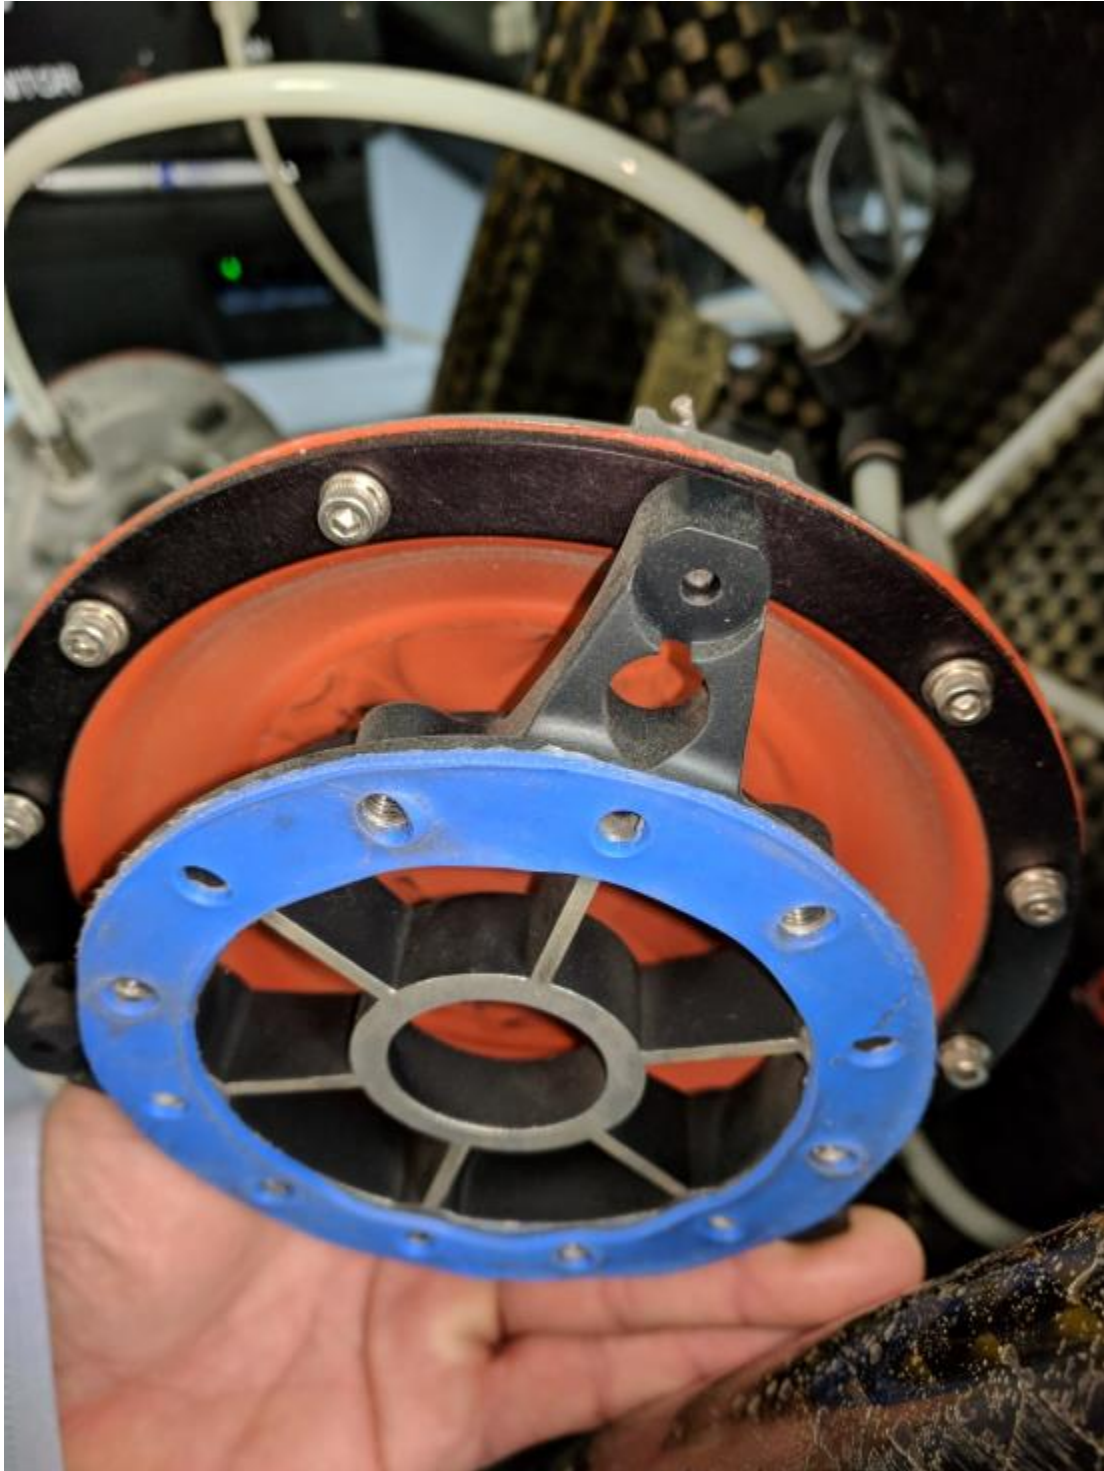
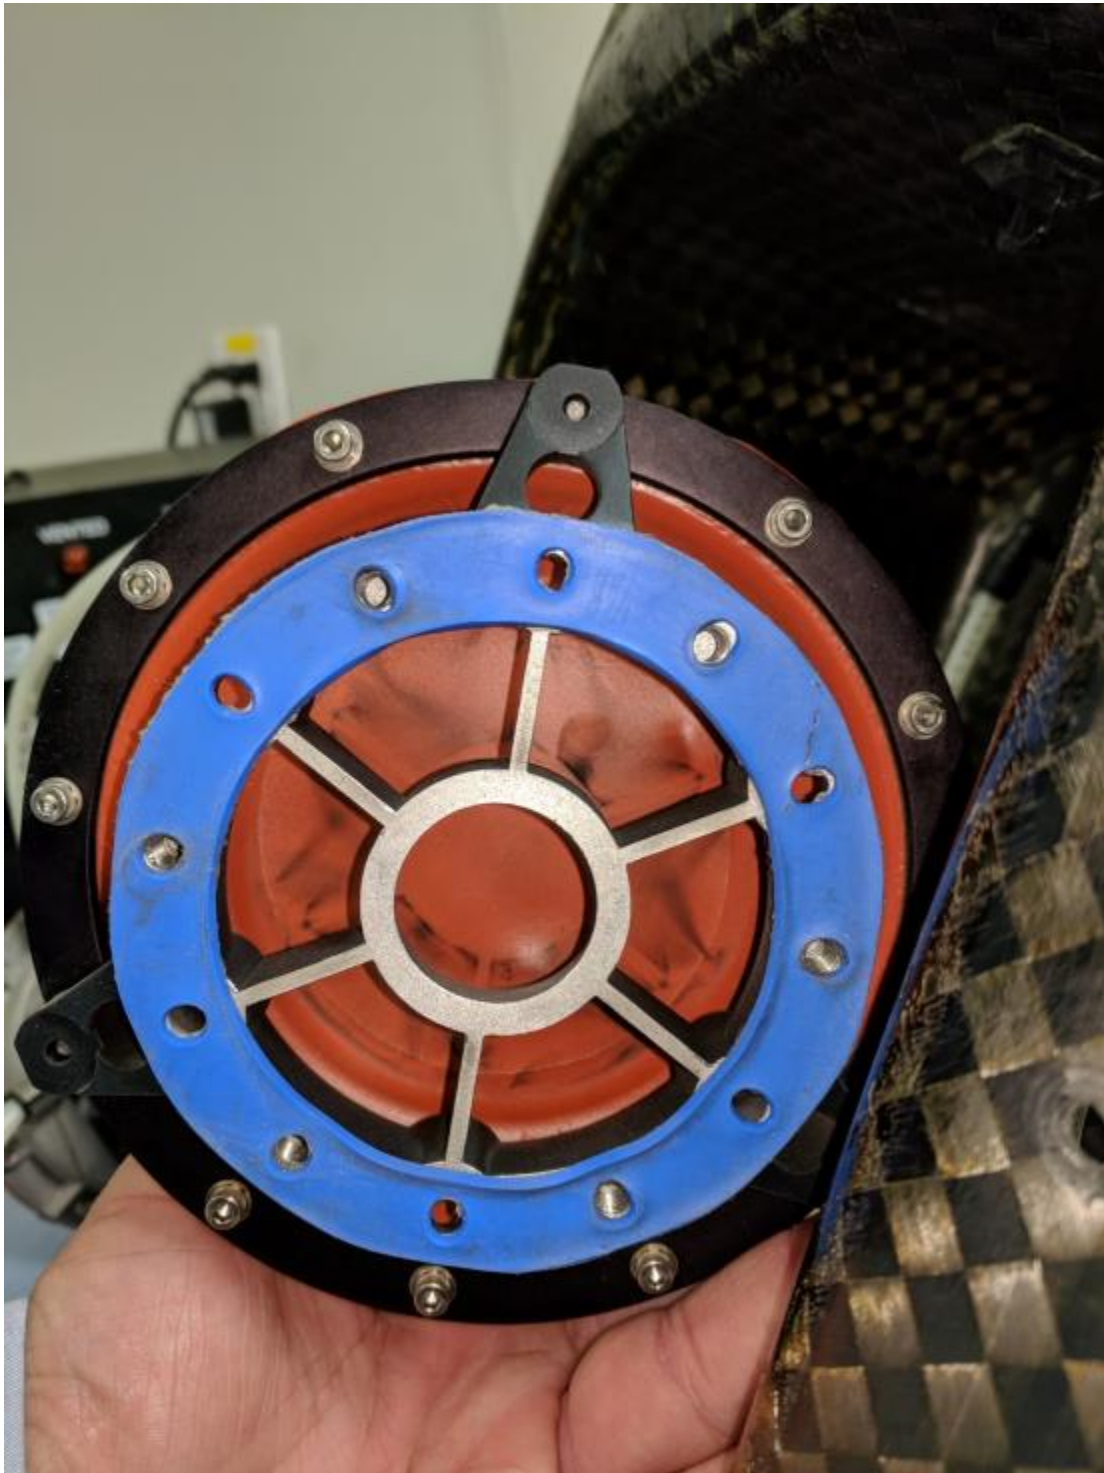
The outflow valves were removed from the mounting structure with their plumbing intact to allow for further visual inspection as shown in Figures 13-20. All valves showed to be in their normal functional positions with no abnormalities observed.

Figure 13 – Removed outflow valve showing open diaphragm

Figure 14 – Bottom side of removed outflow valve

Figure 15 – Side view of removed outflow valve

Figure 16 – Outflow valve mounting surface

Figure 17 – Removed outflow valve

Figure 18 – Bottom side of removed outflow valve

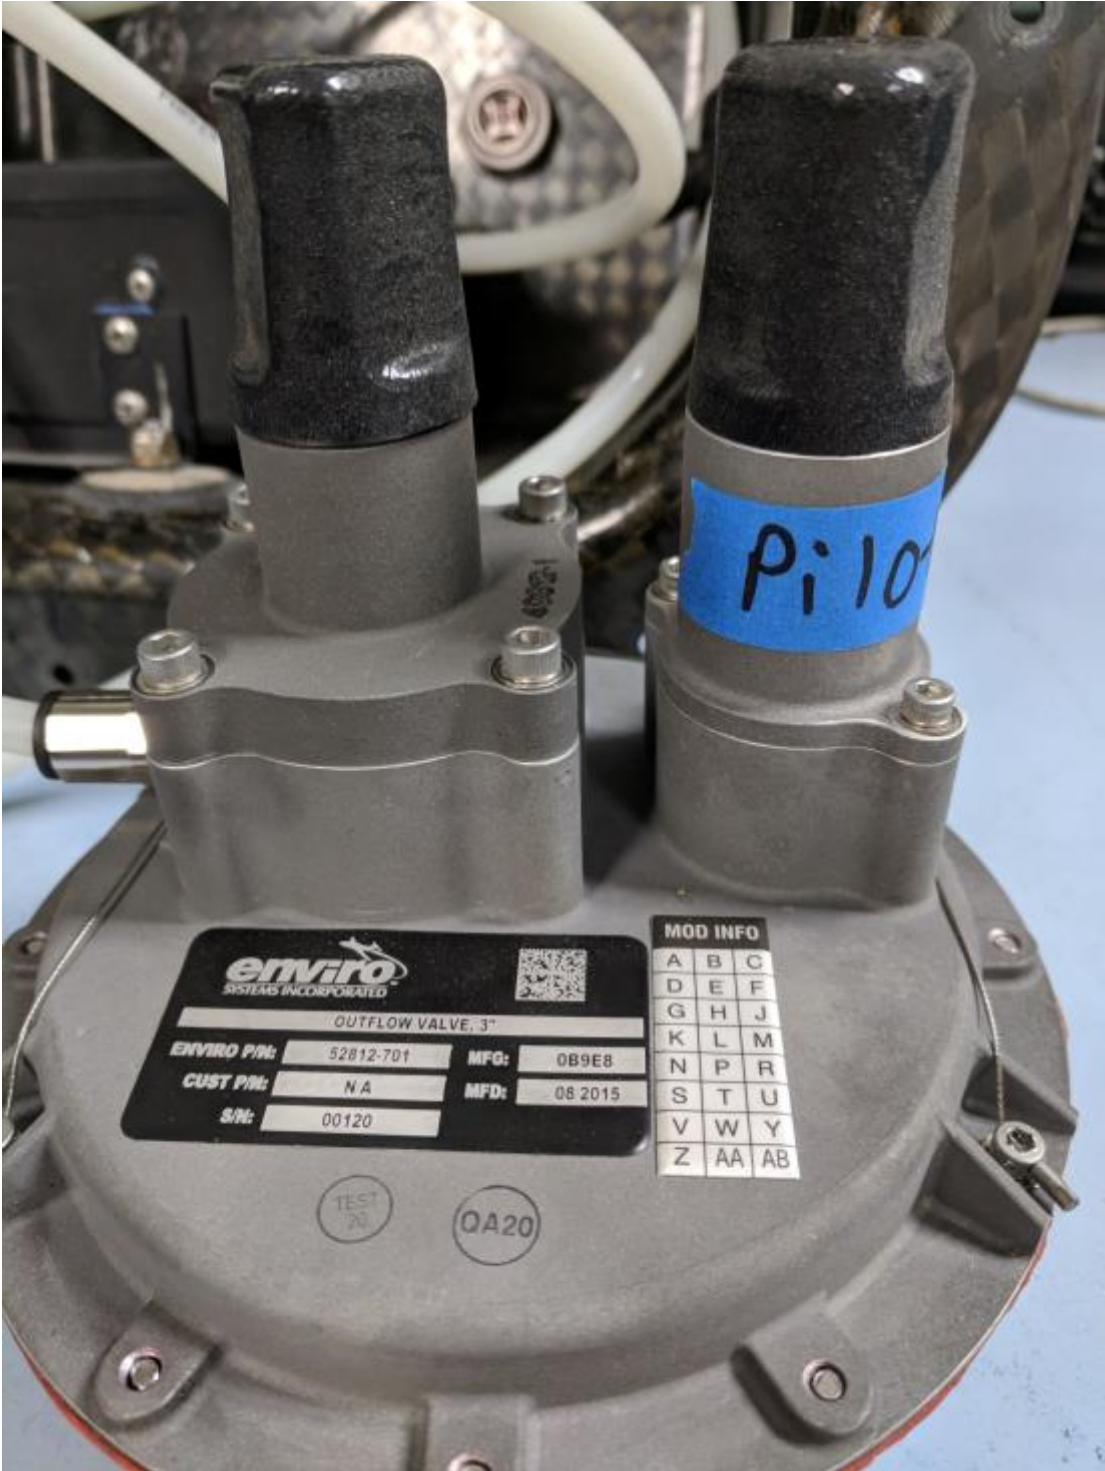
Valve serial number 00120 shown in Figure 21 passed ATP and met all original functional requirements. The valve air filters were removed and inspected and found to be free of any contamination as shown in Figure 27. See Appendix B for test data sheet. Specifically of interest, the set point of the maximum differential pressure limiter 6.42 PSID (488.7 knots) was within the specified tolerance of  $6.5 \pm 0.1$  PSID. Additionally, the maximum altitude limiter was measured at 14,224 ft which is within the specified tolerance of  $14,300 \pm 300$  ft.

Figure 21 – Outflow valve 52812-701 SN 00120

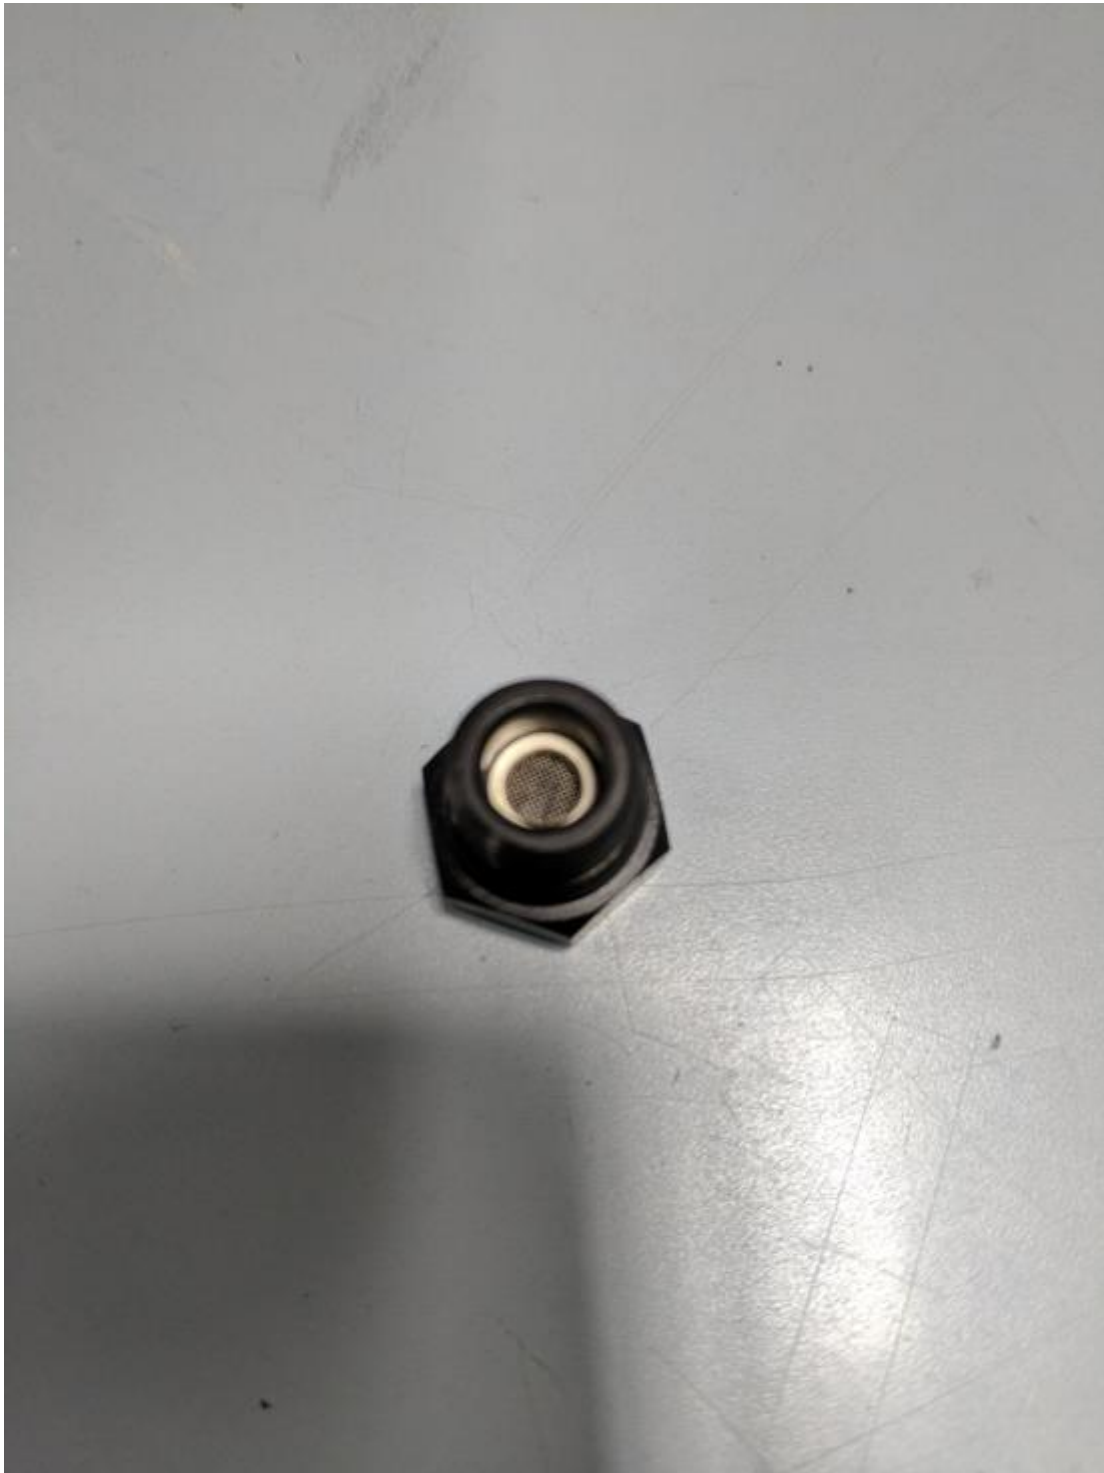
Valve serial number 00119 shown in Figures 22 and 25 passed ATP and met all original functional requirements. The valve air filters were removed and inspected and found to be free of any contamination as shown in Figure 26. See Appendix B for test data sheet. Specifically of interest, the set point of the maximum differential pressure limiter 6.42 PSID (488.4 knots) was within the specified tolerance of  $6.5 \pm 0.1$  PSID. Additionally, the maximum altitude limiter was measured at 14,303 ft which is within the specified tolerance of  $14,300 \pm 300$  ft.

**Figure 26 – Cabin air filter removed for ATP testing**

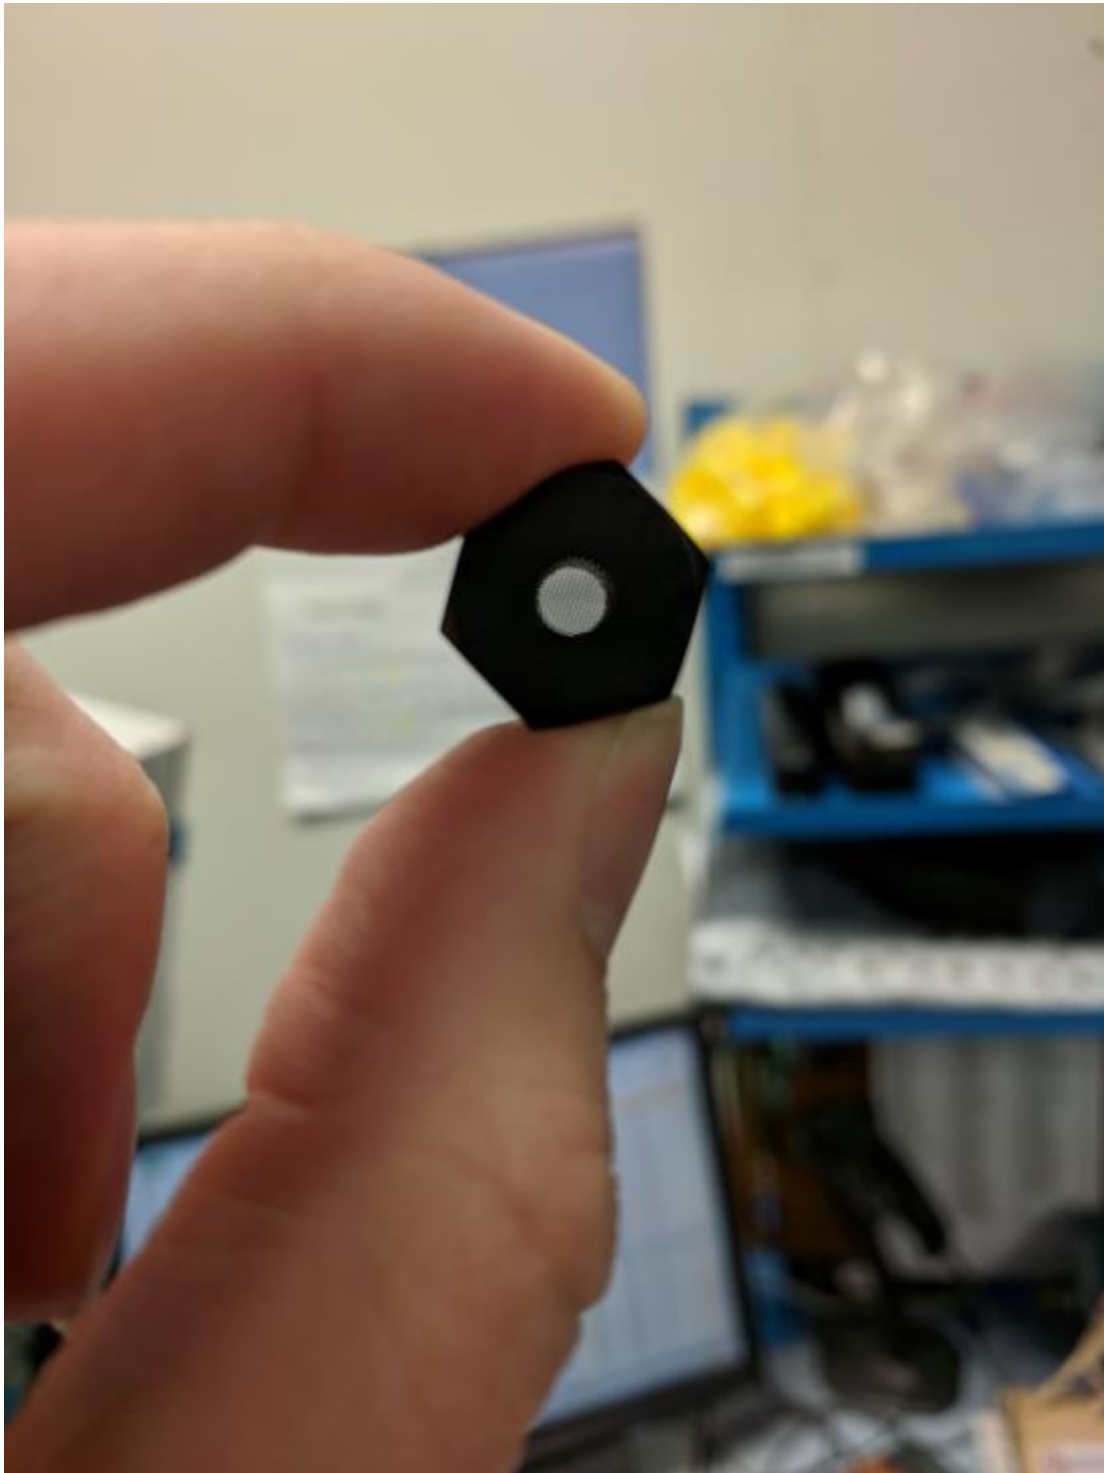
**Figure 27 – Cabin air filter showing free from contamination or clogging**
