Enviro Systems, Inc. Evaluation Test Report – Cabin Pressurization Control System

## Evaluation Test Report Cabin Pressurization Control System

**Enviro Part Numbers:**  
Controller – 52811-701  
Valves – 52812-701

The purpose of this evaluation test report is to document the condition of the pressurization control system as received by Enviro Systems. The system was removed from an accident aircraft that had a wind screen failure in flight. All unpacking and testing was witnessed by Mr. Gail Sober from the FAA Oklahoma City Flight Standards District Office

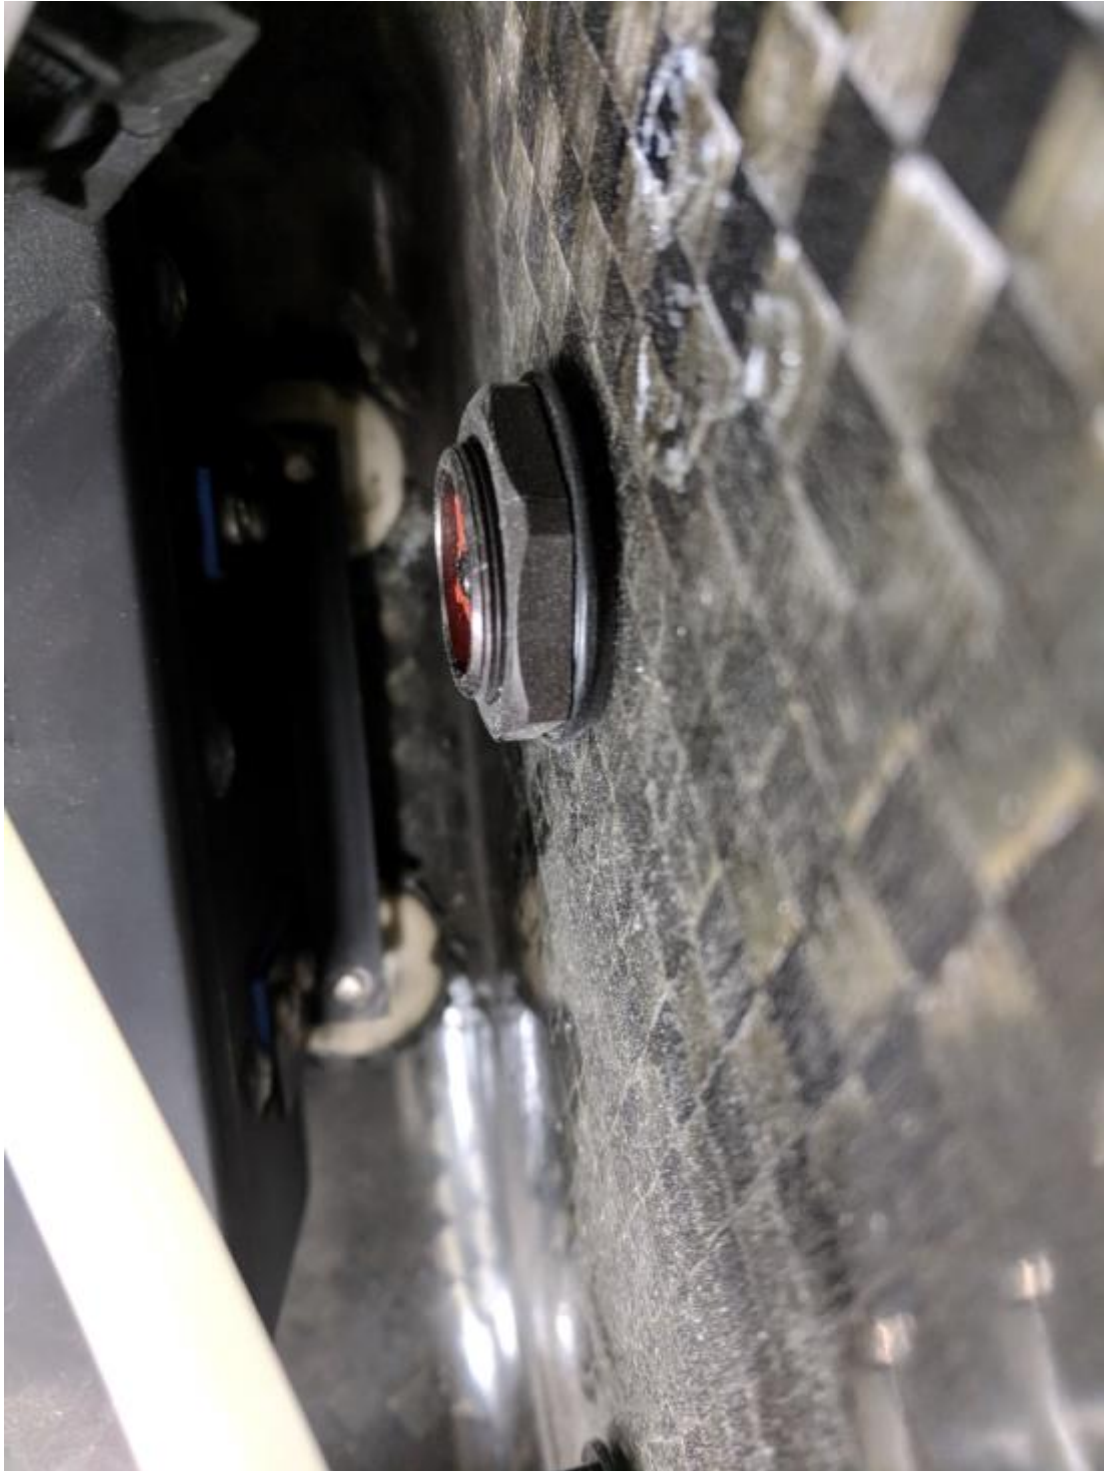
Assembly was returned to Enviro complete and installed in the Evolution Aircraft provided mounting assembly, see Figure 4. Evolution Aircraft provided hardware included composite housing and metal mounting assembly in black, mounting hardware for outflow valves and controller, all plumbing connecting the valves and controller together, and two additional valves not provided by Enviro Systems as shown in Figure 32.

Figure 32 – Evolution aircraft supplied pop off valve

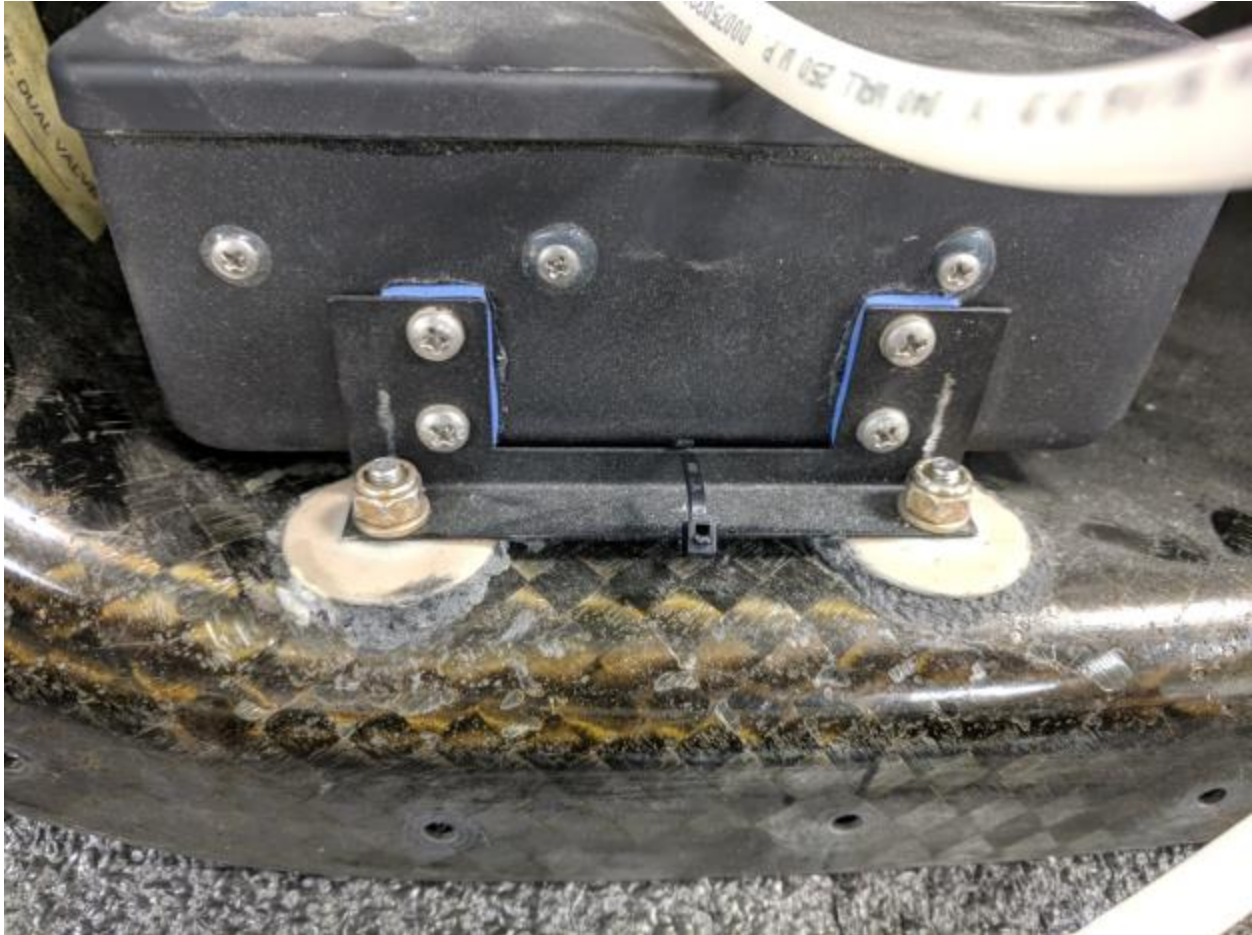
Visual inspection revealed the entire system was intact and with no damage. A functional Leak test on the static ports of the entire system revealed no leaks and the diaphragms remained in the normal fully open position. See Figure 1, Figure 3, Figure 8, Figure 9, Figure 10, and Figure 11 showing diaphragm position and leak test setup. The hardware securing each valve was properly fastened and the gasket was compressed and sealed in the normal condition. See Figure 2 showing installed outflow valve with compressed gasket. The controller installation only utilized two of the four mounting provisions. See Figure 12 and Figure 33 showing mounting hardware.

Figure 33 – Controller mounting hardware showing paint damage
