## Air Safety Investigations Aircraft Incident/Accident Technical Report

| Aircraft Incident/<br>Accident Information | Year: 1976 | Make: Cessna | Model: 310R |
| Senior Air Safety Investigator: Andrew L. Hall | | Report #: ASI-17-BQ-T | Report date: 01-11-19 |

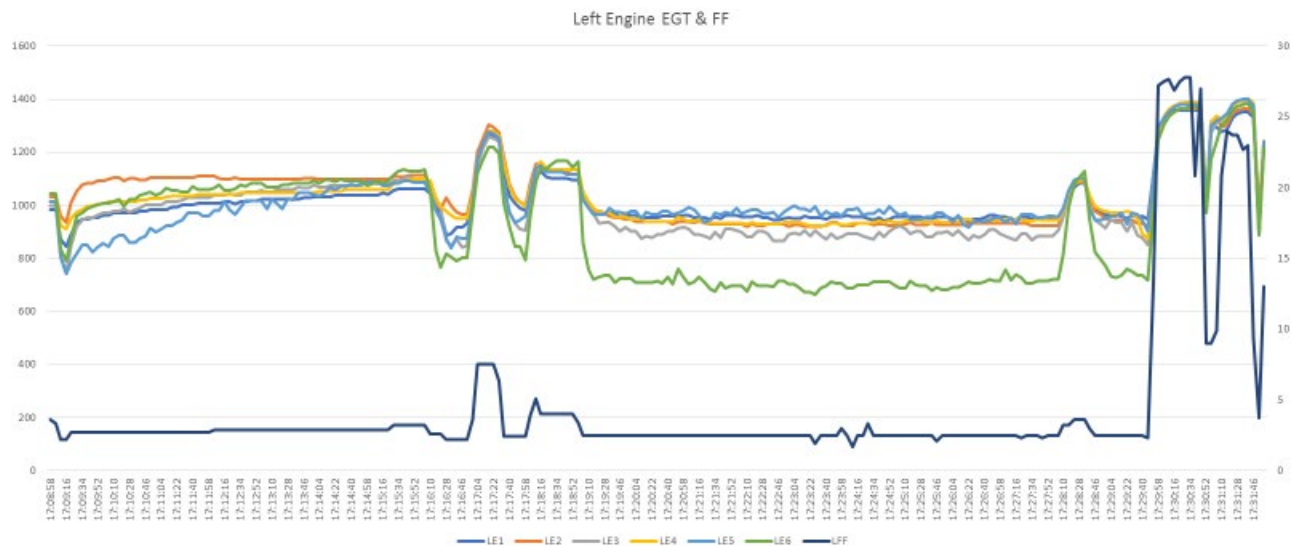
The JPI indicator was reviewed by the NTSB and data downloaded. These plots show Fuel Flow and each cylinder Exhaust Gas Temperature (EGT). The first plot is the left engine entire flight and the second is the left engine takeoff. The third and fourth charts are for the right engine. Note only the full flight legends were correctly annotated.
