# **R-1340-AN1 S/N 16302 Engine Inspection**

**Younkin Aviation  
West Fork, AR  
3 October 2017**

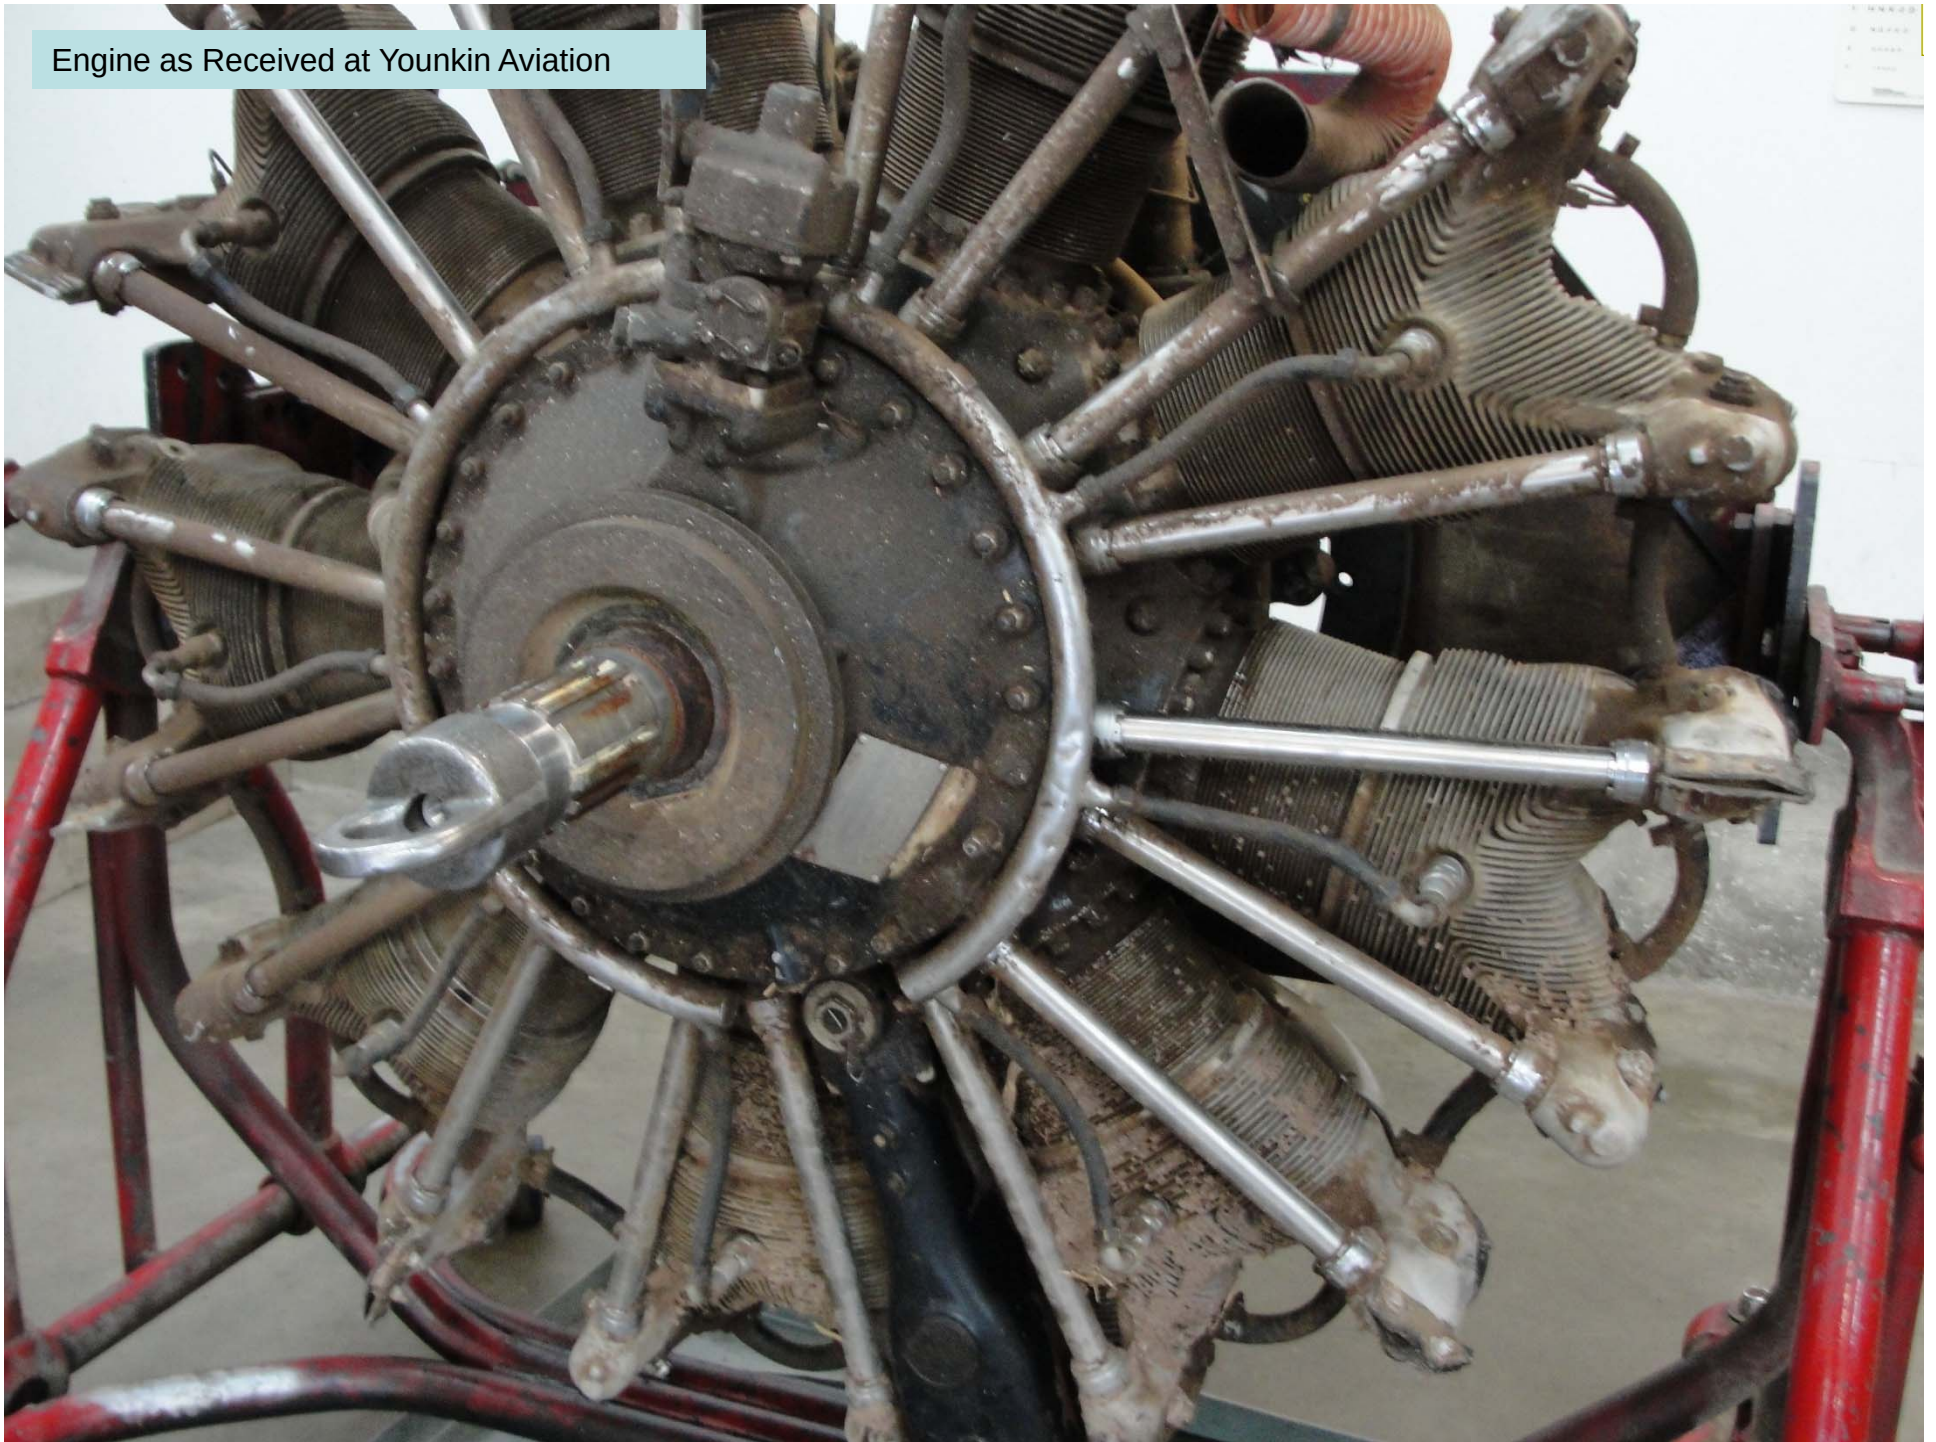
Engine as Received at Younkin Aviation

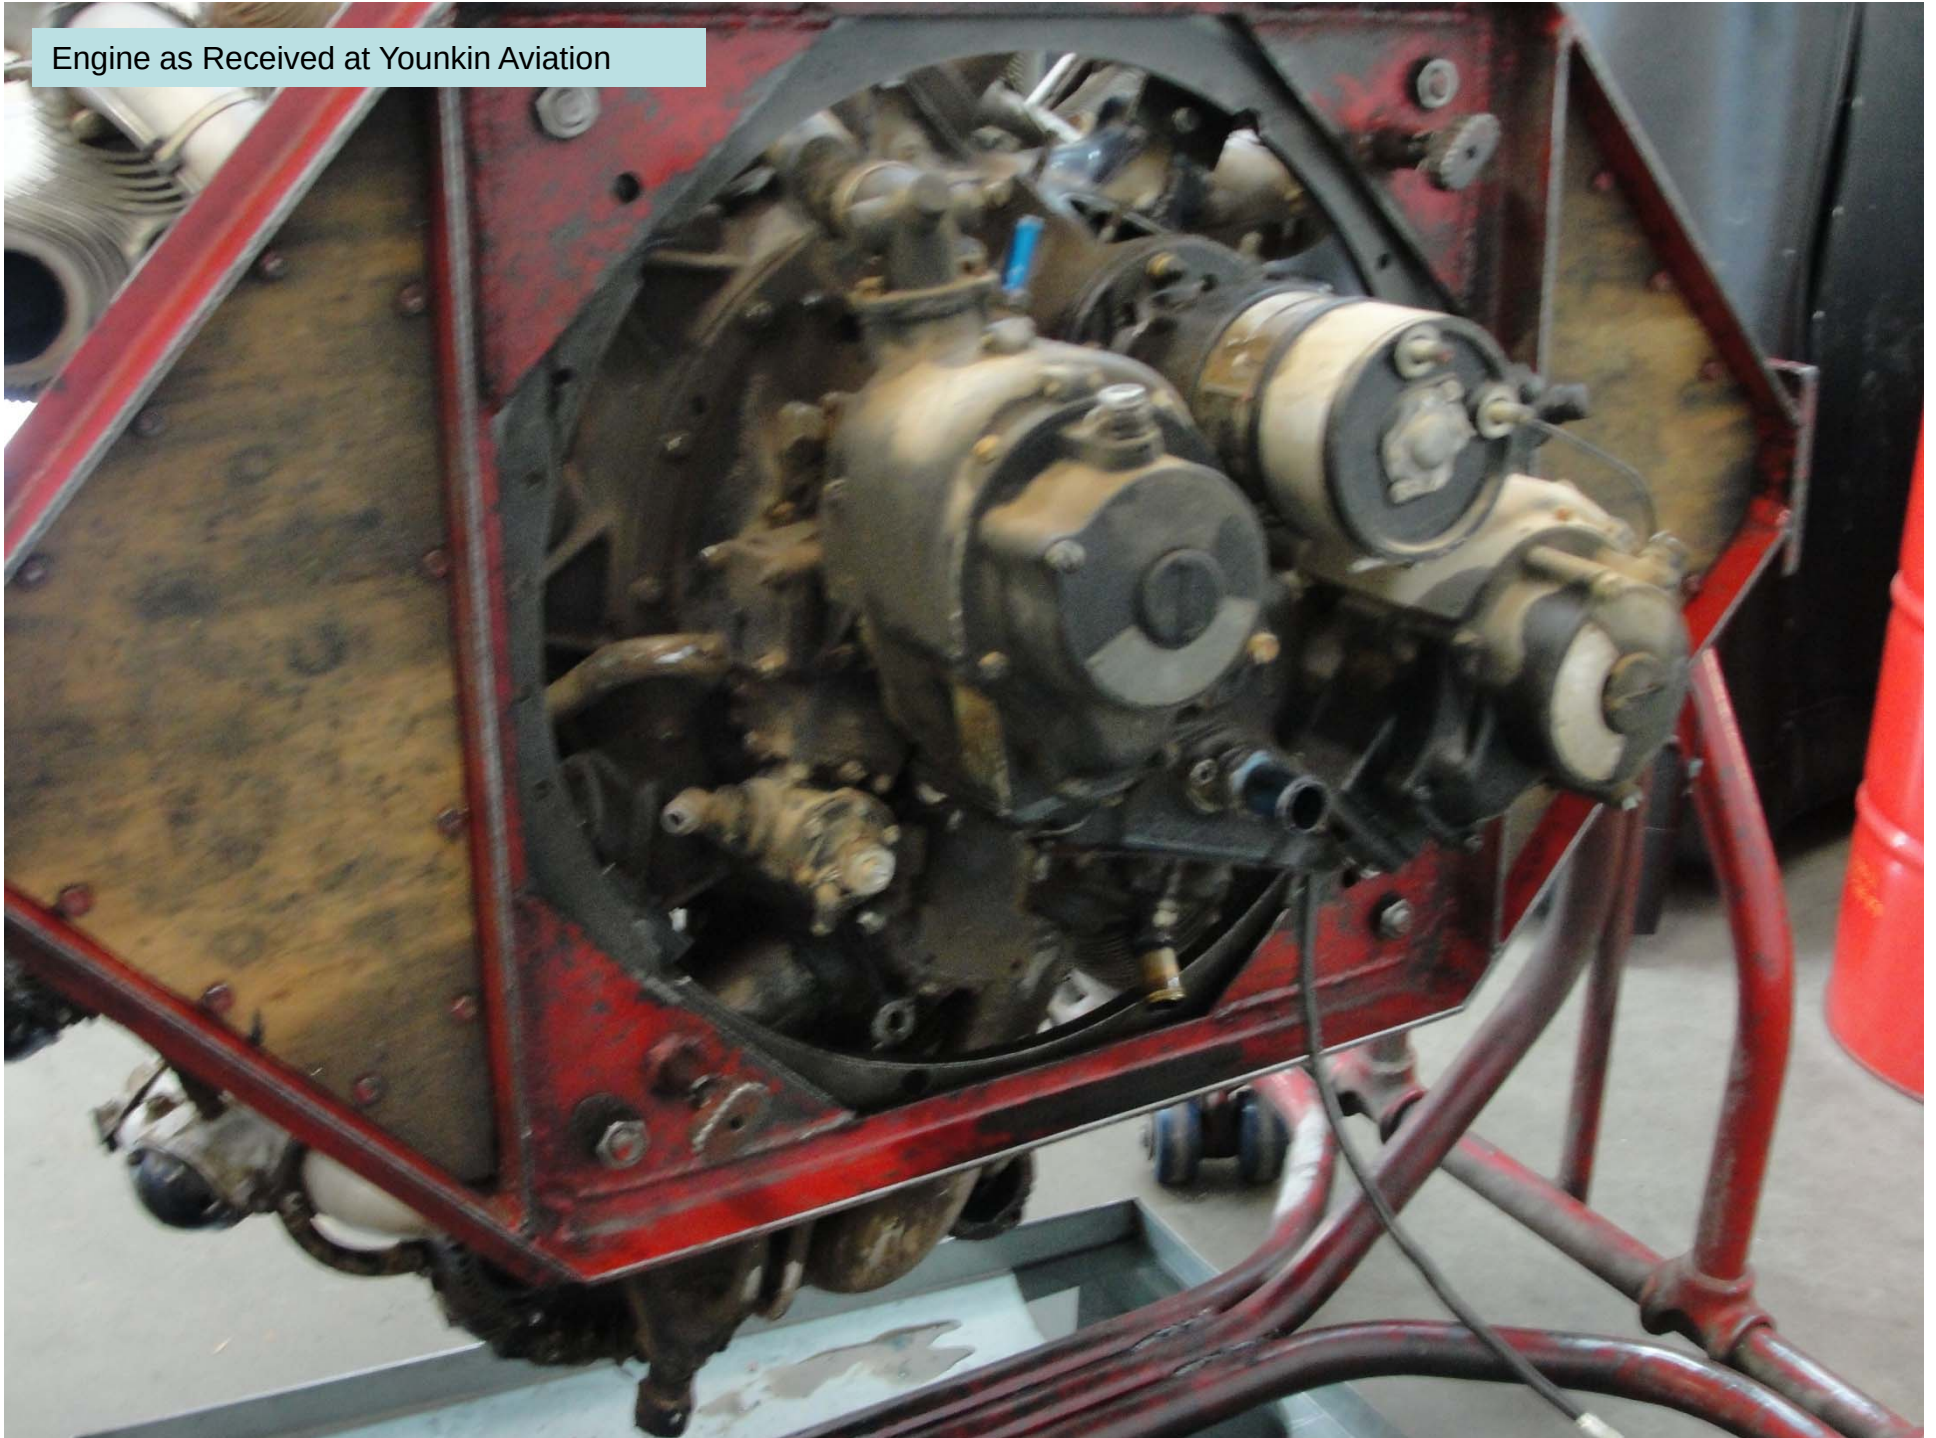
Engine as Received at Younkin Aviation

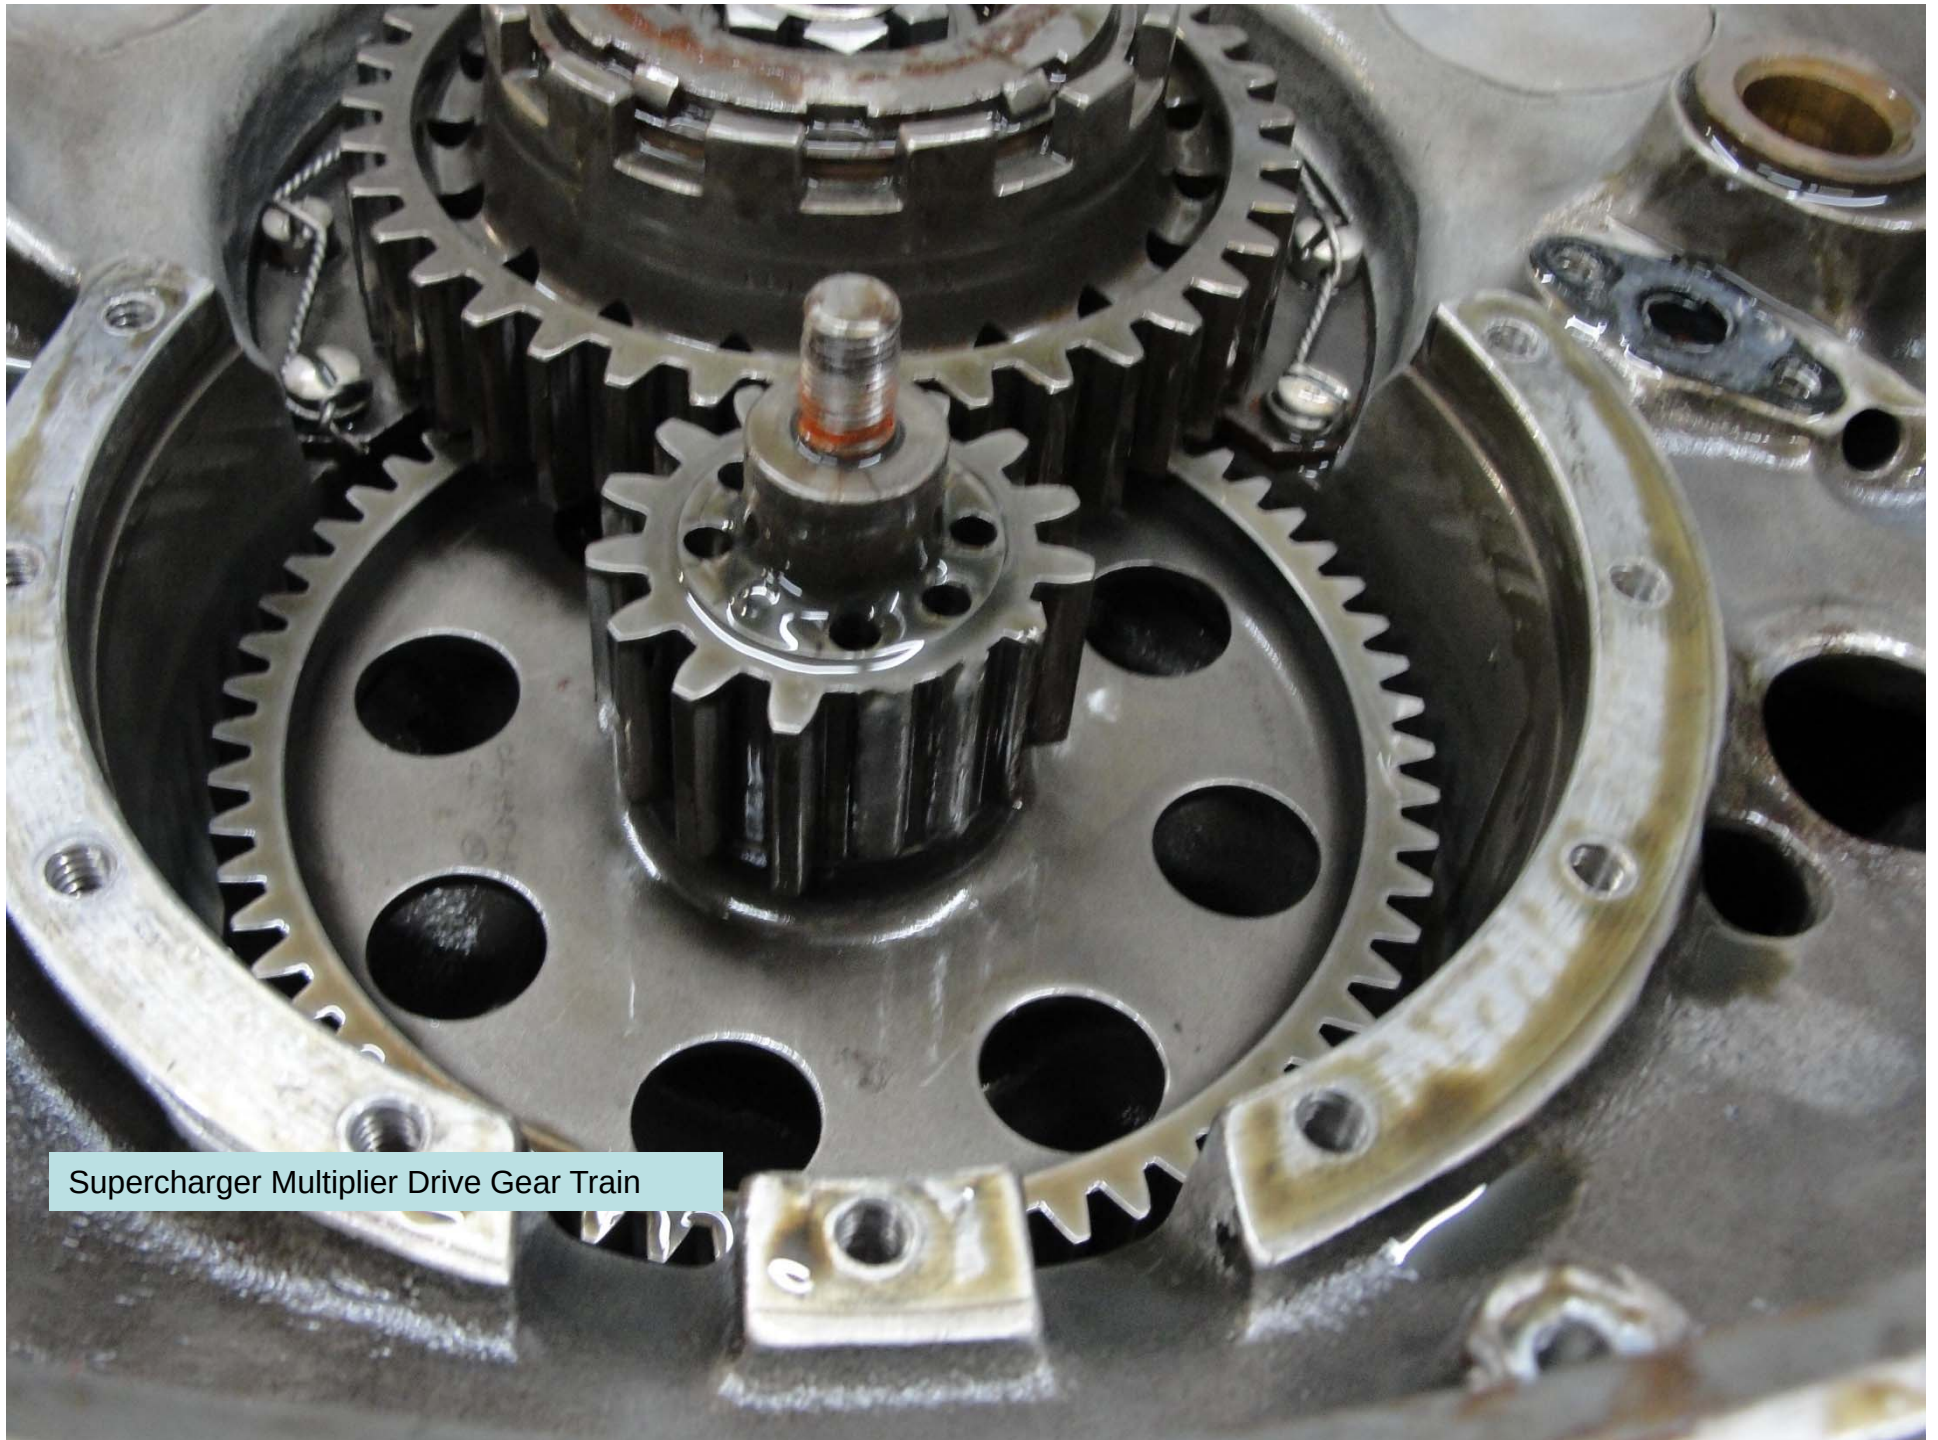
Part Number 14951

- Supercharger multiplier drive gear had three missing teeth.
- Supercharger impeller was not damaged, showed sign of slight rub.
- Oil filter showed signs of high carbon content and some debris, very little metallic content.

Supercharger Multiplier Drive Gear Train

Supercharger Multiplier Drive Gear

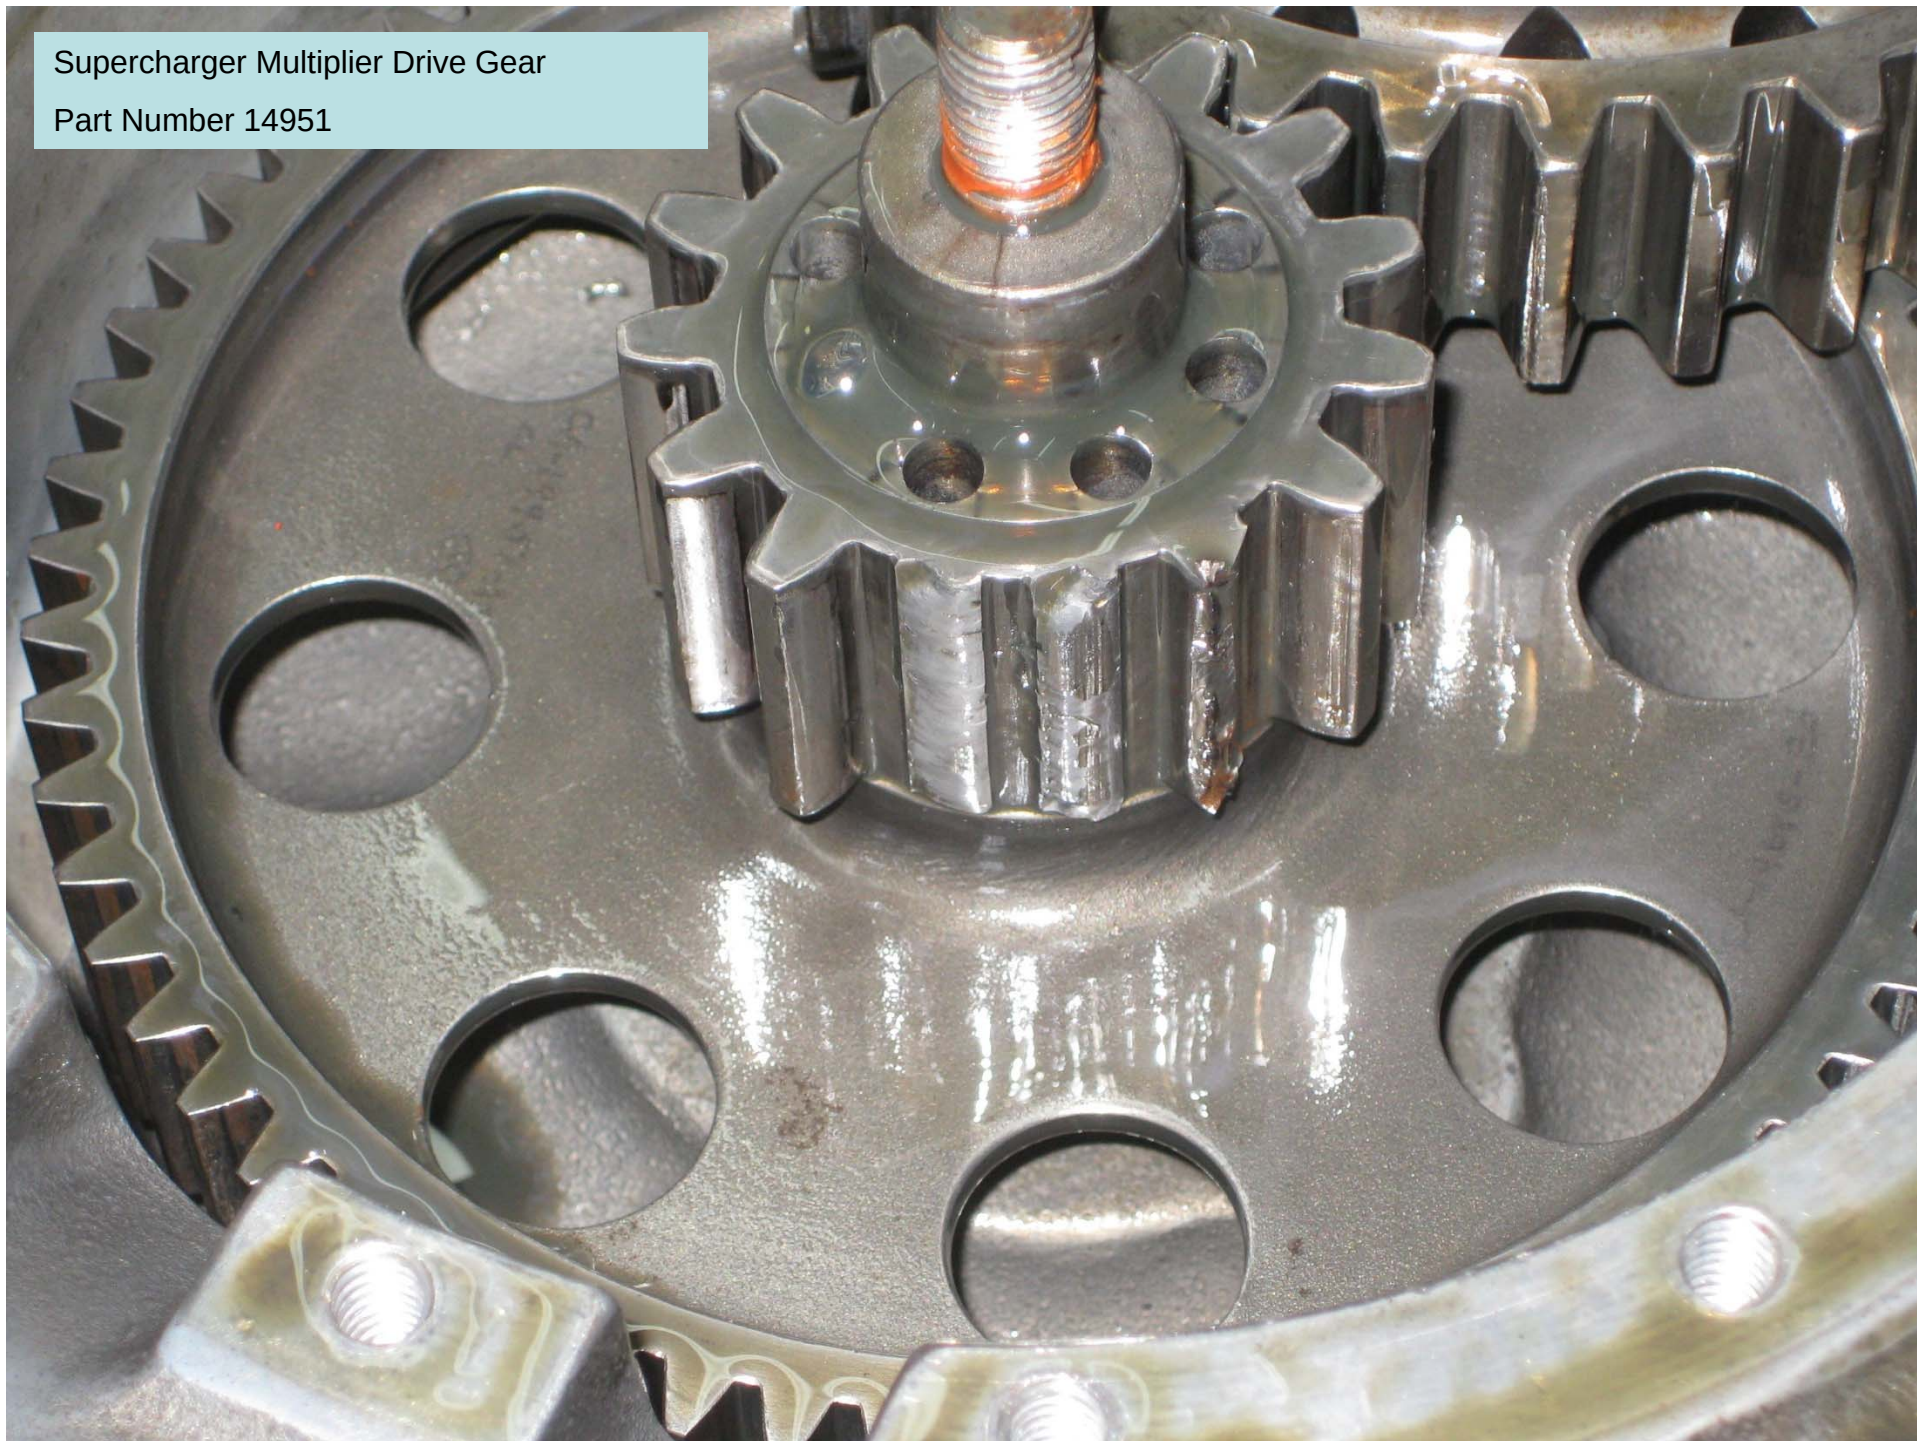
- One supercharger drive gear tooth was located in the engine oil sump.
- Crankshaft end play was measured to have increased by .003 in from recoded clearance in overhaul build record.
- Thrust bearing shows signs of propeller strike.
- Supercharger drive section was not disassembled.

Supercharger Multiplier Drive Gear Tooth  
Found in Oil Sump

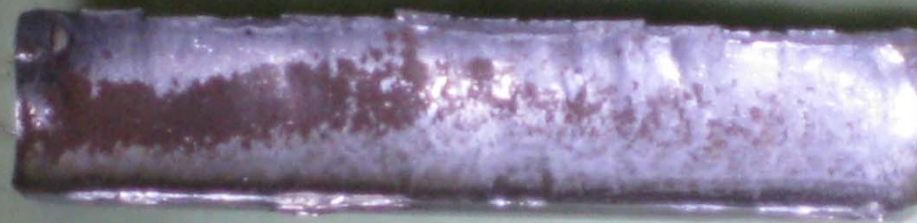
Recovered Supercharger Multiplier Drive  
Gear Teeth

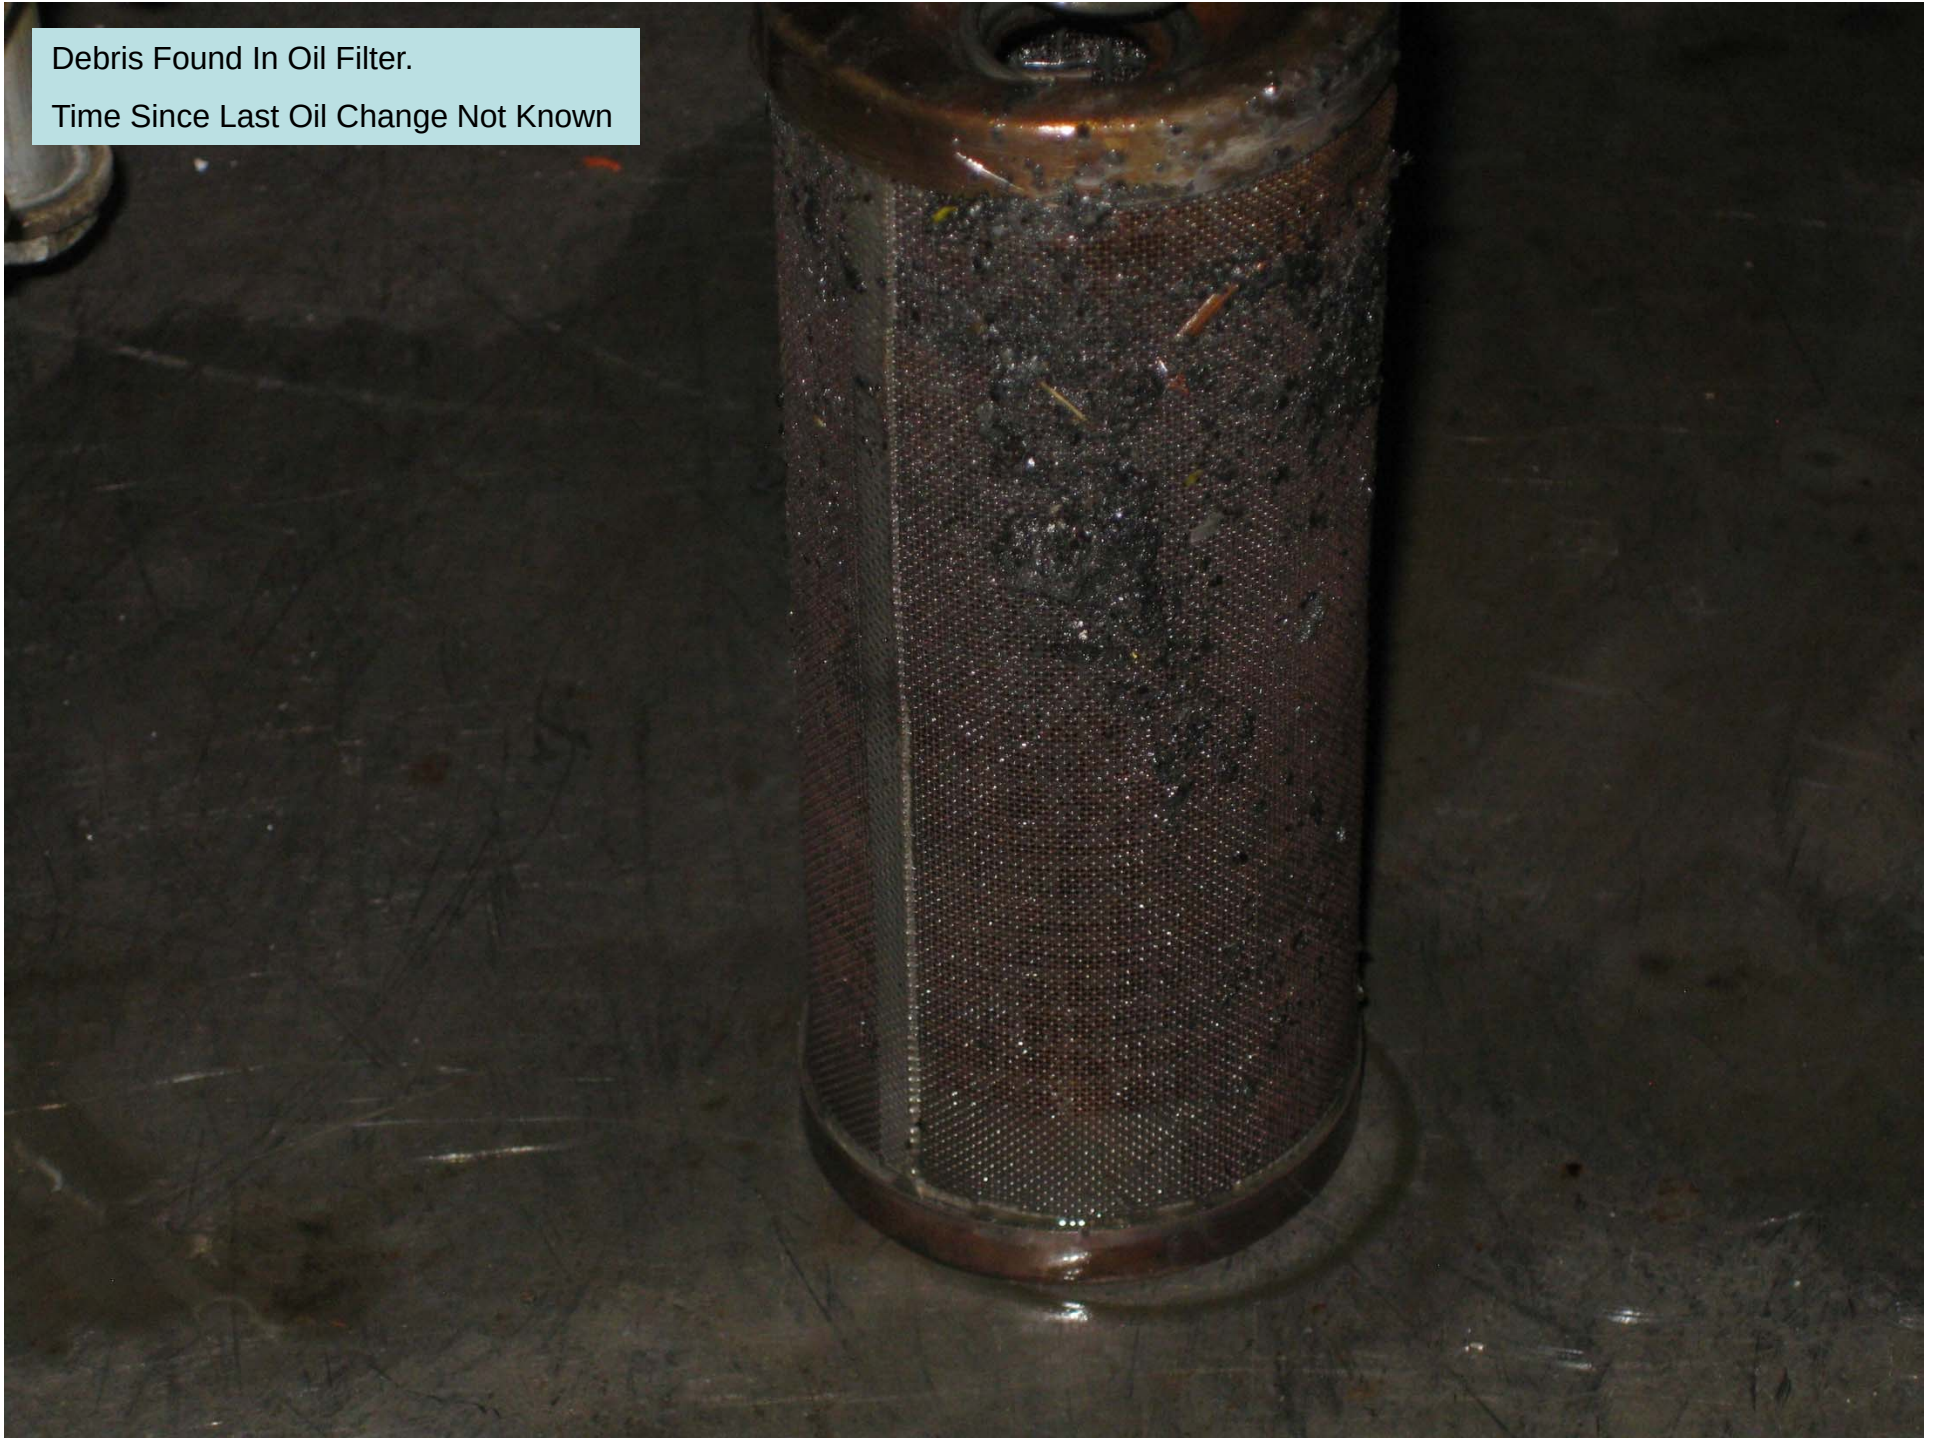
Debris Found In Oil Filter Housing.

Time Since Last Oil Change Not Known

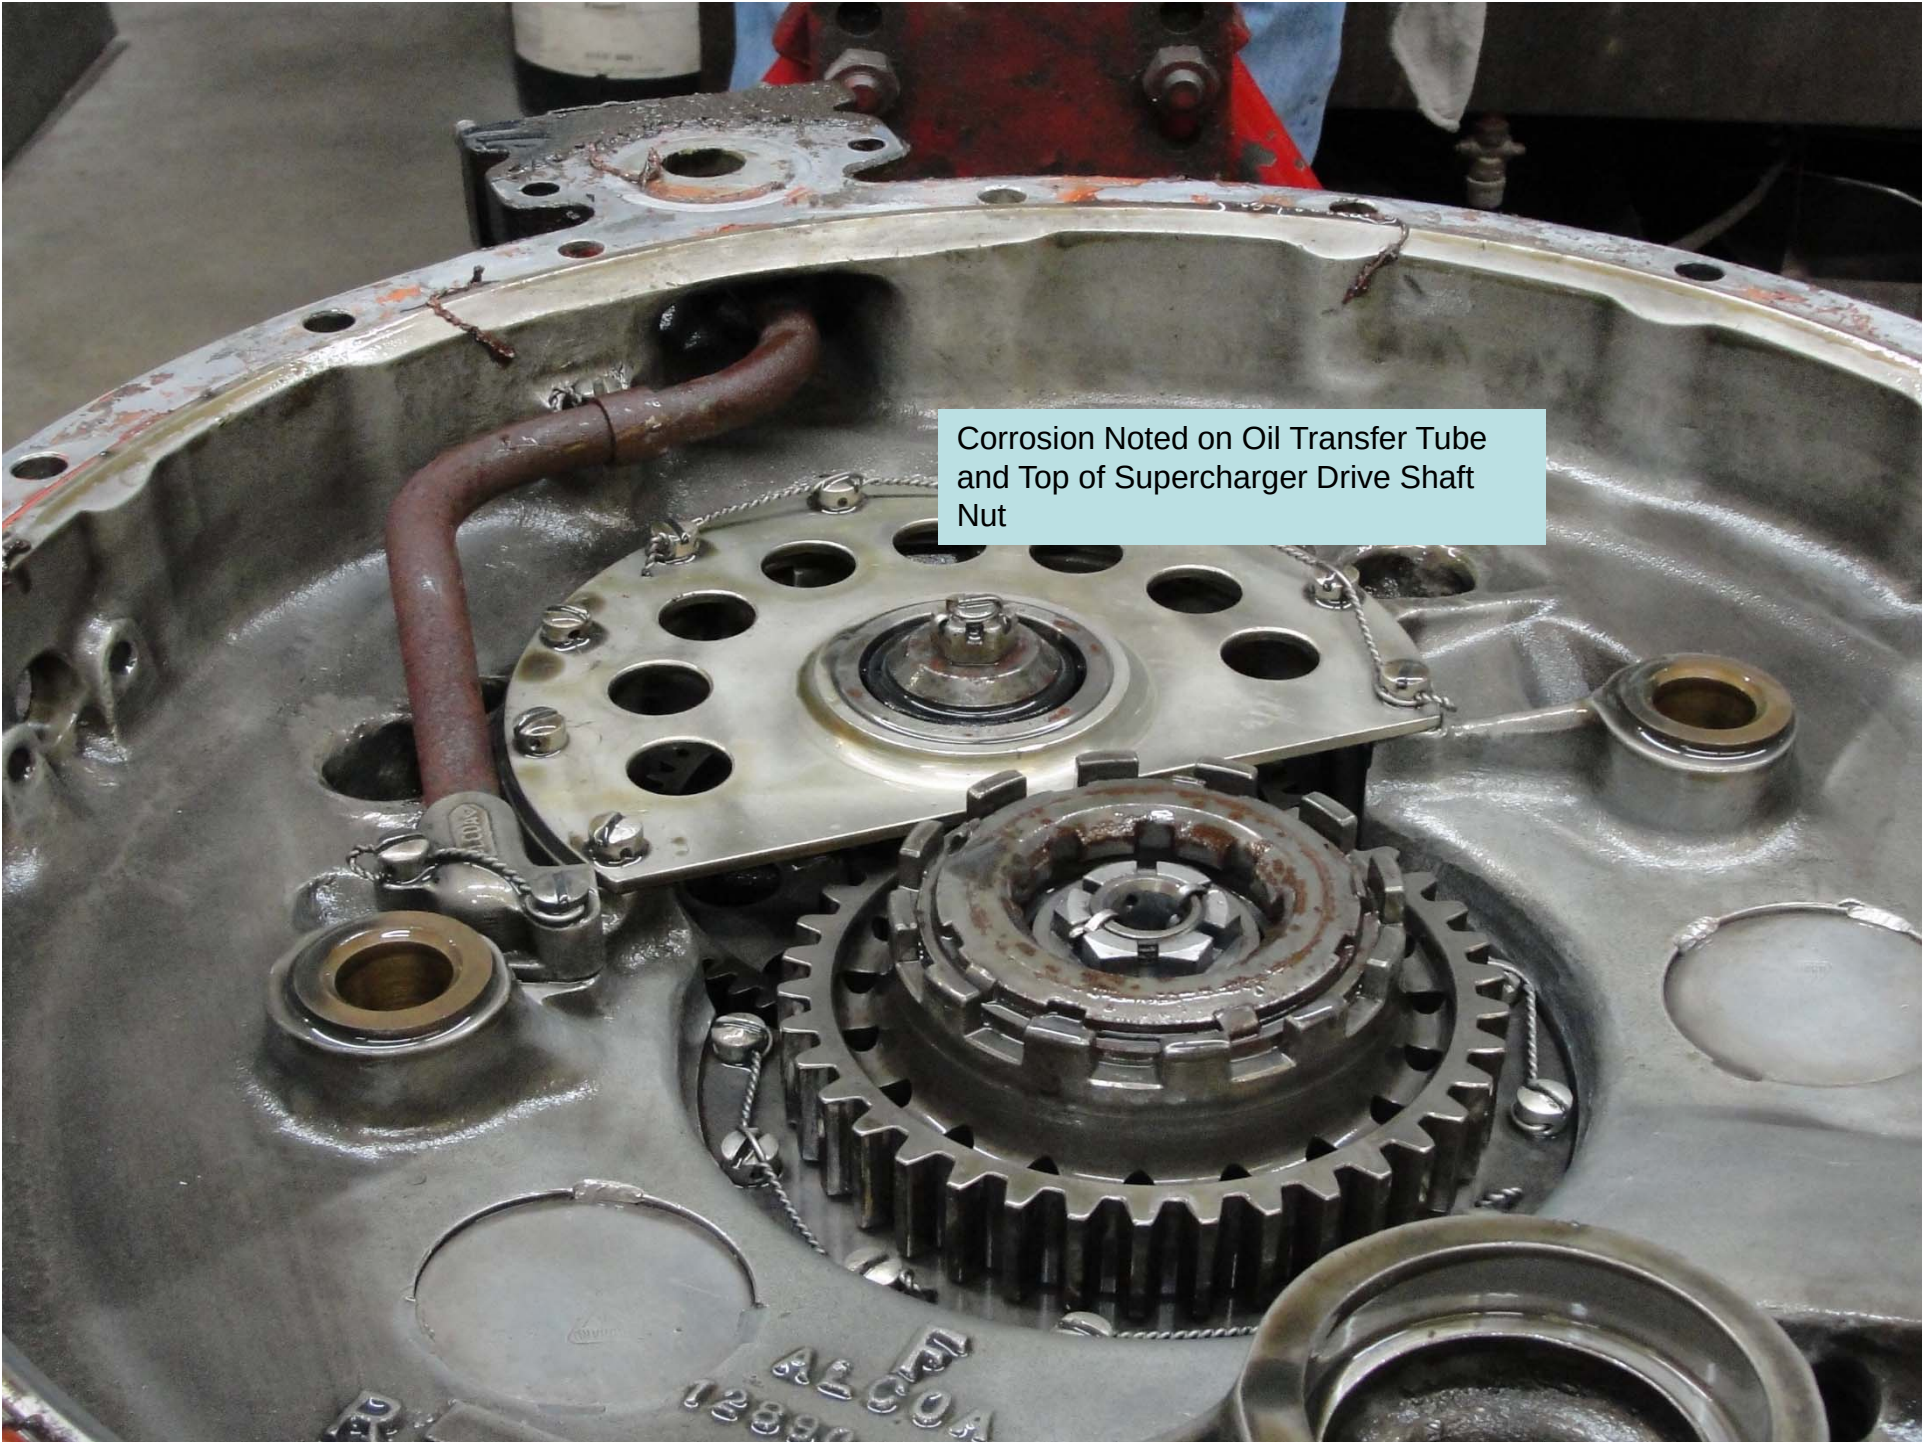
- Engine appears to have been operated in a dirty environment with lack of regular cleaning.
- Surface rust was noted on internal oil transfer tubes, cam drive gear, on supercharger drive gear.

Corrosion Noted on Oil Transfer Tube  
and Top of Supercharger Drive Shaft  
Nut

The image shows the internal components of an engine, specifically the oil pan area. A large, curved metal oil pan is visible, with a central oil pump and a supercharger drive shaft assembly. The oil transfer tube, which is a curved metal pipe, shows significant rust and corrosion. The top of the supercharger drive shaft nut also exhibits corrosion. The oil pan has several circular holes and a central oil pump assembly. The supercharger drive shaft is a large, circular gear-like component. The overall condition of the engine components appears to be poor, with significant rust and corrosion visible throughout.

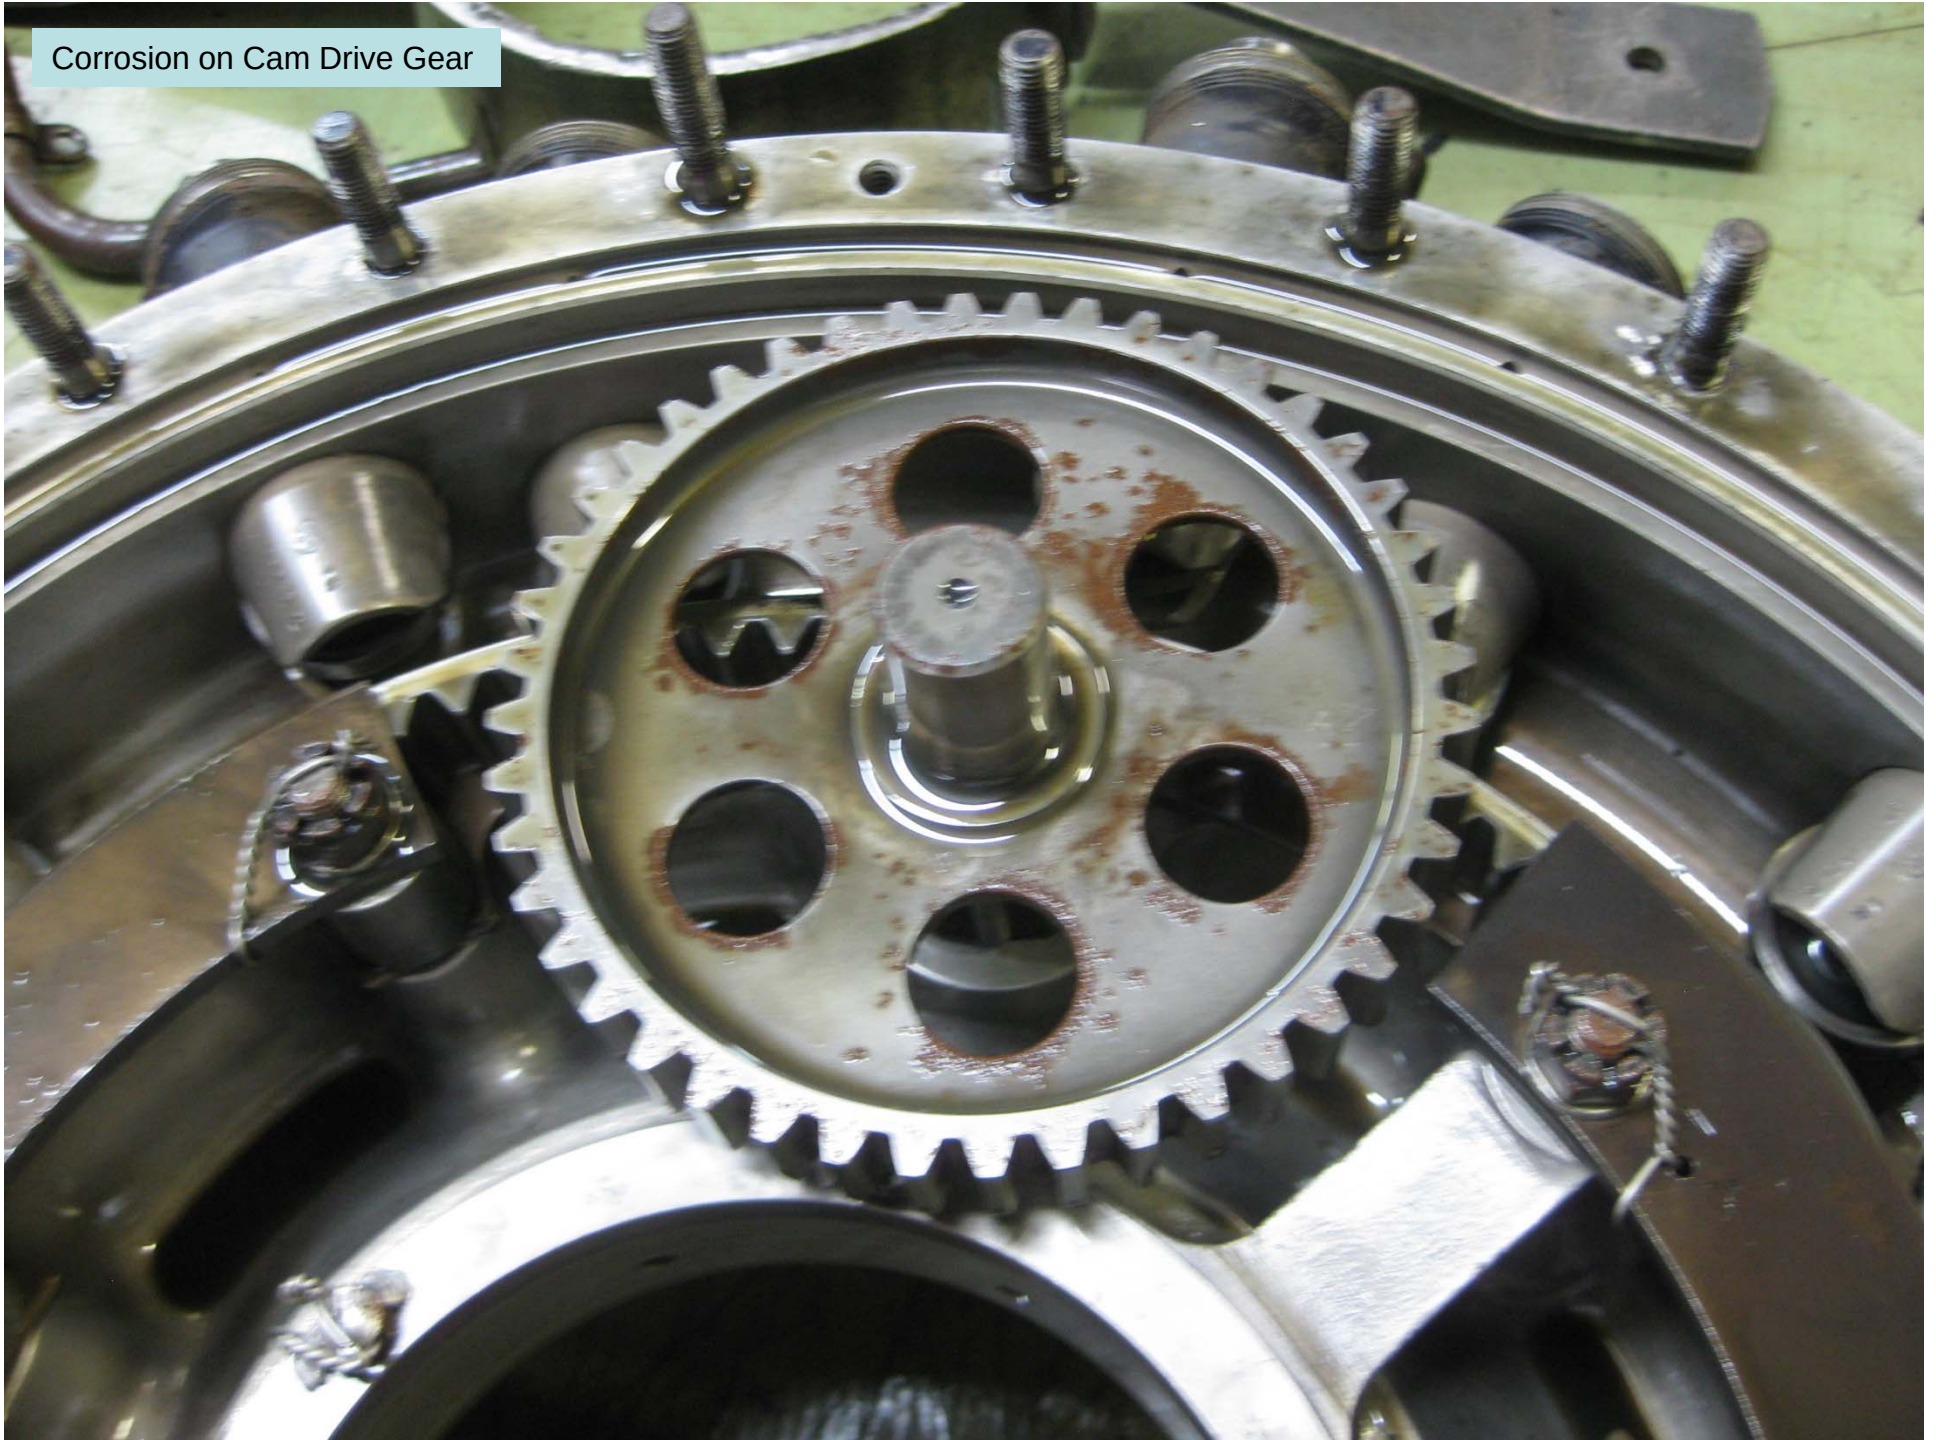
Corrosion on Cam Drive Gear
