## WRECKAGE AND IMPACT

The Safety Board investigator-in-charge performed an on-scene wreckage documentation the day following the accident on October 20, 2017.

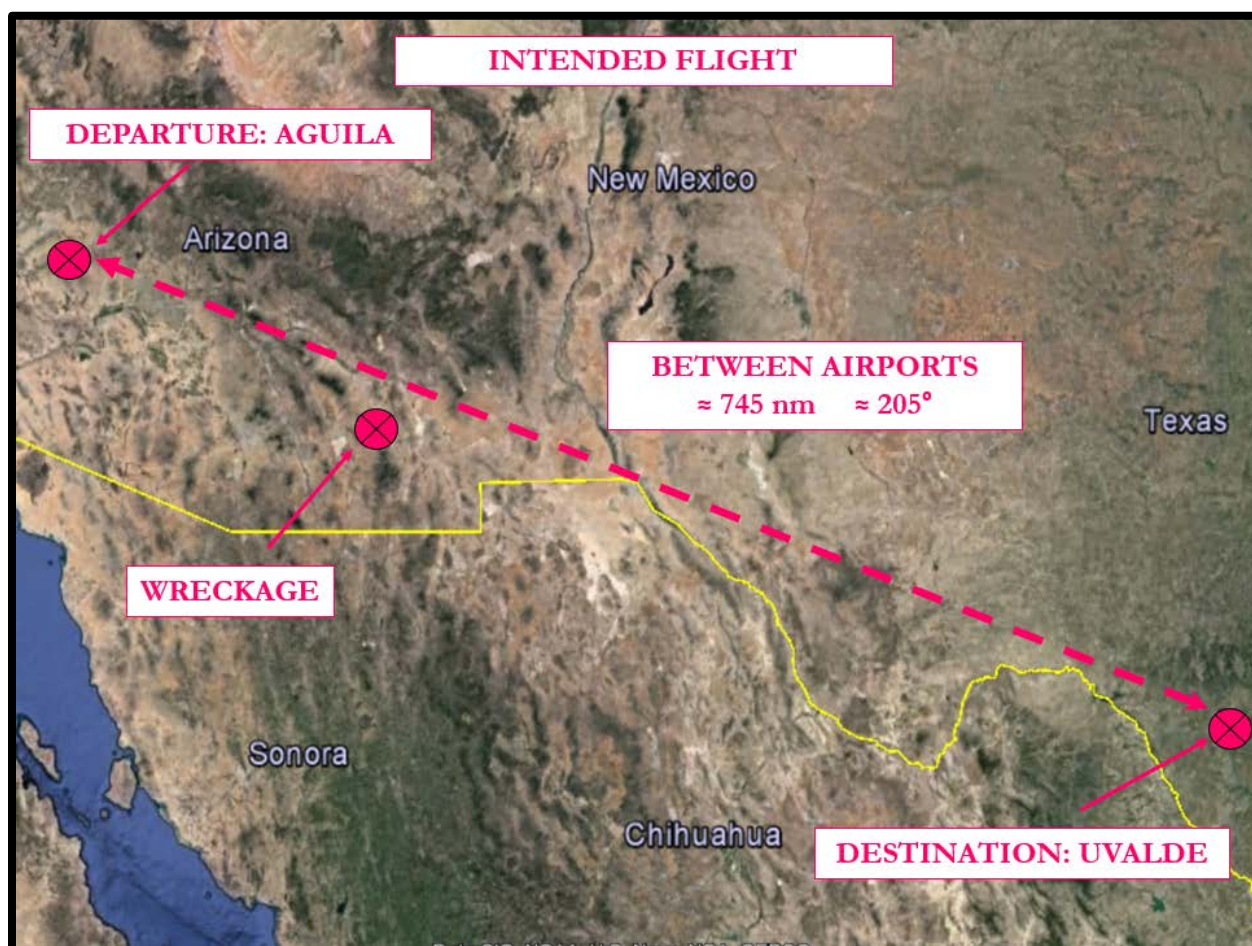
Figure 1: Intended Flight

The airplane was based in Aguila and the pilot had planned to attend a fly-in over the weekend in Uvalde, Texas about 745 nm southeast. The pilot had registered for the event a few weeks before the accident and located in the wreckage was a flight plan outlining the intended flight to Uvalde. The flight plan showed that the pilot departed at 0710 and had reached his next planned checkpoint of Buckeye VORTAC at 0739; the next listed checkpoint was San Simon VORTAC.

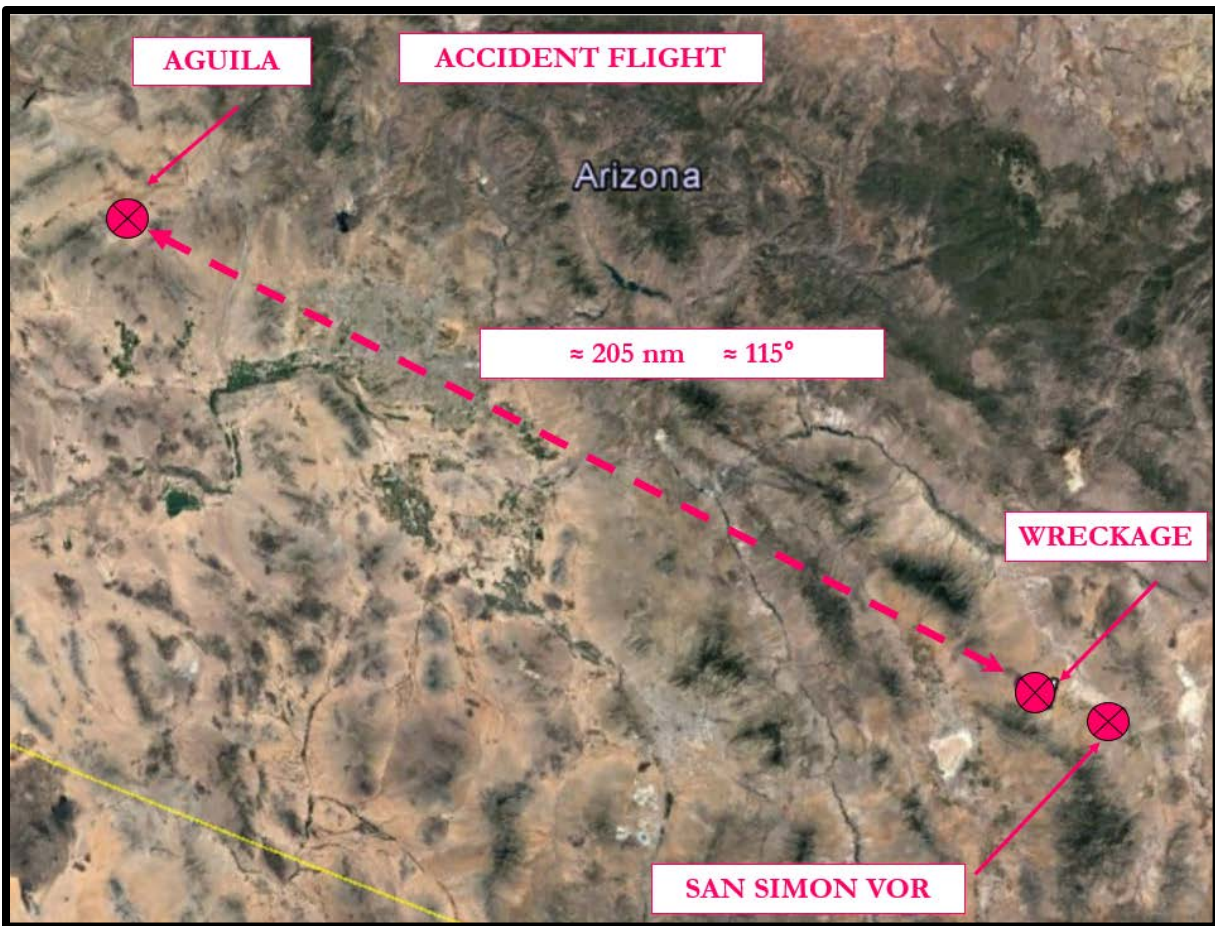
Figure 2: Accident Flight
