# NATIONAL TRANSPORTATION SAFETY BOARD

## Global Positioning System Device

### Specialist's Factual Report

Location: Tehachapi, California  
Date: November 19, 2017  
Aircraft: Beech 35-C33  
Registration: N24987  
Operator: Private  
NTSB Number: WPR18FA035

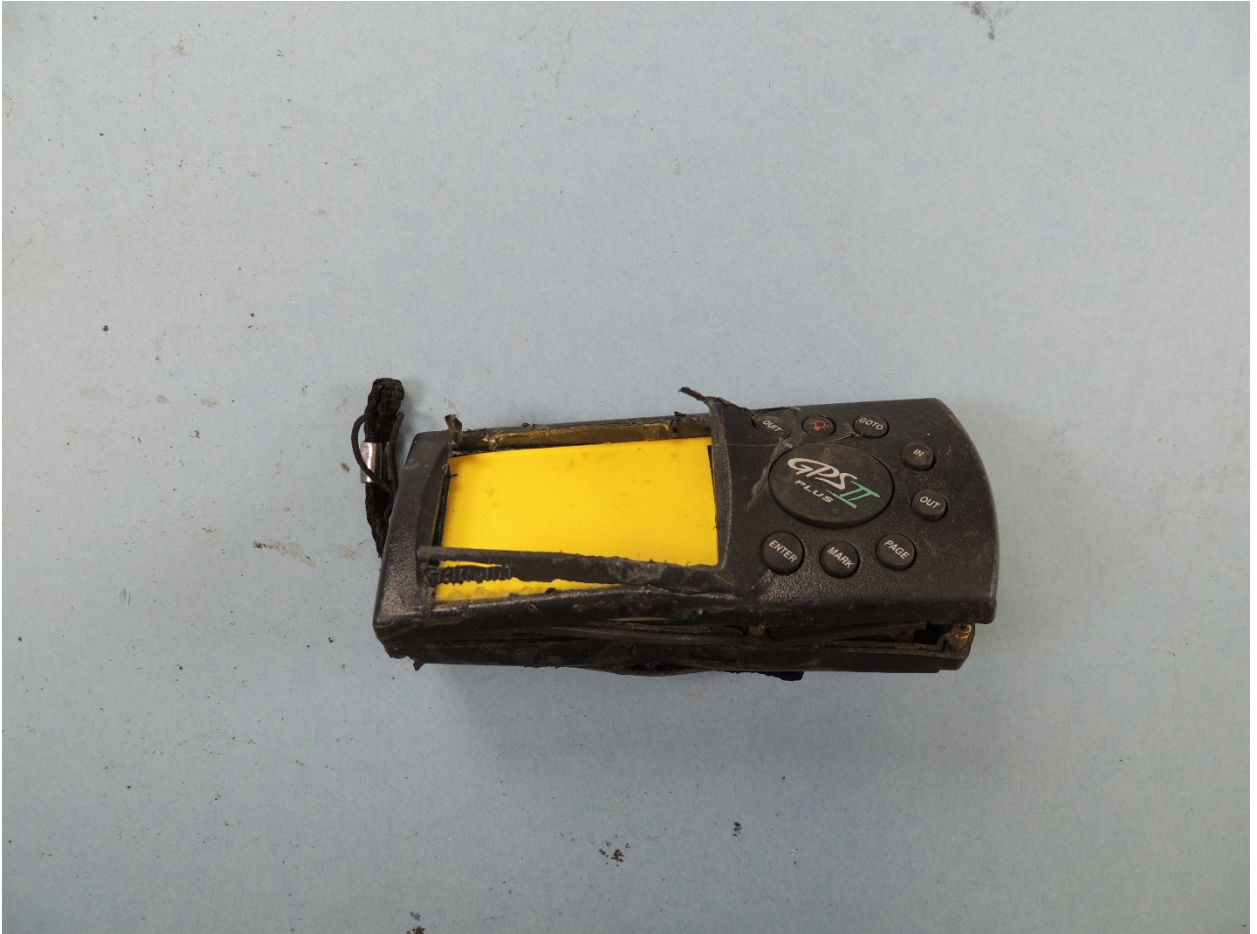
Upon arrival at the Vehicle Recorder Laboratory, an exterior examination revealed that the unit experienced severe impact damage during the accident and would not power on. It was disassembled for further examination. Figures 1 and 2 show the device as received. The GPS II Plus stores recorded data in *non-volatile* memory (FLASH).<sup>2</sup> This model stores recorded data on an AM29LV 800BT FLASH memory device mounted to the main printed circuit board (PCB) (see figure 3 in red circle). Due to the damage, data could not be recovered.

**Figure 1. Damaged exterior of Garmin GPS II Plus (front side)**

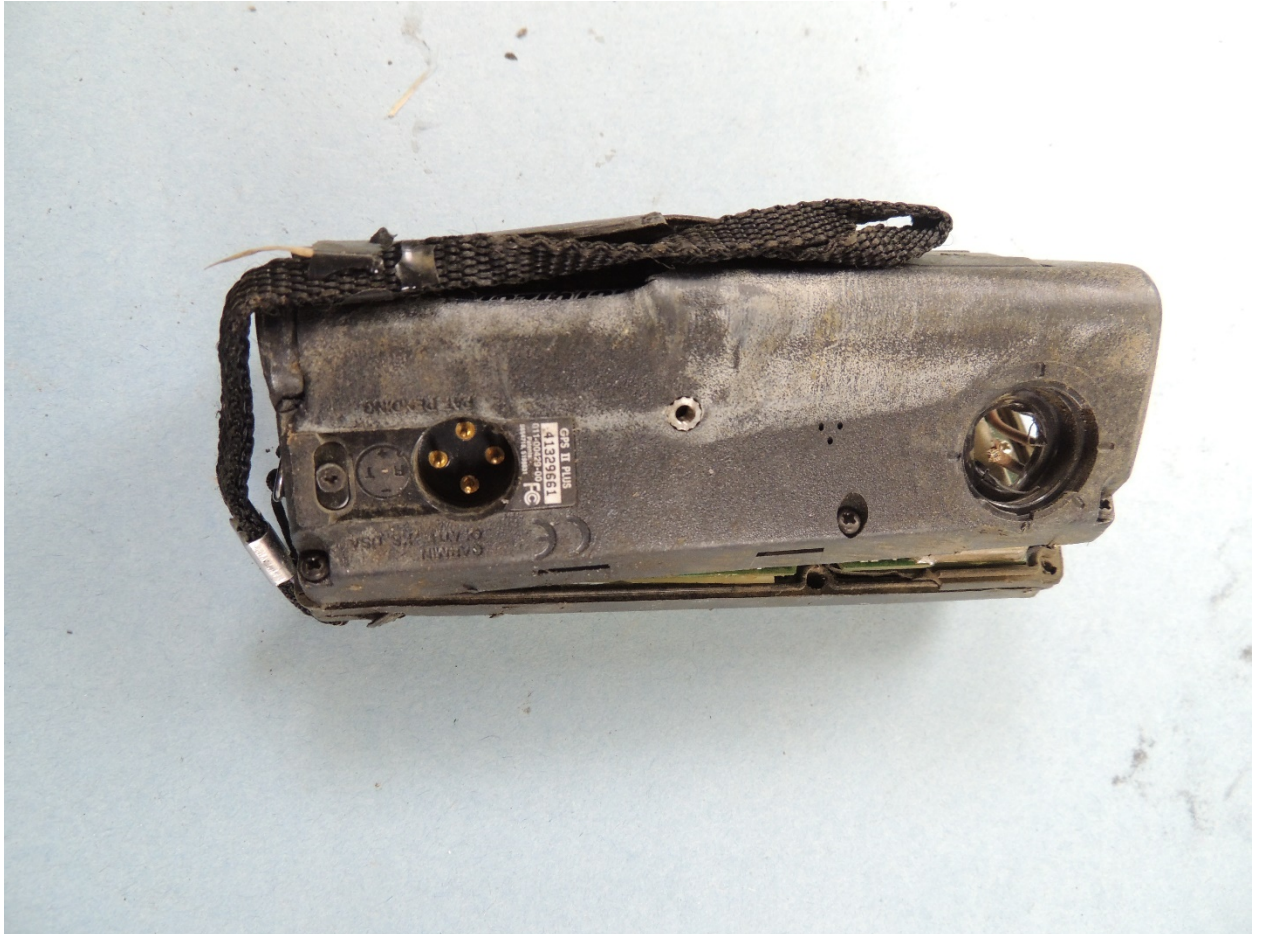
**Figure 2. Damaged exterior of Garmin GPS II Plus (back side)**

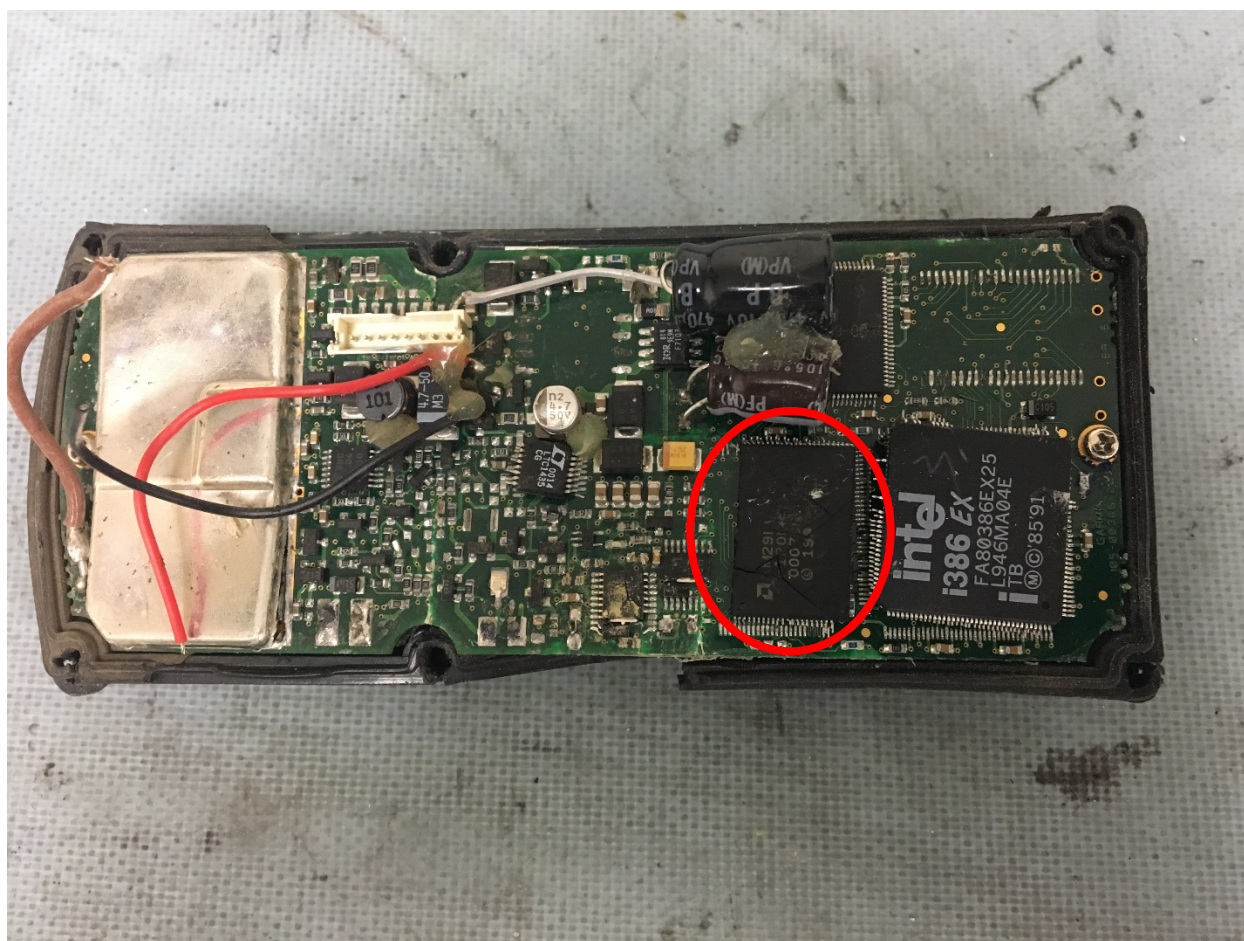
**Figure 3. Inside of Garmin GPS II Plus**
