**NATIONAL TRANSPORTATION SAFETY BOARD**

## **Global Positioning System Device**

### **Specialist's Factual Report**

Location: Minden, Nevada  
Date: February 19, 2018  
Aircraft: Piper PA-34-200T  
Registration: N14GQ  
Operator: Private  
NTSB Number: WPR18FA091

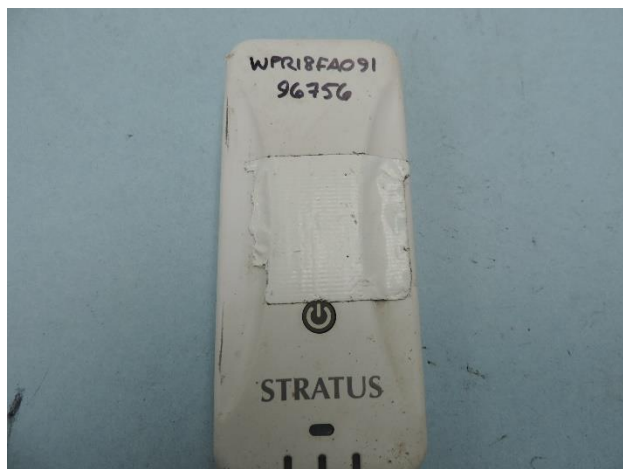
The device is pictured below in figure 1. The device appeared undamaged externally. Movement of internal parts were heard when the unit was disturbed. The device was opened and examined. The device's Wi-Fi module was found to be displaced from the unit's main circuit board. An attempt at resoldering the Wi-Fi module to the unit's main board was unsuccessful.

**Figure 1.** Photo of damaged Appareo Stratus.

The device's internal memory chip was identified and removed using a hot air rework station. The chip was cleaned and read with the appropriate model reader. A binary image was collected of the internal memory. Laboratory software tools were then used to convert the binary data to engineering units.

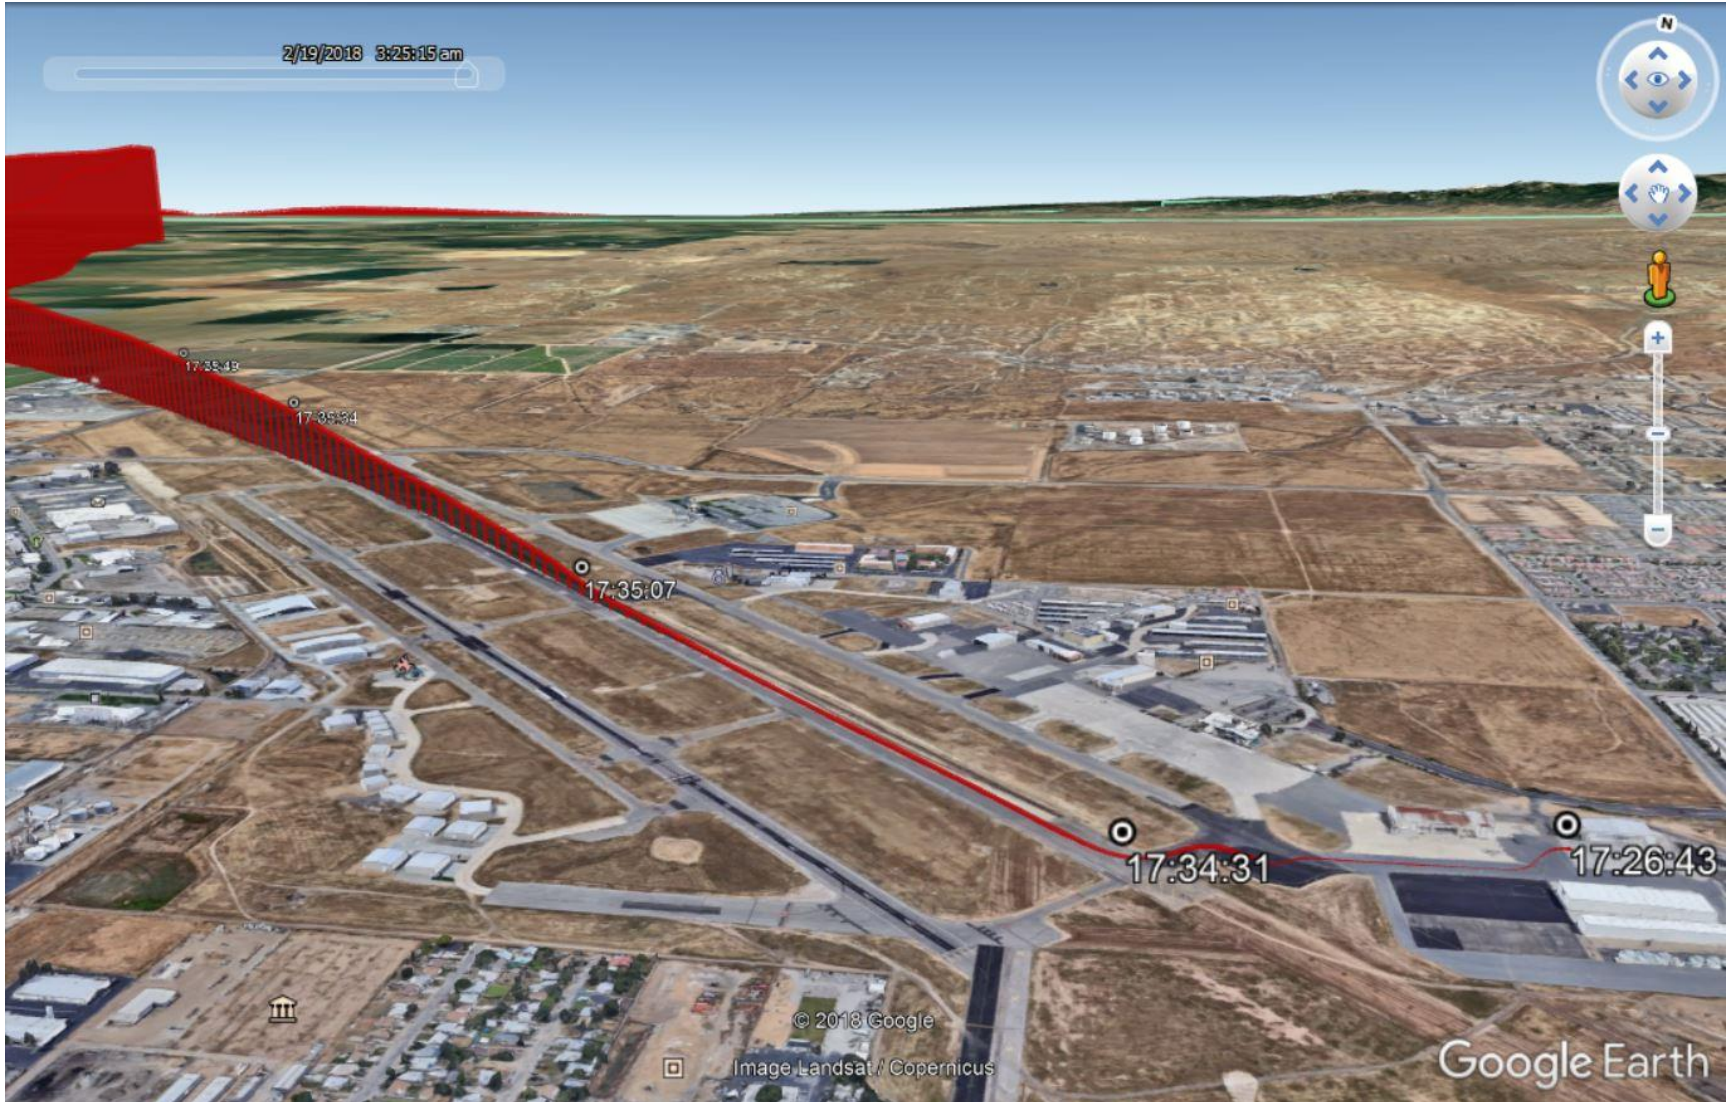
Figure 2 is an overlay on Google Earth of the aircraft's departure from BFL. The recording originated around 17:26 near a ramp area in the southwest corner of BFL. By 17:34:31, the aircraft had entered runway 30R. By 17:35:34, the aircraft had departed straight out from runway 30R at BFL.

Figure 2. Google Earth overlay showing the aircraft's departure from BFL.
