**Factual Report – Attachment 2**  
**Graphics**

**AIR TRAFFIC CONTROL**

WPR18FA141

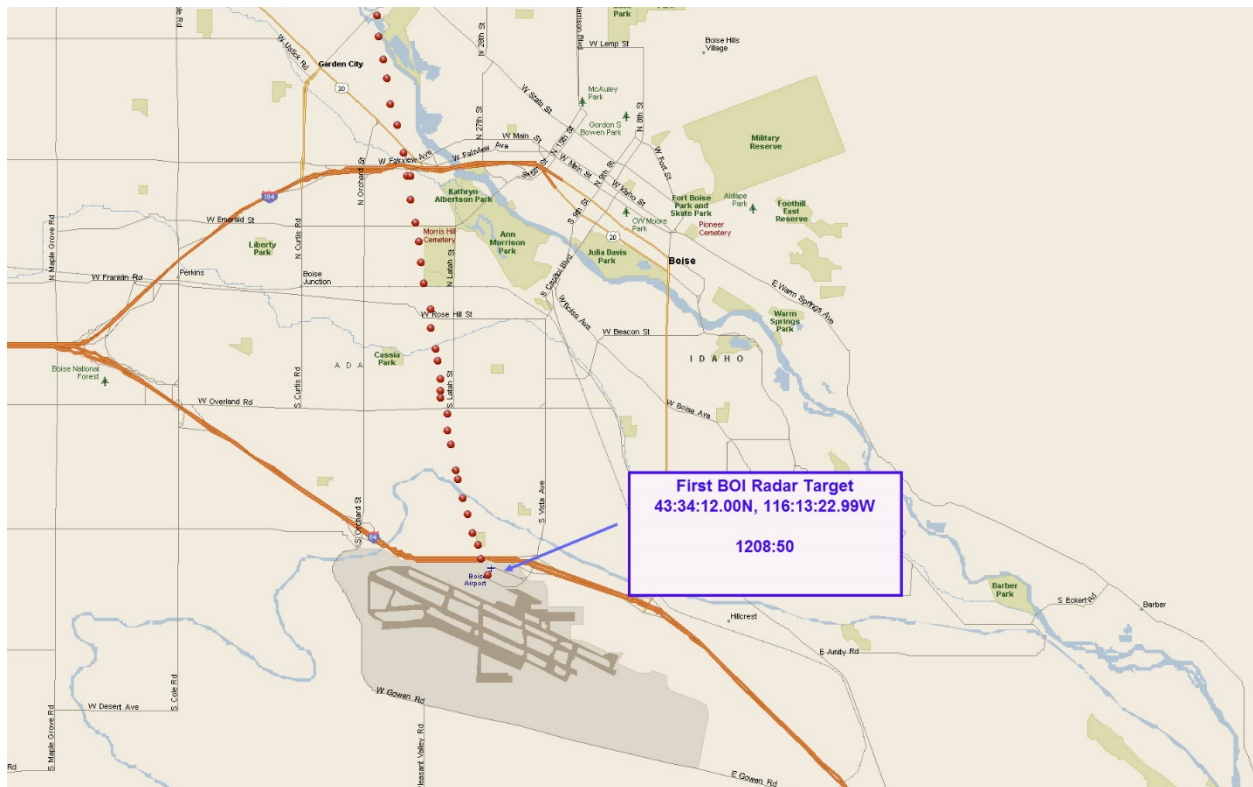
Figure 2 - Graphic showing the first radar target of the accident aircraft and travelling northbound.

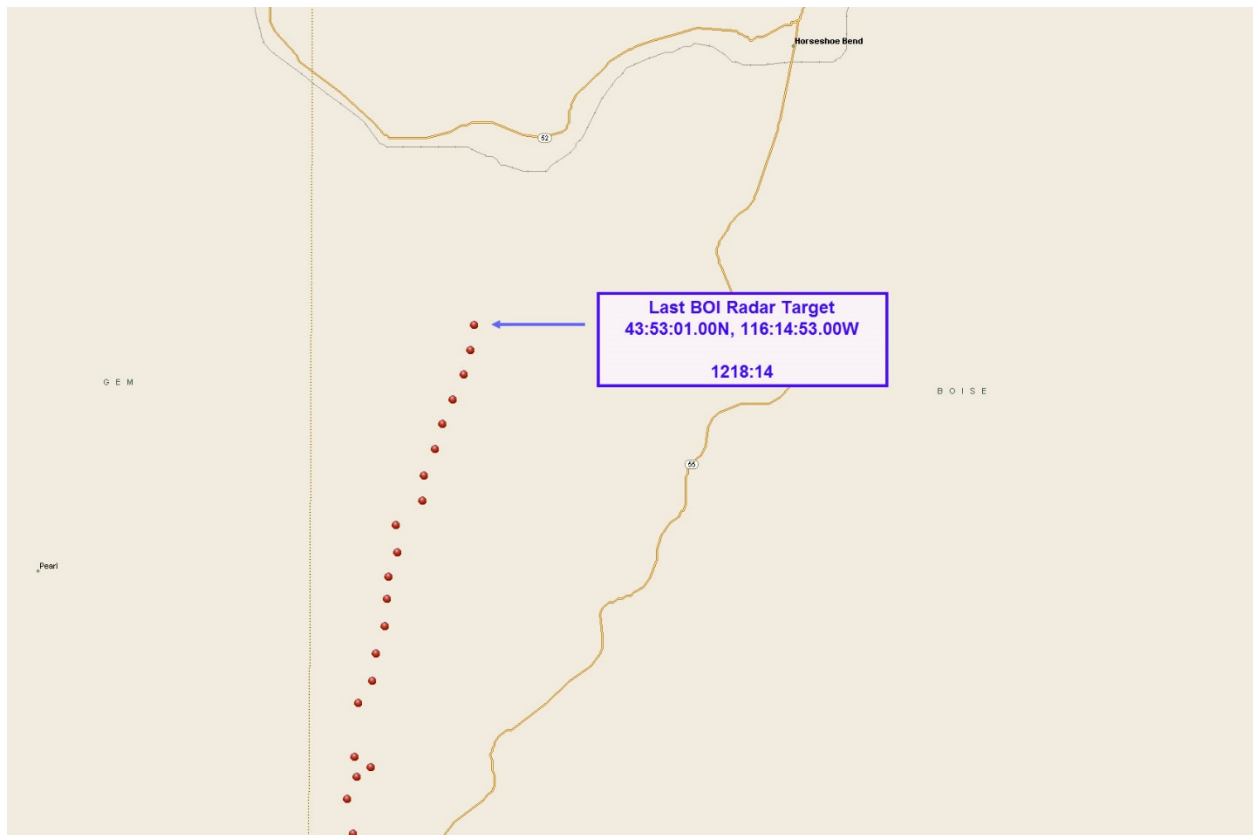
Figure 3 - Graphic showing the last radar target of the accident aircraft before the accident sequence.

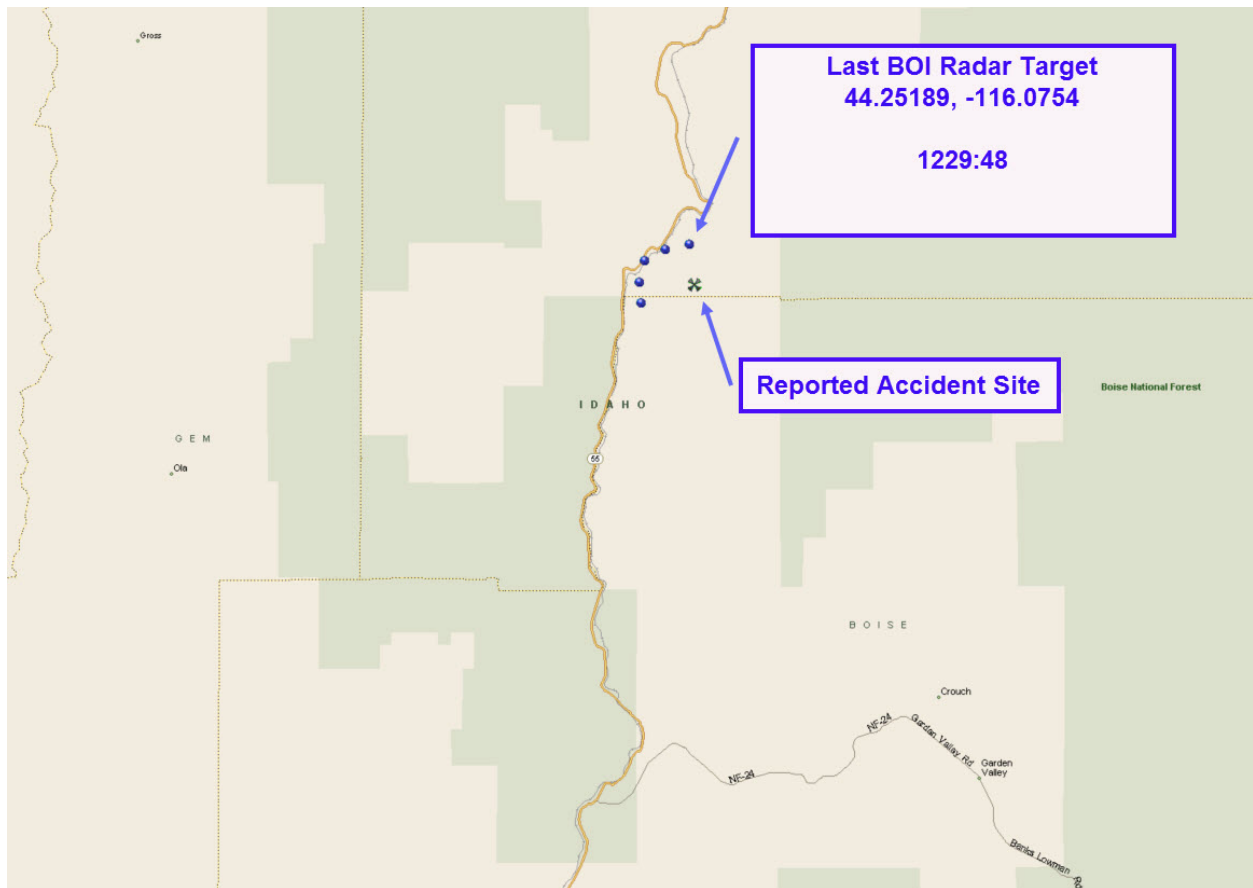
Figure 4 - Graphic showing the reported accident location and a possible track of the accident aircraft. The track was established after the loss of radar contact and cannot be confirmed as the accident aircraft.
