# NATIONAL TRANSPORTATION SAFETY BOARD

## Electronic Device

### Specialist's Factual Report

Location: Melville, New York  
Date: May 30, 2018  
Aircraft: North American SNJ-2  
Registration: N62382  
Operator: Skytypers  
NTSB Number: WPR18FA155

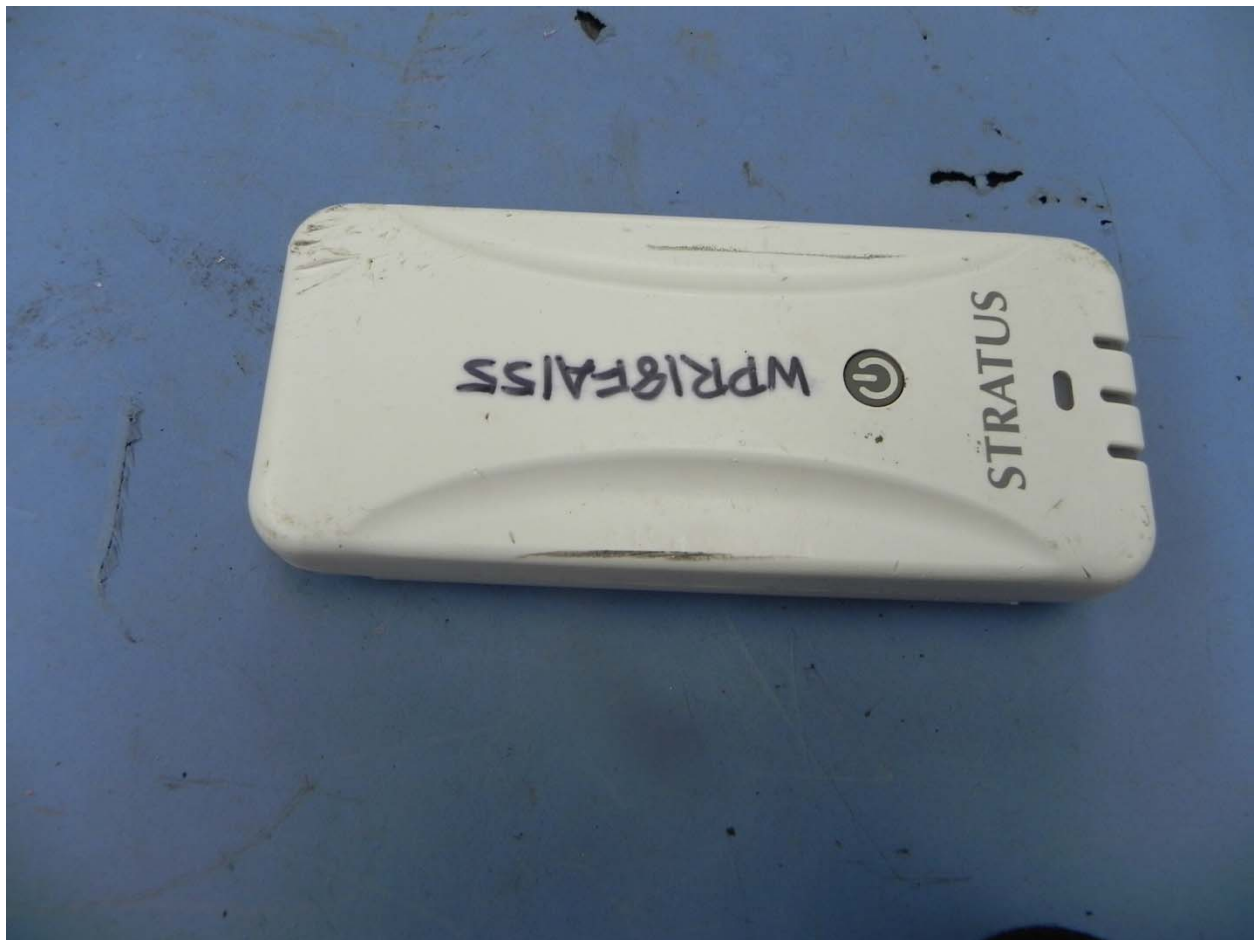
Upon arrival at the NTSB Vehicle Recorders Division a visual inspection revealed minor impact damage and water damage. The device was disassembled and upon further inspection it was also noted that a capacitor had fallen off one of the circuit boards. The non-volatile memory chip was removed from the device and read out using lab equipment.

**Figure 1. Photo of minor damage to Stratus PRX V2.**

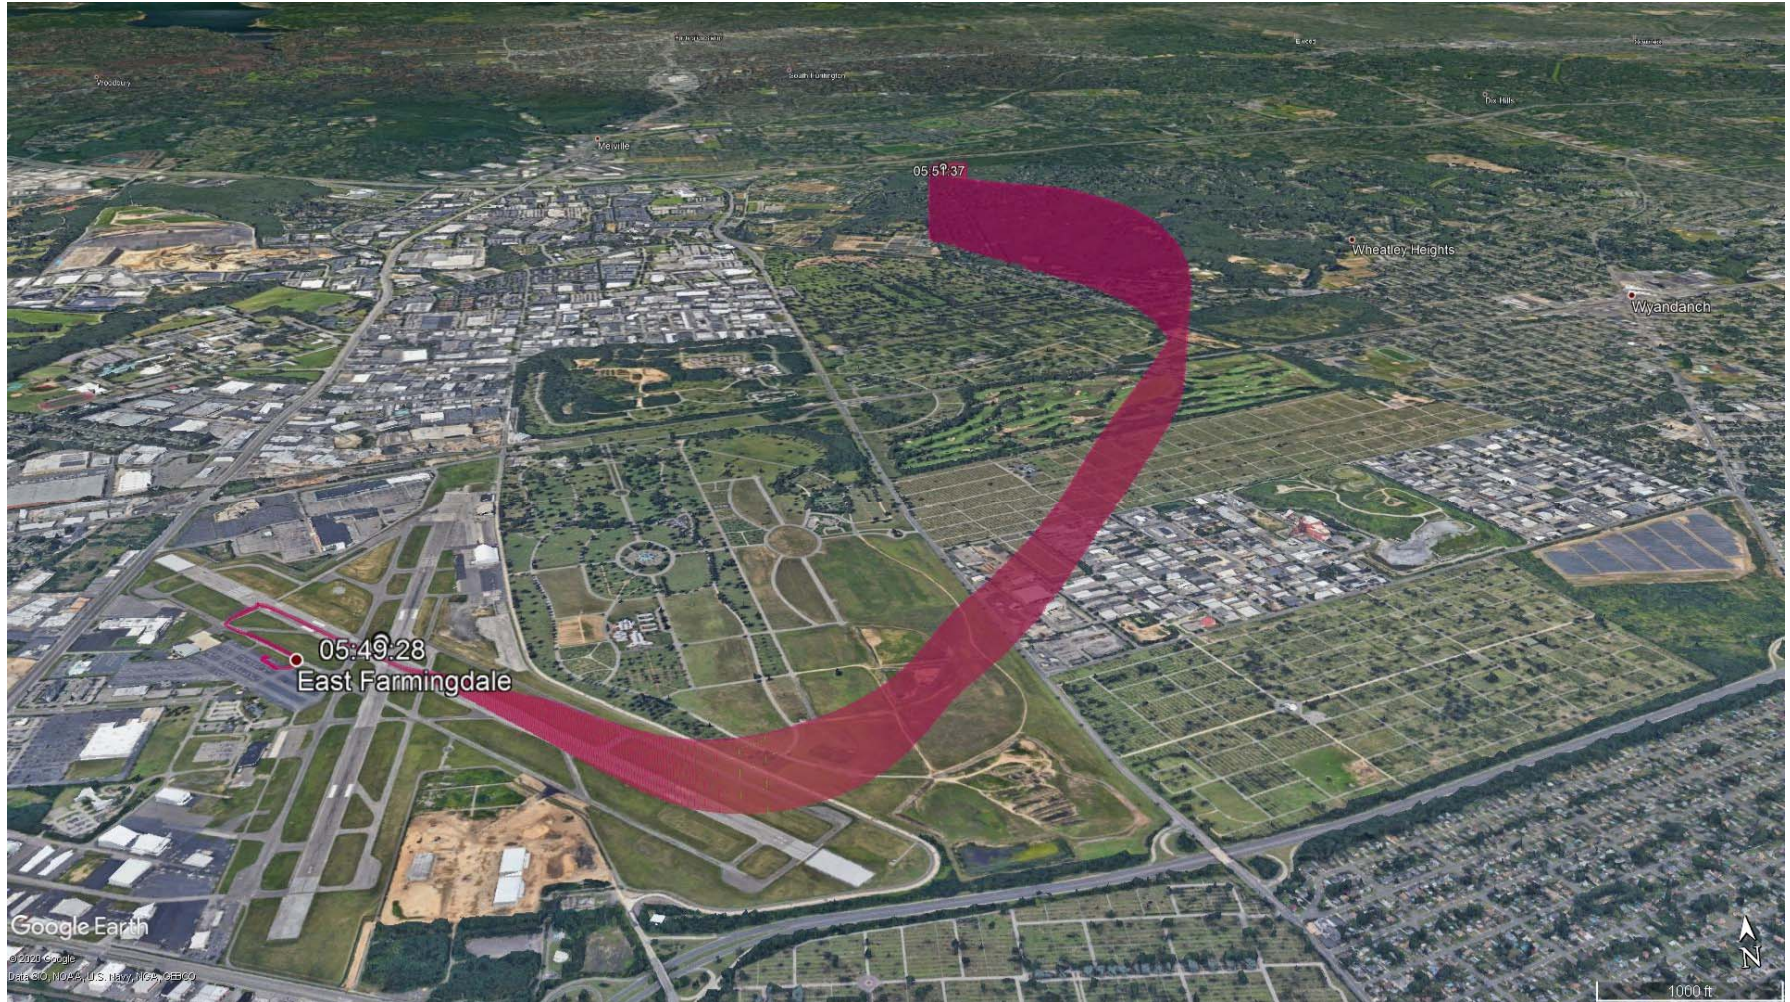
Figure 2 is a graphical overlay generated using Google Earth for the accident flight. The weather and lighting conditions in Google Earth are not necessarily the weather and lighting conditions present at the time of the accident flight.

Figure 2. Google Earth overlay showing the accident flight.

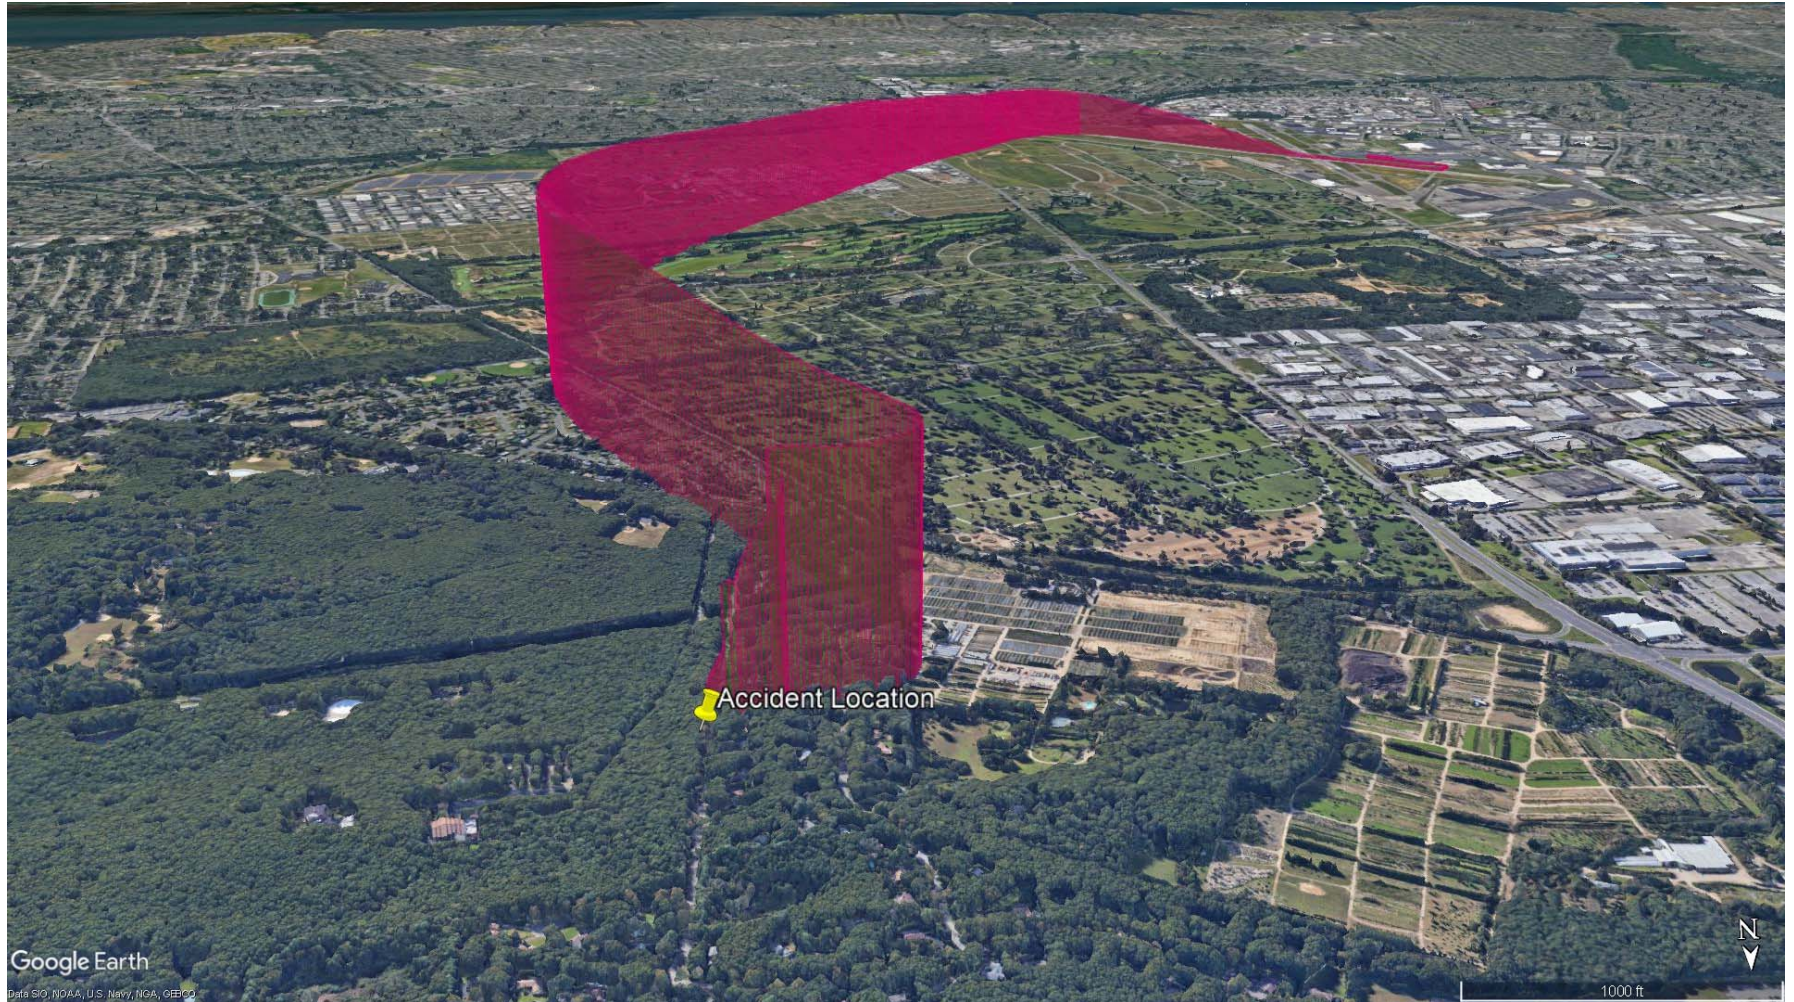
Figure 3 is a graphical overlay generated using Google Earth for the end of the accident flight.

Figure 3. Google Earth overlay showing the end of the accident flight.
