**From:** [McAtee Nancy](#)  
**To:** [Salazar Fabian](#)  
**Cc:** [Budinski Michael](#)  
**Subject:** Email report-WPR18FA279 (fuel hose)  
**Date:** Wednesday, April 24, 2019 1:34:21 PM  
**Attachments:** [IV000001.JPG](#)  
[IV000002.JPG](#)

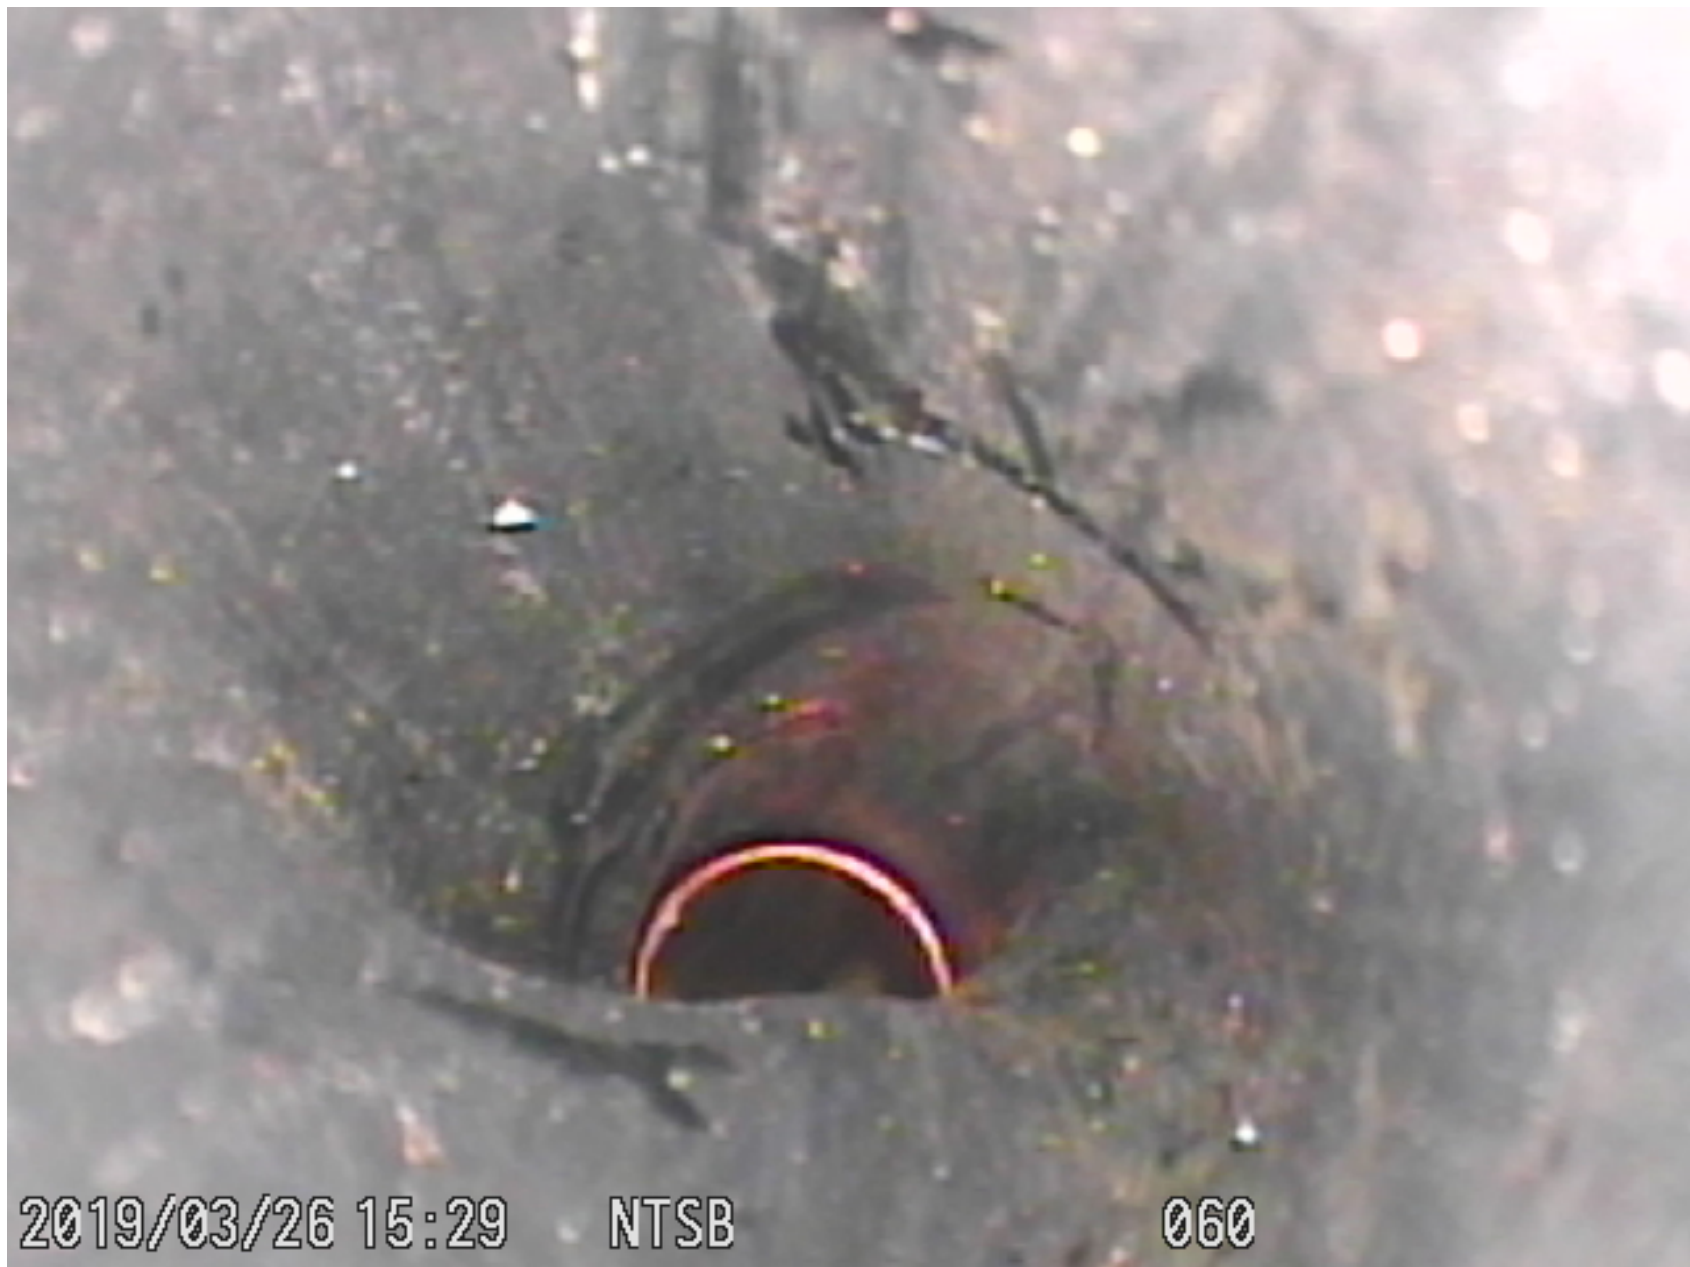
A fuel hose from the accident aircraft was submitted to the Materials Laboratory for examination. The hose was 11.5 inches in total length (included the nut assemblies on each end) and consisted of an inner rubber hose with an outer layer of stainless steel wire braid. The hose was an Aeroquip Brand hose manufactured by Eaton. At one end of the hose, there was an indentation, approximately 1 inch in length, in the steel wire braid layer. The interior of the hose was examined to determine if the indentation continued through to the inner rubber hose and if so, to determine if the inner diameter of the hose was obstructed by the indentation. The inner hose was examined using a borescope. While the inner hose did exhibit some degree of indentation, the deformation did not appear to significantly compromise the inner diameter of the hose. Photographs of the indentation of the inner hose have been attached.

**Photo 1 – Fuel Hose Inner Diameter View**

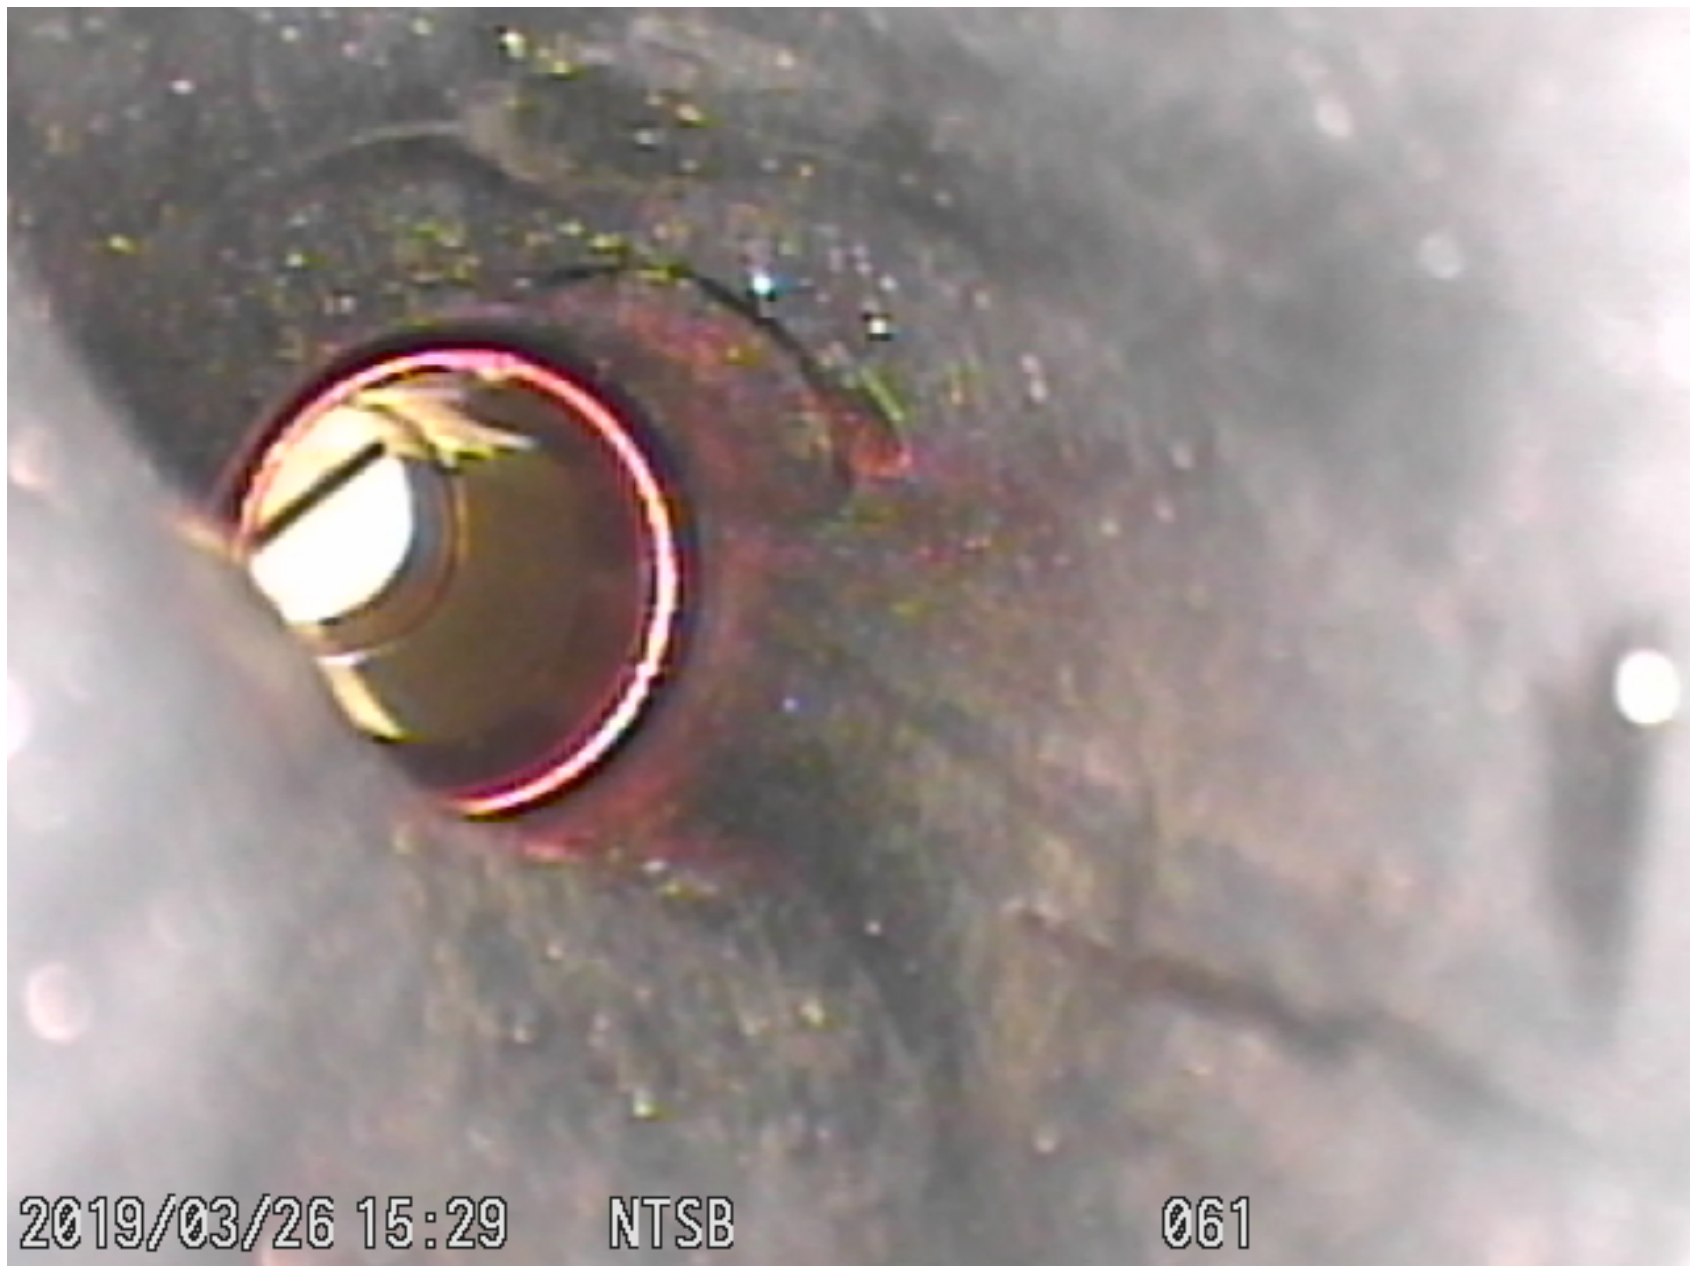
**Photo 2 – Fuel Hose Inner Diameter View number 2**
