# NATIONAL TRANSPORTATION SAFETY BOARD PILOT/OPERATOR AIRCRAFT ACCIDENT/INCIDENT REPORT

Registration Number: N2351N

Manufacturer: CESSNA

**Damage Assessment by Luis J. Jimenez, Pilot-in-Command.**  
**Private Pilot Certificate # [REDACTED]**  
**Incident Date: 04/07/2017 16:00 PDT**  
**Location: Auburn Airport, WA (S50)**  
**Aircraft: N 2351U Cessna 172D S/N 17249951**

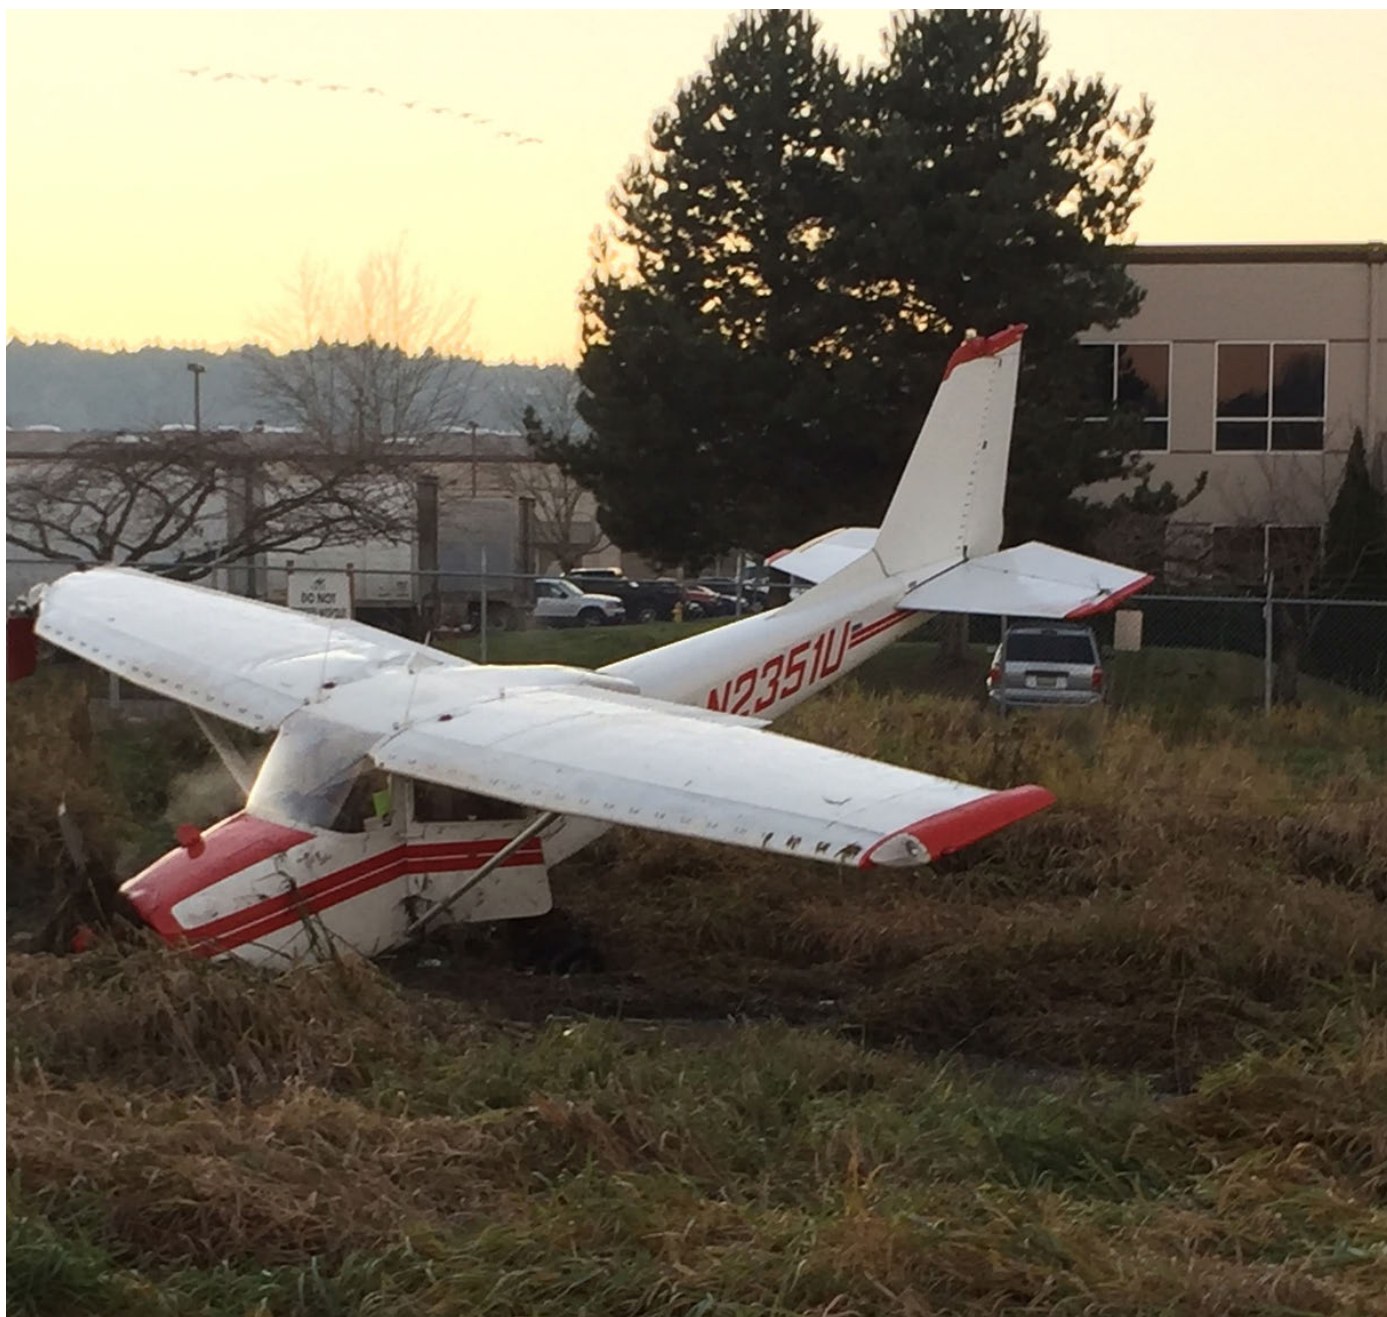
I opened the pilot's door without any problem and stepped out into the water and mud; I was able to walk to the side of the runway (while stumbling several times in the deep water and bird netting) and a couple of individuals including Mr. Pomeroy were already there. They asked if I was ok and I asserted all was fine. After a few minutes, I was offered a ride to the office but before that, the three of us went back to the aircraft to collect my personal belongings. I picked up my flight bag, headphones, aircraft documents and my jackets. After we returned back to the side of the runway, I took several pictures with my phone, one of them shown below (Illustration #1)

ILLUSTRATION #1 – Taken @ 16:15 PST on 12/07/2017, shortly after the incident.

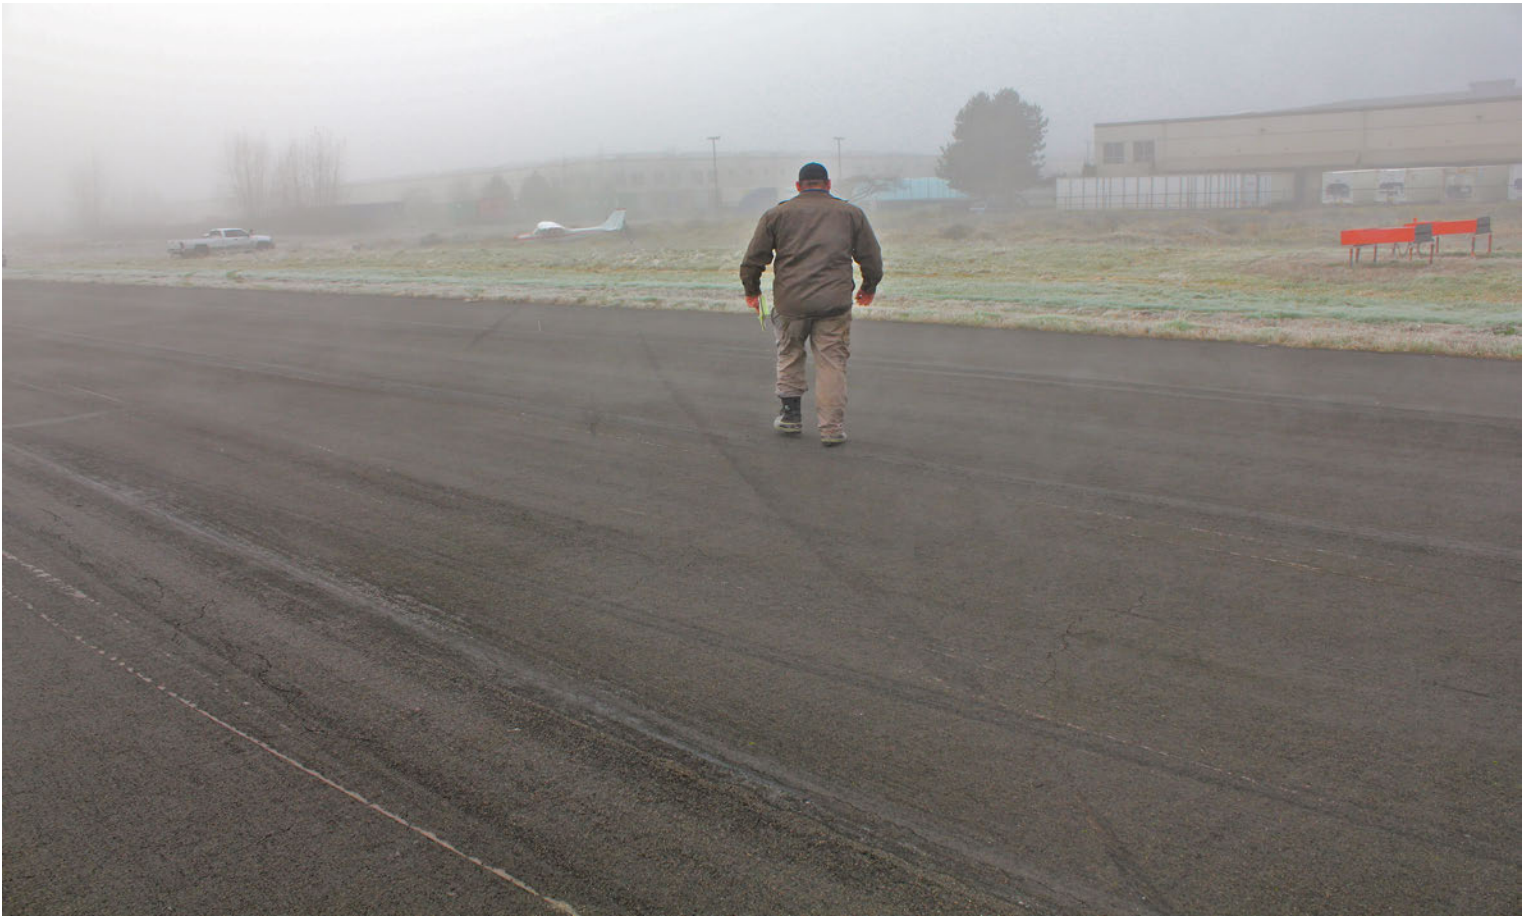
On 12/08/2017 at about 8:45 AM PST, I stopped by the airport office. Tanya escorted me to the incident site where Mr. Donald Bacon, FAA Aviation Safety Inspector and Mr. Jack Vanover of the NTSB were already inspecting the aircraft. Also three employees from AvTech Services LLC [REDACTED] were in the recovery process. On arrival I introduced myself as the pilot of the plane to Joe, an employee of AvTech who was manning the winch being used for recovery. He stated that it must have been a wild ride because both ailerons were drooped (e.g. both in the down position). I stated it was interesting landing and waited until Mr. Vanover, NTSB investigator in charge, came over and I introduced myself as the pilot and we then proceeded to his vehicle where I answered his questions and I gave a brief recollection of what had happened. We then both walked north on the runway, where we located the skid marks from the aircraft. Based on these, it appears that when the aircraft landed in the center of the runway, the right main gear touched first, skidded for several feet, then the nose gear touched briefly and the plane then shifted to the left main gear albeit at a slightly different angle. See Illustration #2 below.

ILLUSTRATION #2- Skid Marks. Photo taken on 12/08/2017.

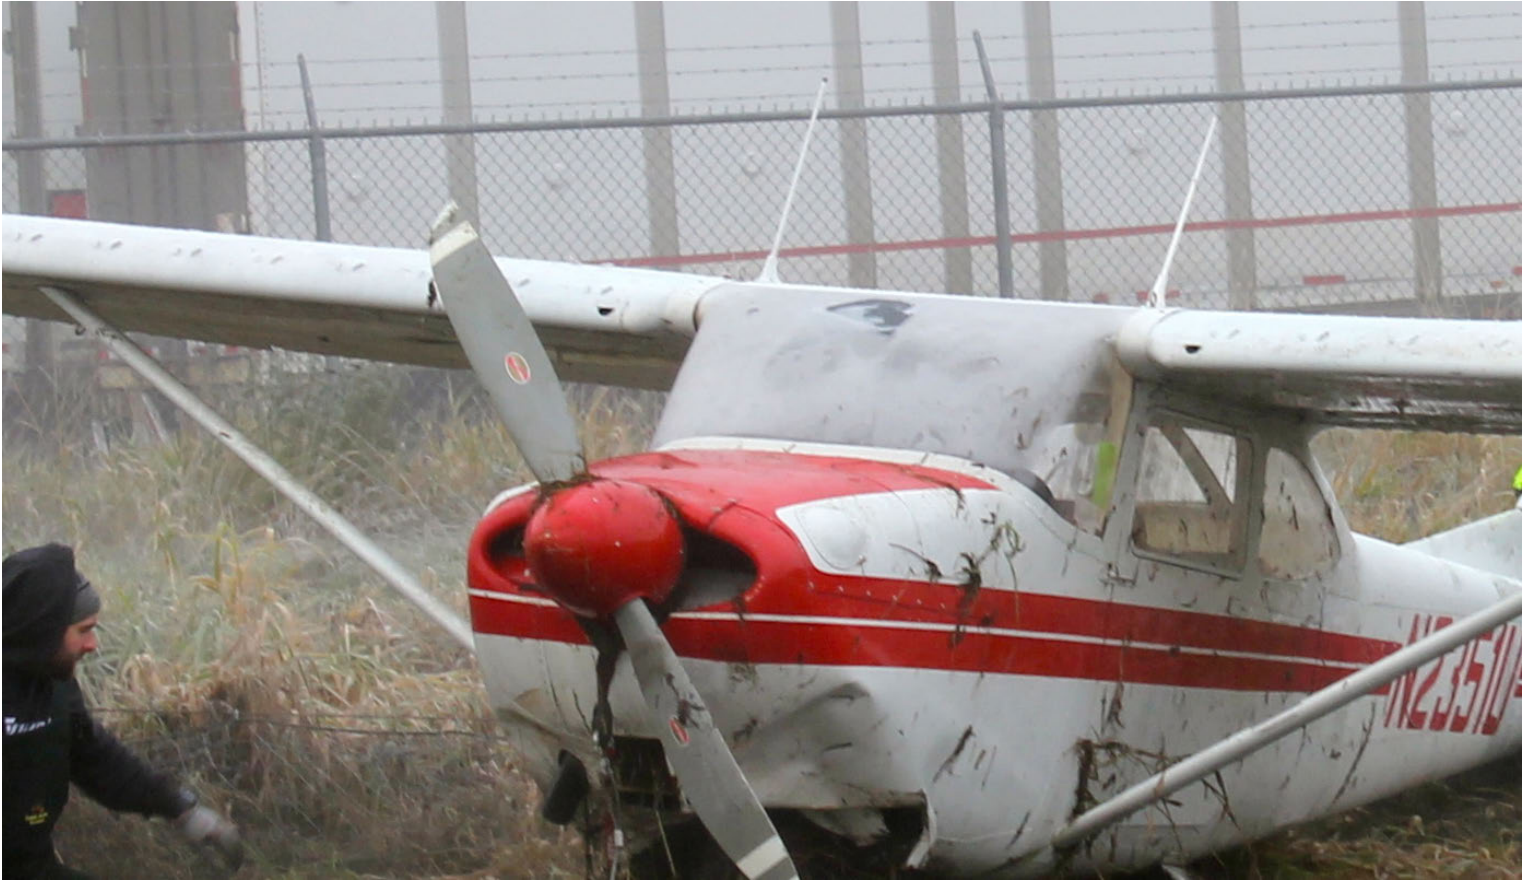
Illustration #3 below shows a frontal view of the aircraft. I noticed how indeed the left flap was in line with the trailing edge of the wing (corresponding to a 0 degree flap setting), yet the right flaps' trailing edge was significantly lower. I then recalled when I took the pictures the day before shortly after the incident, that the right wing was buckled at the root and this must have pushed the flap downward from a neutral position (see illustration #1). This fact is relevant as I then looked at the relative position of the ailerons on both wings.

**ILLUSTRATION # 3 – Frontal view; trailing edge of right flap noticeably below the left flap trailing edge. Flap Setting at 0 degrees.**

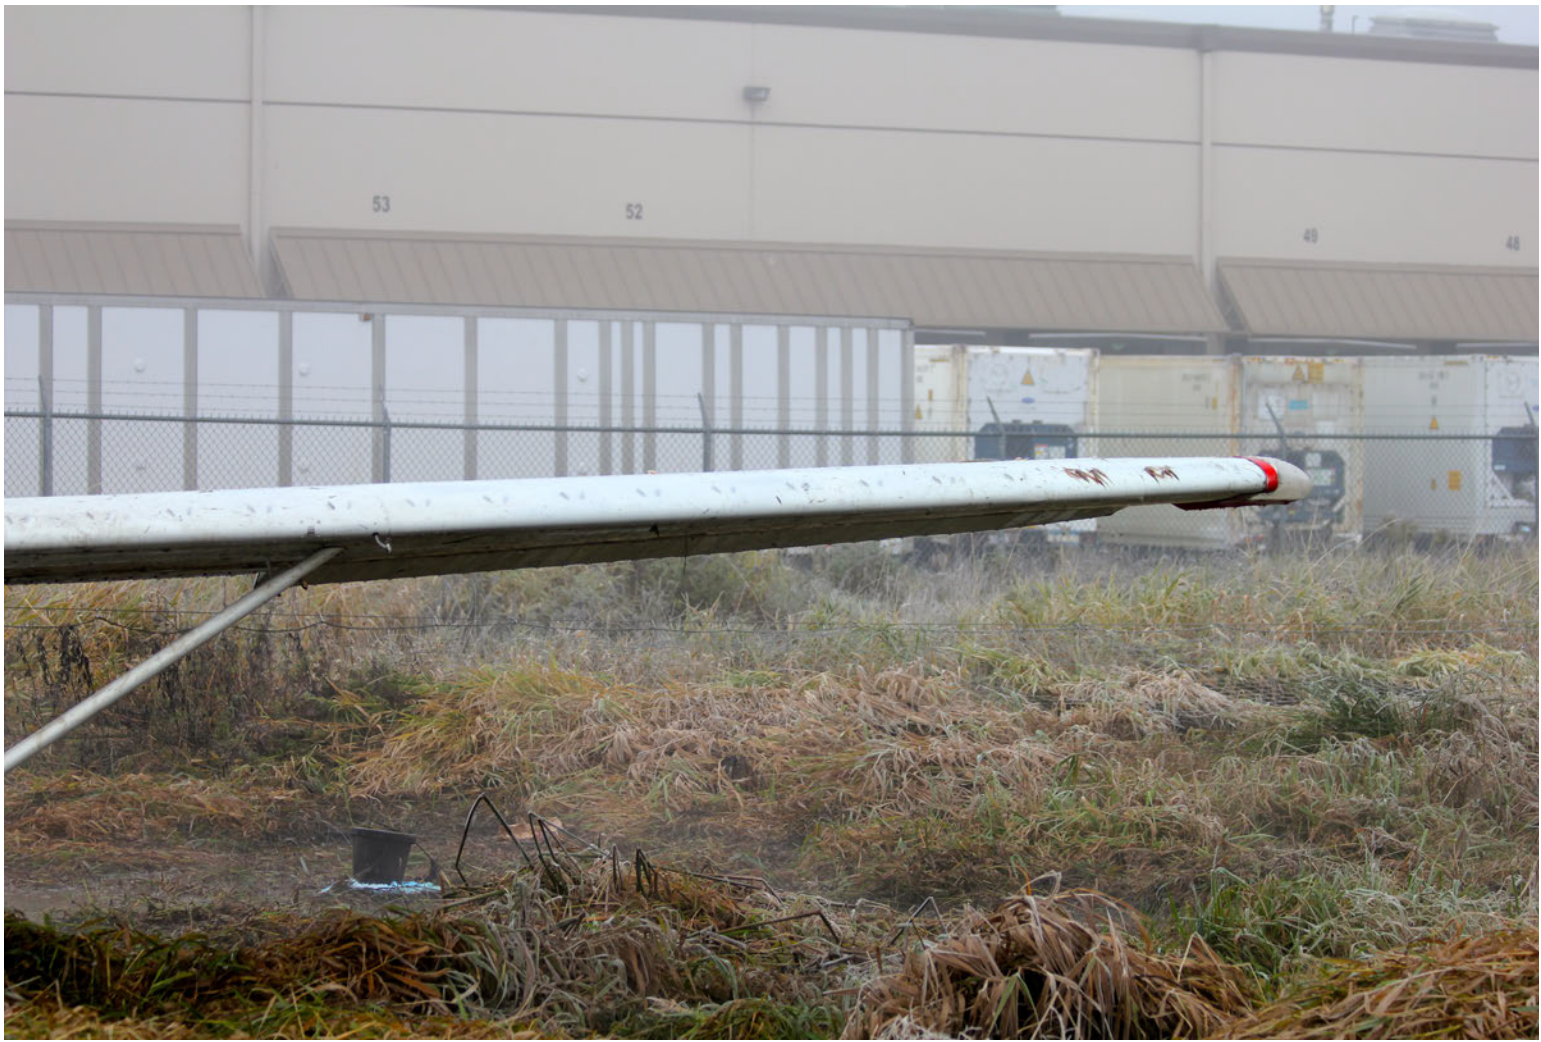
Illustration #4 a shows a photo of the left wing. A magnification on the inboard edge of the aileron (4 b) shows how it is in a downward position relative to the left flap (assumed to be neutral and thus a reference point of 0 degrees).

ILLUSTRATION # 4 a – Left wing; photo taken 12/08/2017

Per Cessna's Service Manual<sup>2</sup>, Aileron travel specs are: Up: 20 plus or minus 1 degree; Down: 15 plus or minus 1 degrees. In other words, in a properly function aileron system, for every degree an aileron travels down, the opposing aileron would rise about 1.33 degrees. Thus, if we assume the left aileron to be in a completely down position (as much as 16 degrees), the right side aileron should be at least 19 degrees in the up position.

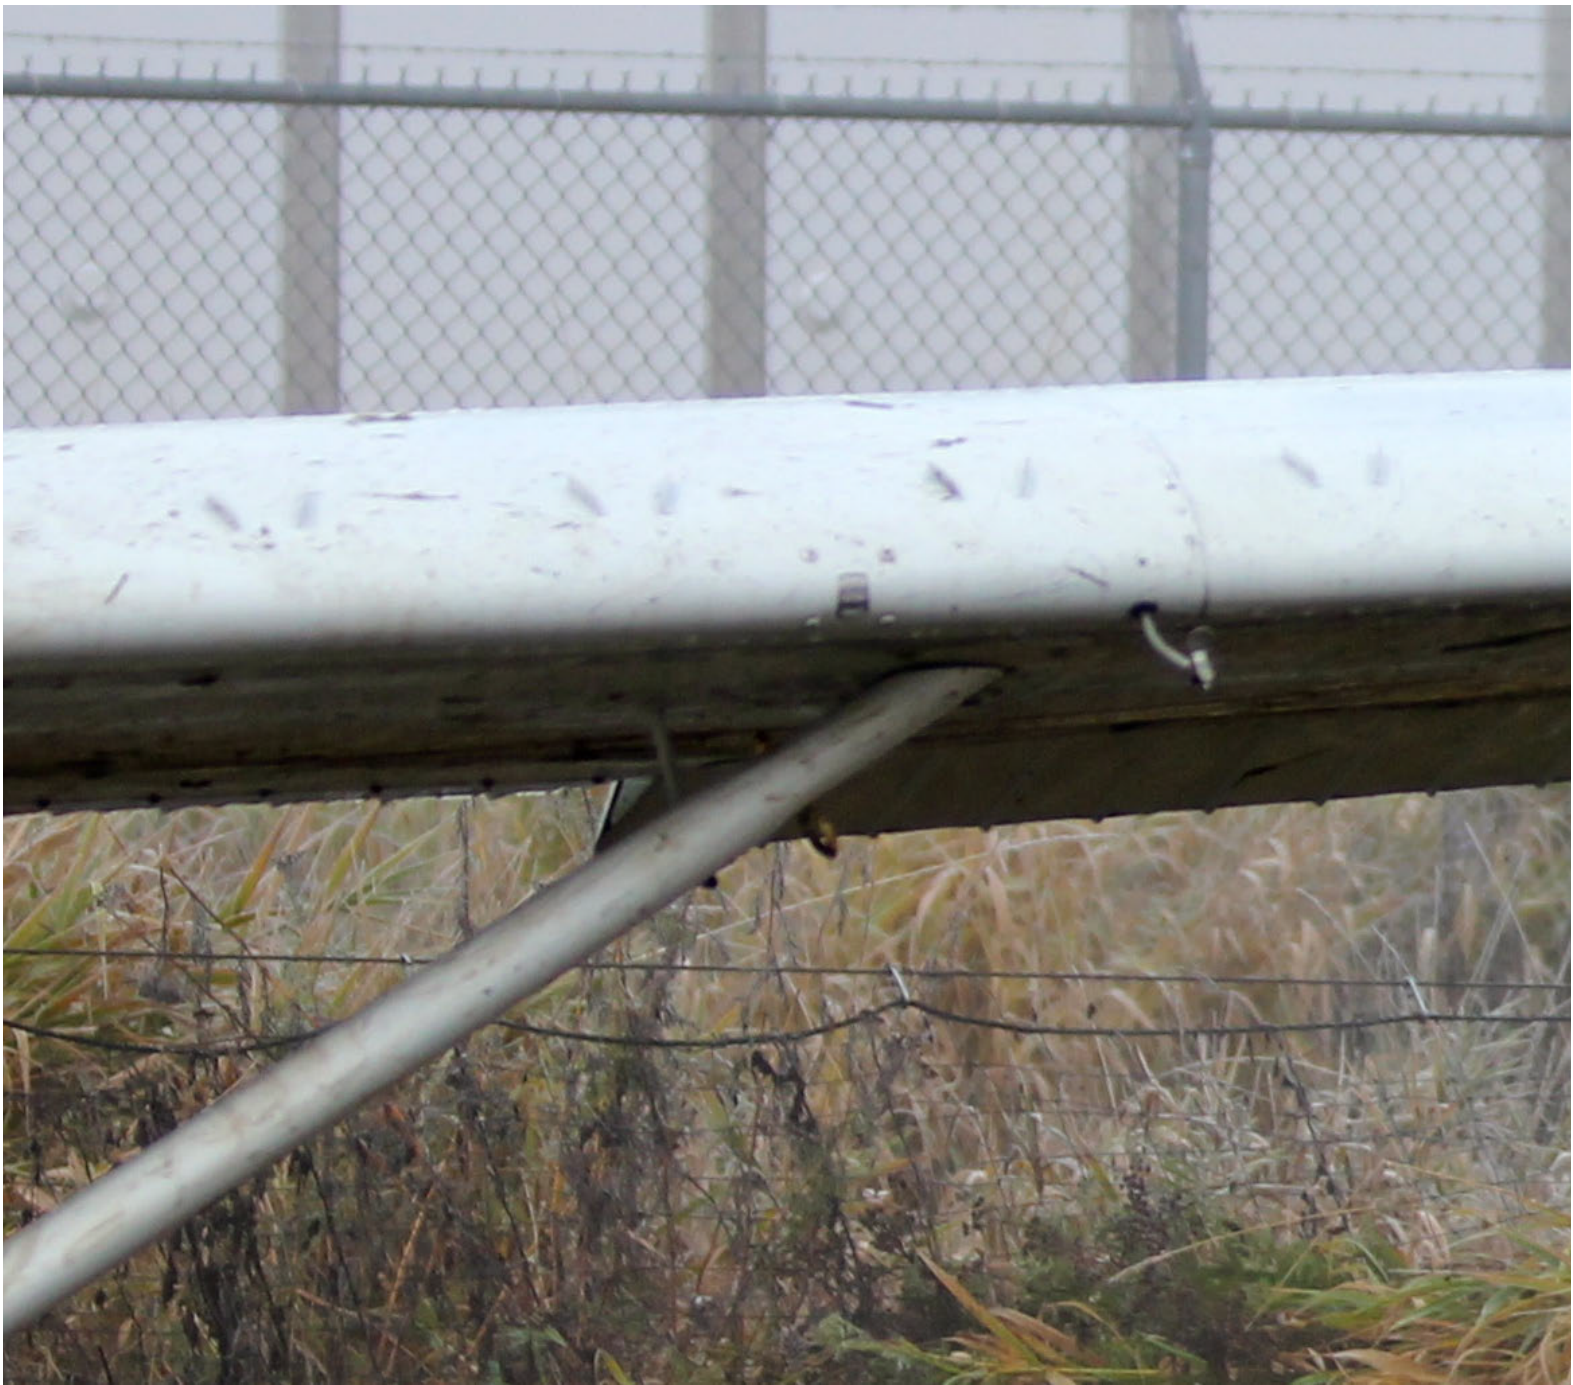
ILLUSTRATION # 4 b – Left wing. Magnification of inner edge of aileron relative to flap trailing edge

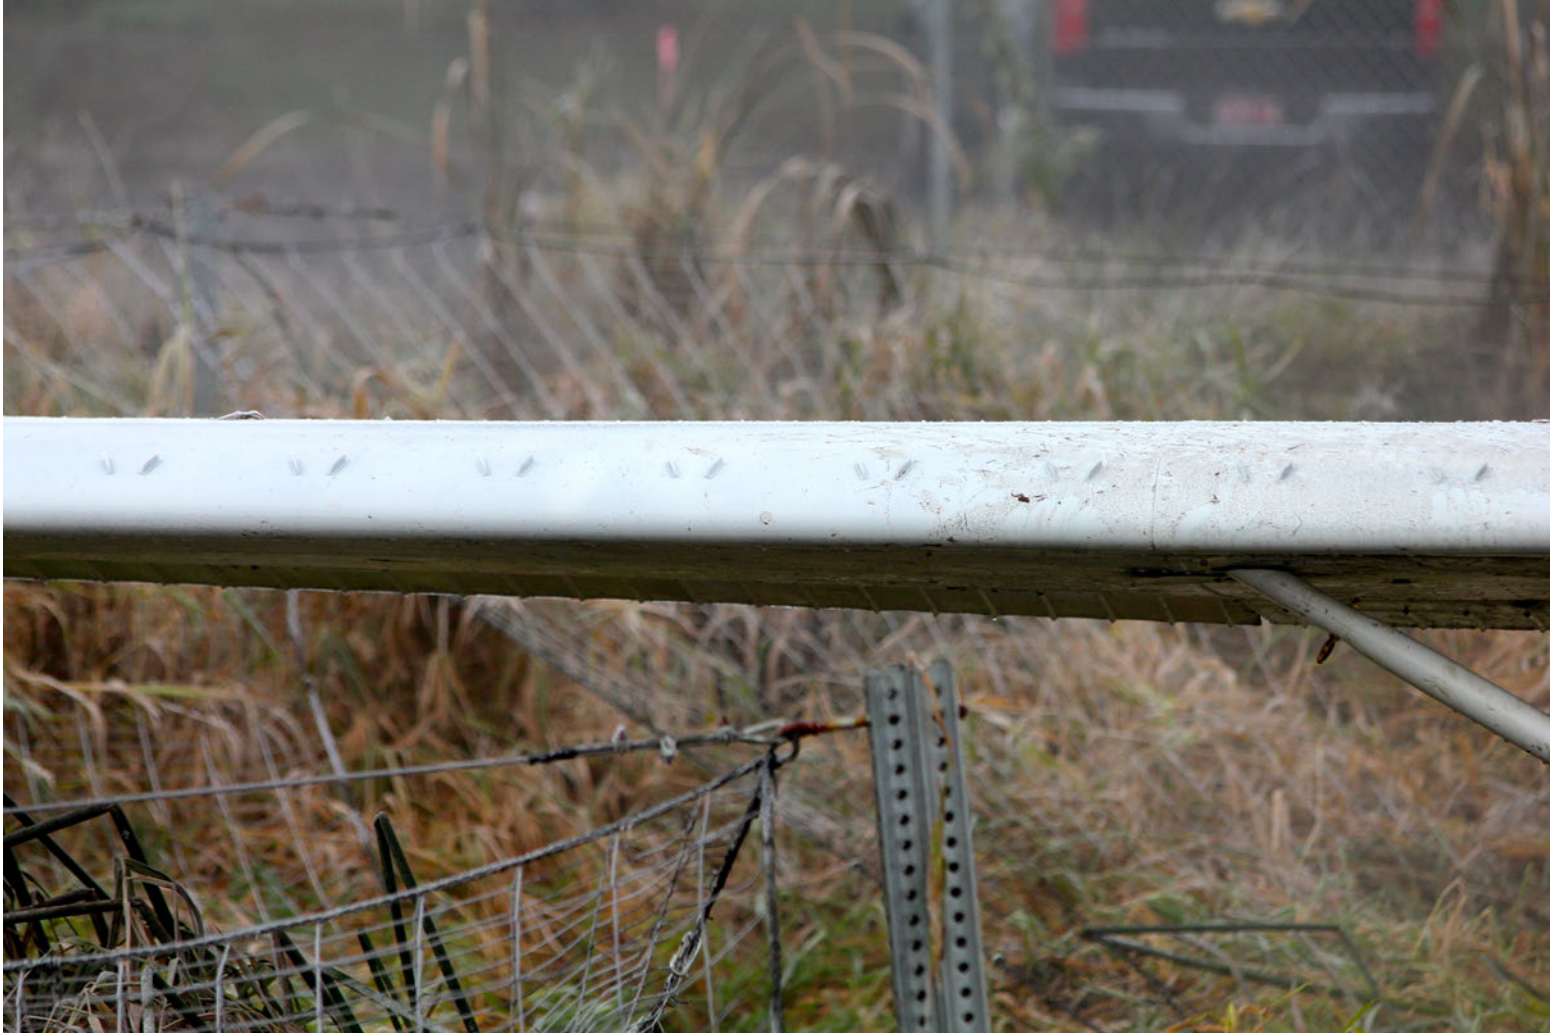
Illustration #5 a is a picture of the right wing as the aircraft was being recovered. A magnification of the same photo (5 b) clearly shows how the right aileron is in the down position. If it is confirmed that the right flap is lower than neutral due to the buckling of the right wing at the root, this photo may show that the right aileron could be as much as 10 degrees to possibly fully deflected in the down position.

ILLUSTRATION # 5 a – Right wing

These pictures confirm that the aileron system was not in specification at the time of the recovery and would make the aircraft, in this condition, impossible to control. If the system was in this condition at the beginning of the day, it would have been noticed during the preflight and on both pre-takeoff checks. Additionally, the day included three touch and goes in Auburn, one in Renton and two steep turns (both to the left and to the right) and such condition would have been noticeable. Yet there were no instances of lack of control response except in the final seconds on final before the incident.

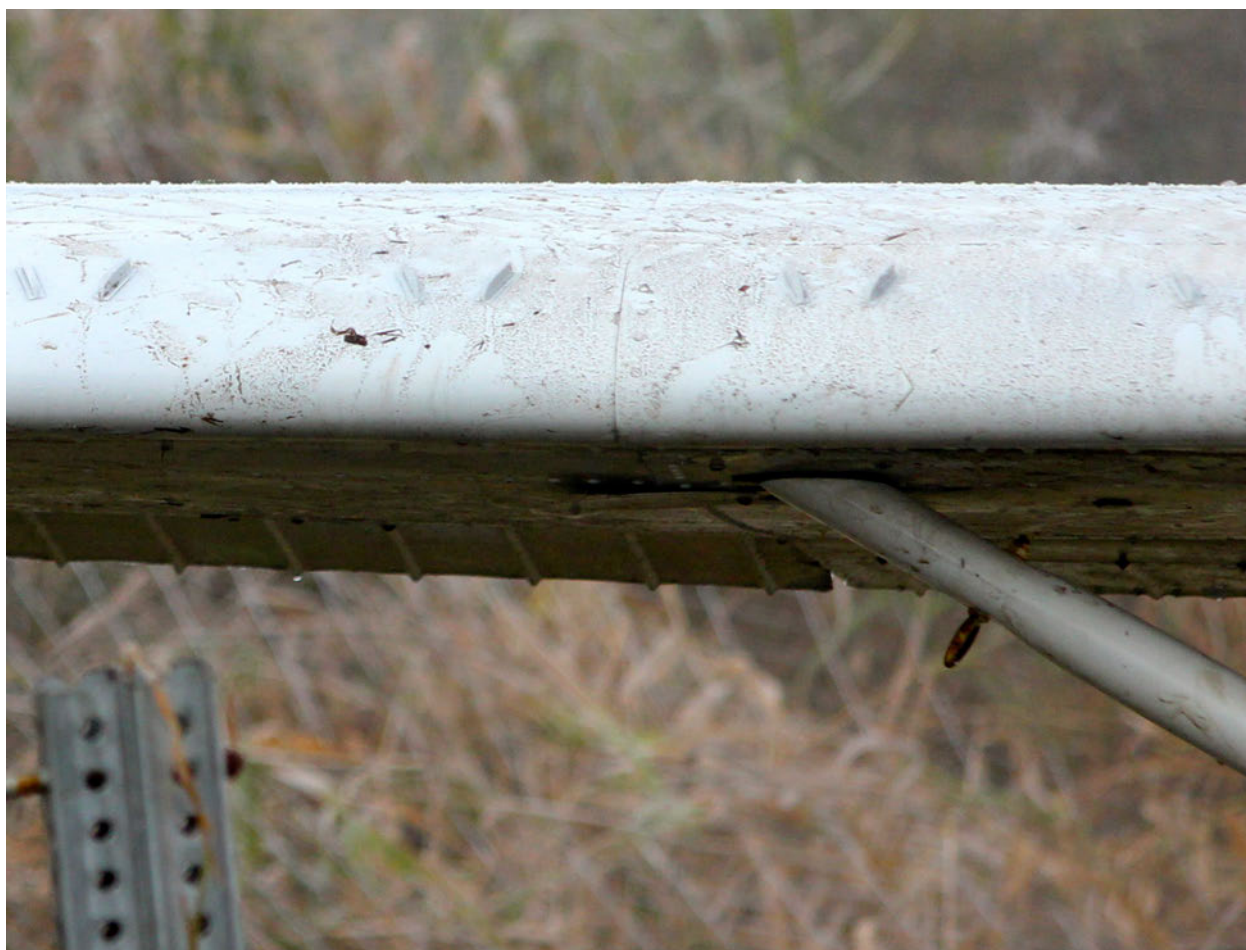
**ILLUSTRATION 5 b – Right Wing- Magnification of inner edge of right aileron relative to a possibly lowered flap.**

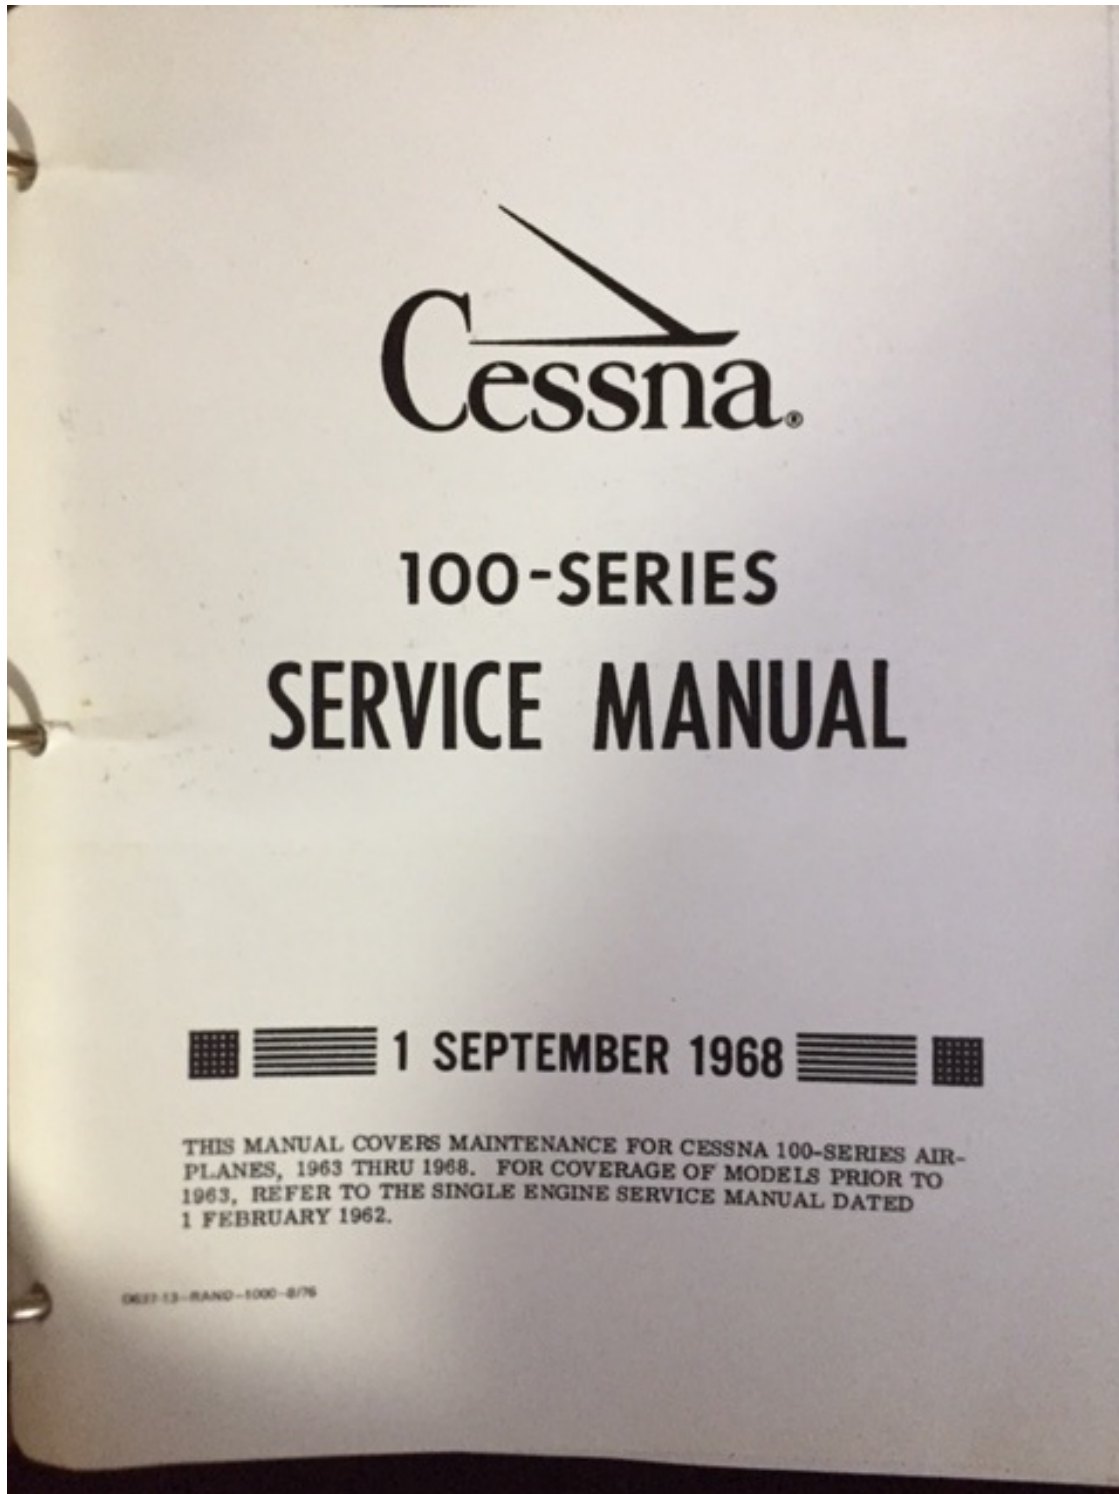
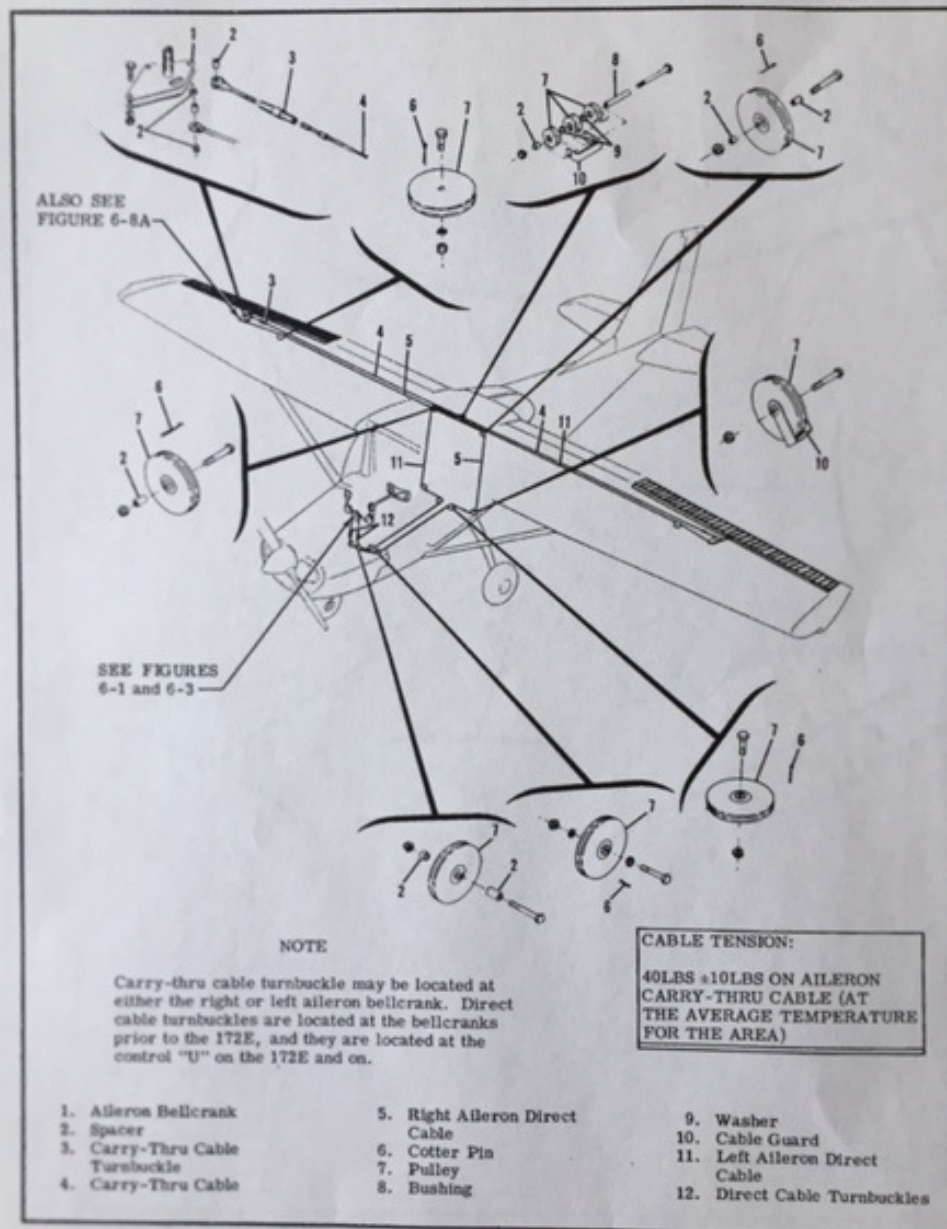
Figure 6-7. Aileron Control System - Model 172 & P172 Series

APPENDIX 2: CESSNA SERVICE MANUAL REFERENCES

Also on that same day, Mr. Vanover and Mr. Bacon called a couple of times for additional information and indicated that on a preliminary basis the cables of the ailerons were “loose” yet no broken turnbuckle nor cable was found. It will be interesting to see the results of analysis of cable tension. The Service manual specifies the tension as 40 lbs +/- 10 lbs for the average temperature of the area. (Appendix #2)

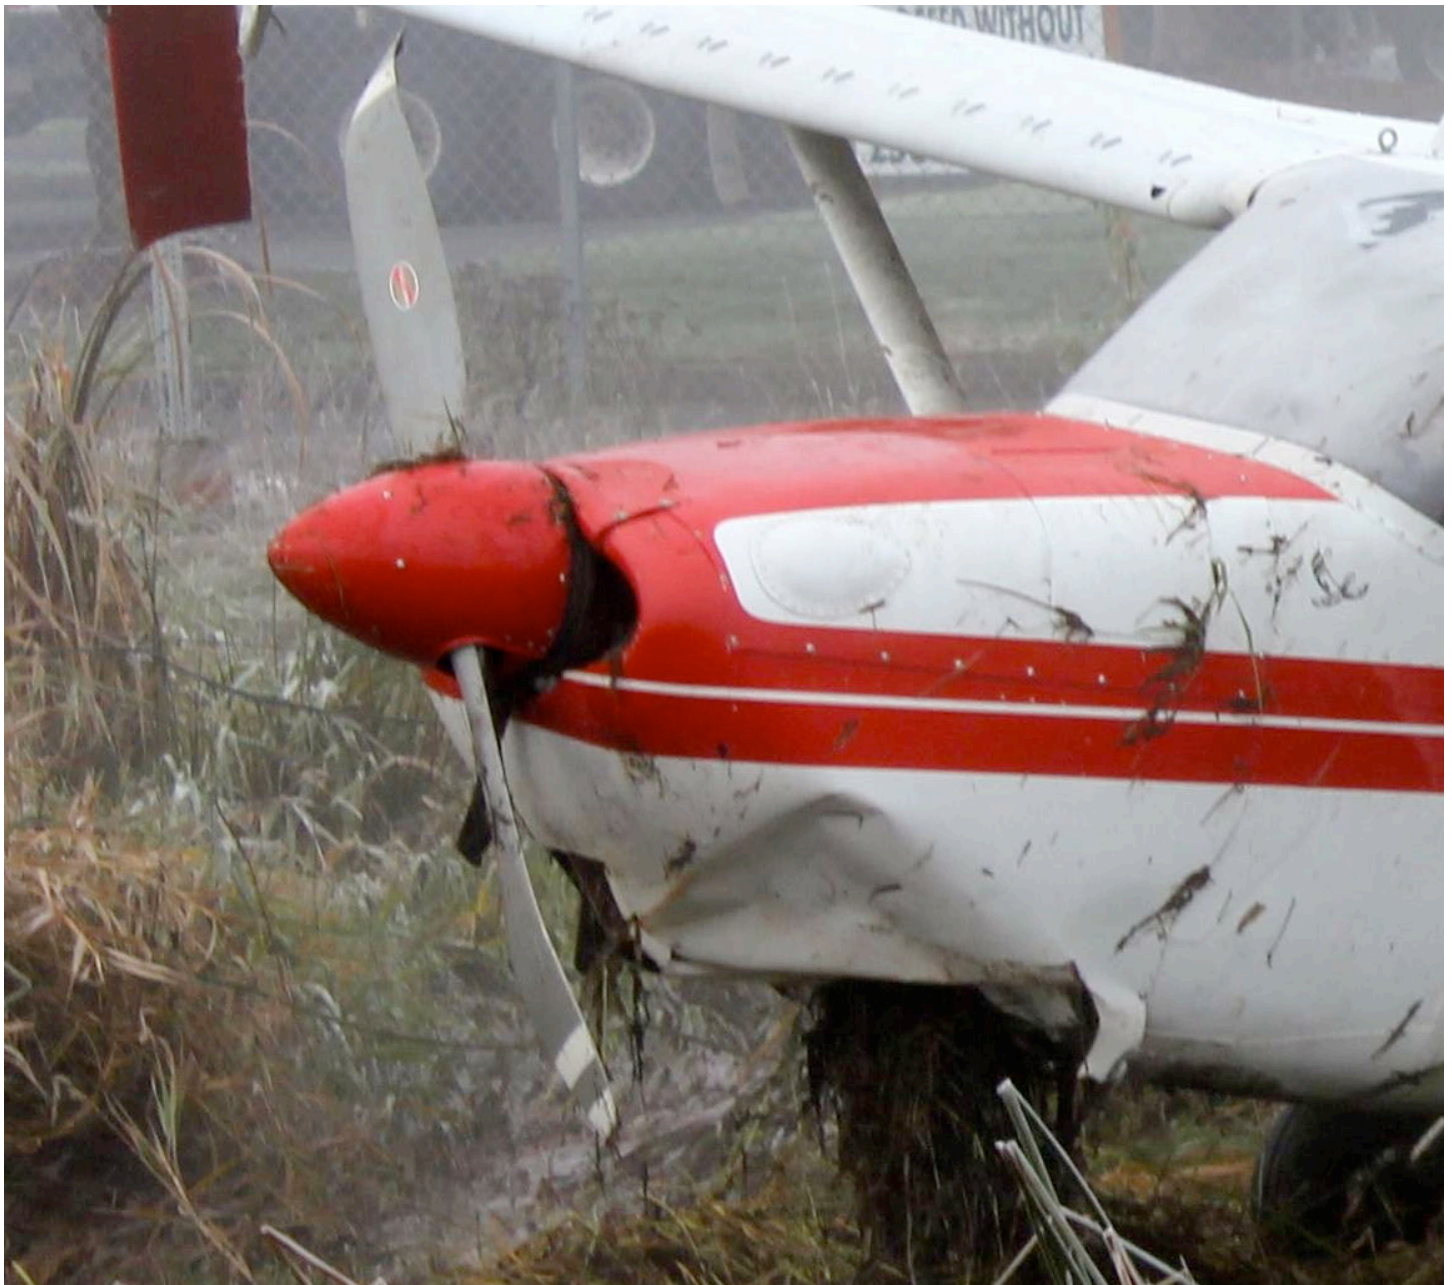
1. Propeller – Ground strike as evidenced by bent propeller blades. Potential damage to hub. Potential engine damage.
2. Right wing buckling at root. Beyond obvious damage of wing attachment to fuselage, possible internal damage to fuselage.
3. Forward of firewall damage; Possible engine hit resulting in possible firewall damage, and motor mounts. Forward landing gear collapsed.
4. Right wing Wingtip broken with internal rib damage possible.

ILLUSTRATION #1 – Prop Strike -Propeller Blades bent

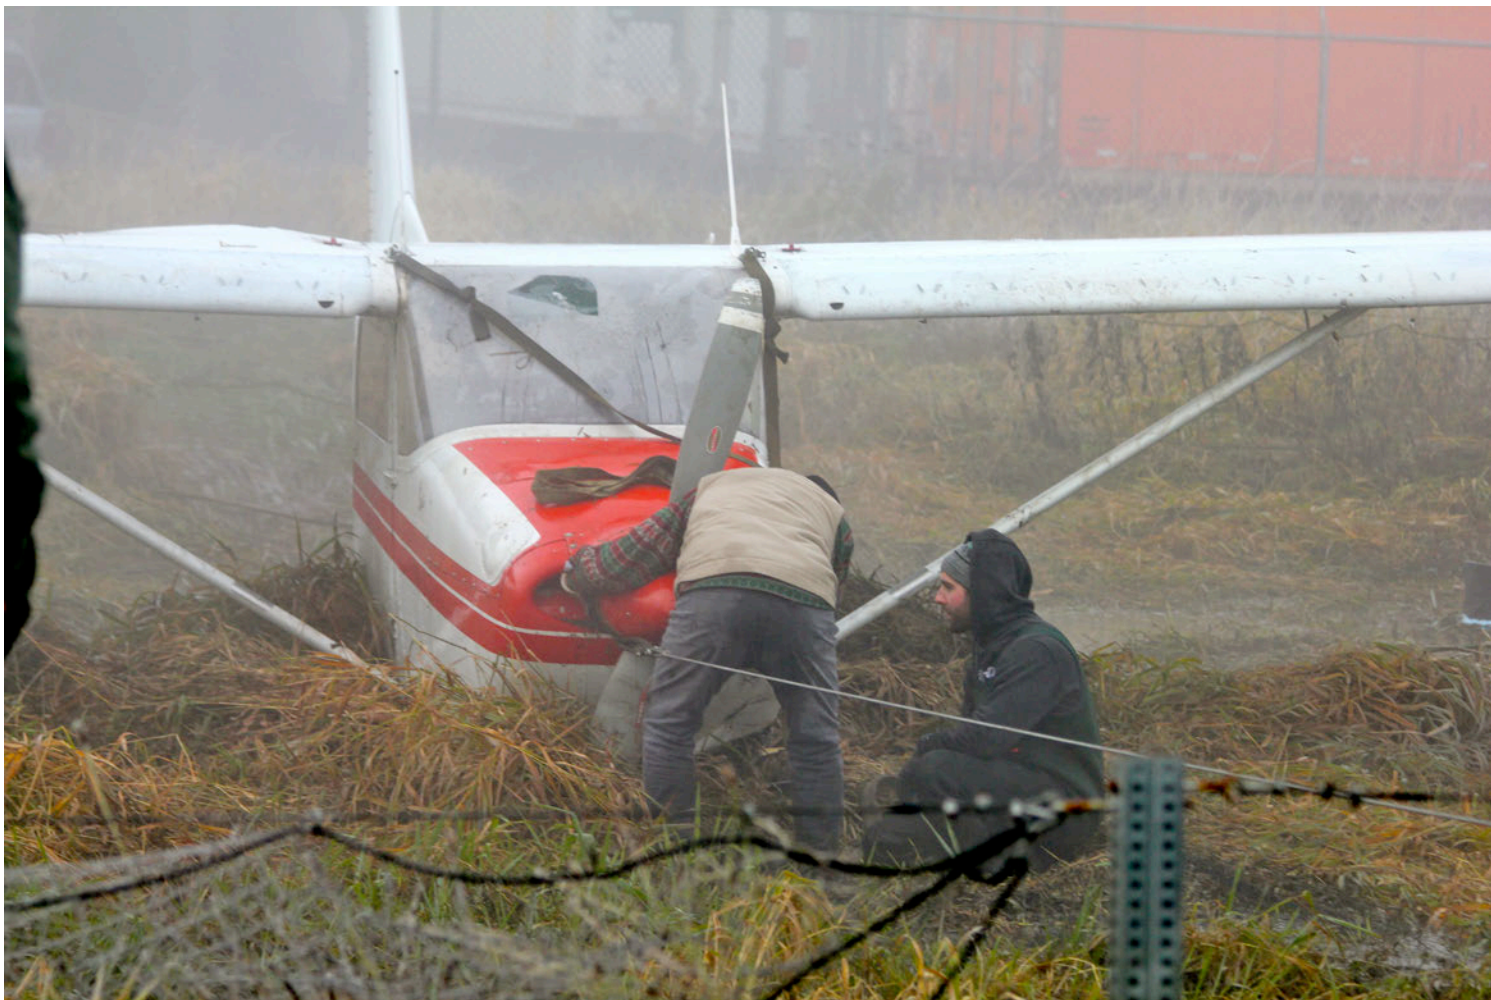
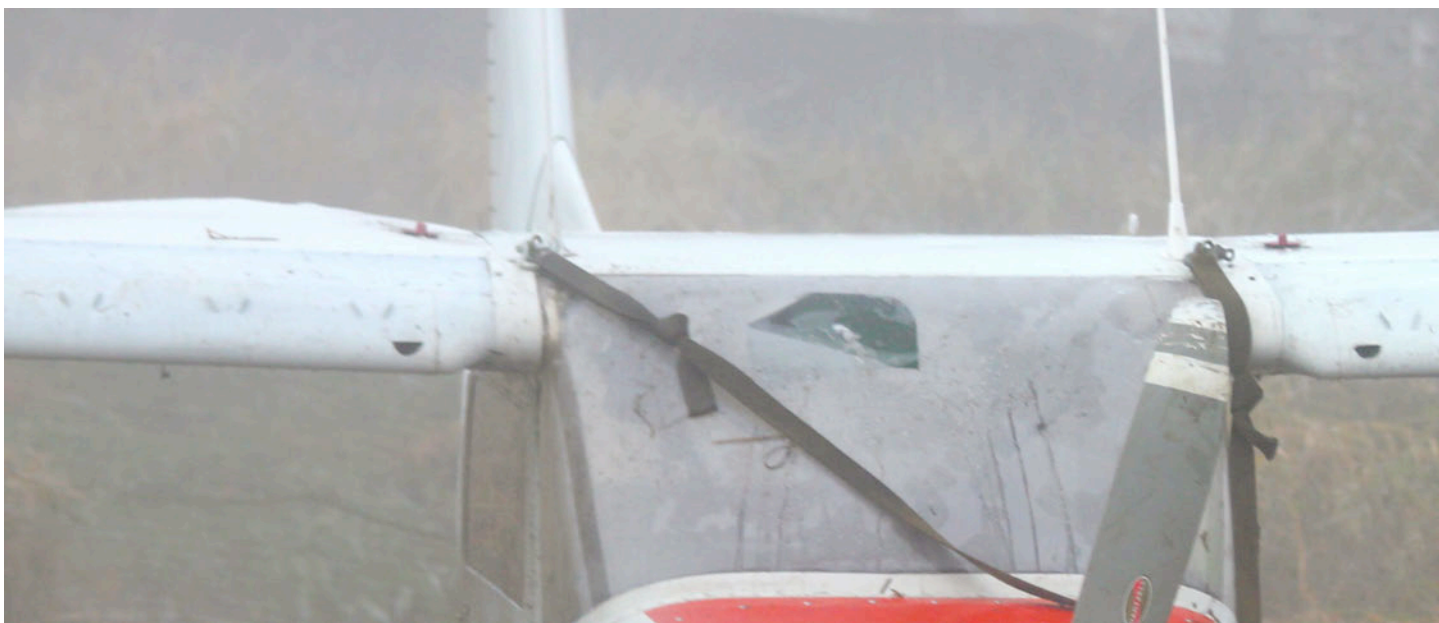
Illustration #2 – Severe buckling of right wing at root. Note the fuel tank cap on right side

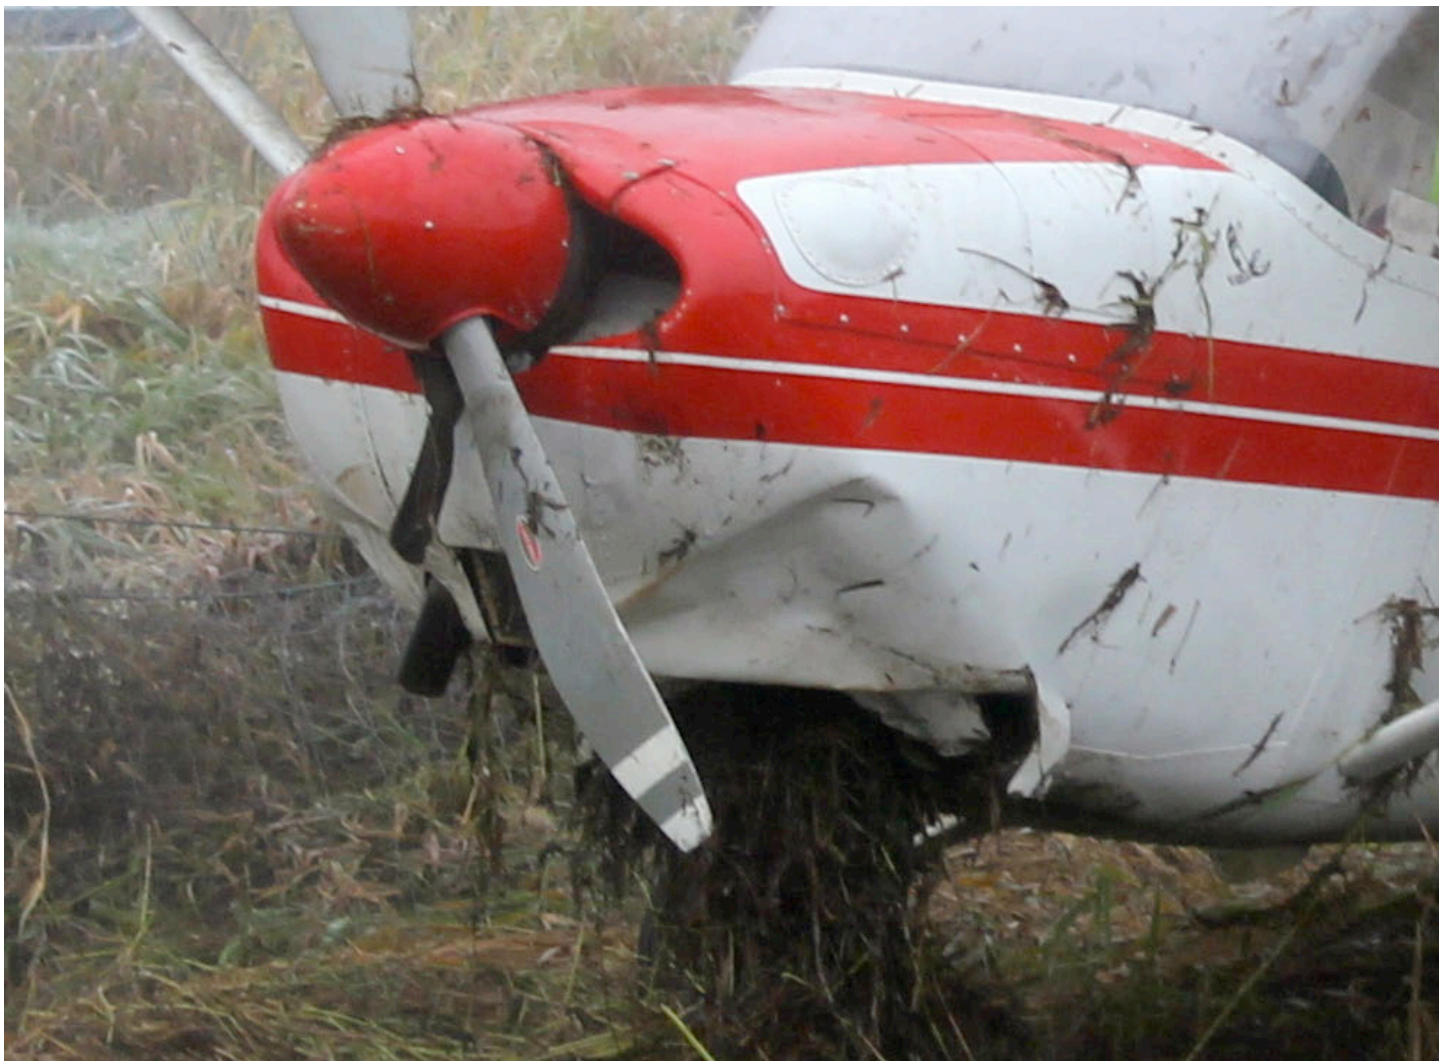
Illustration # 3 – Front of firewall damage.

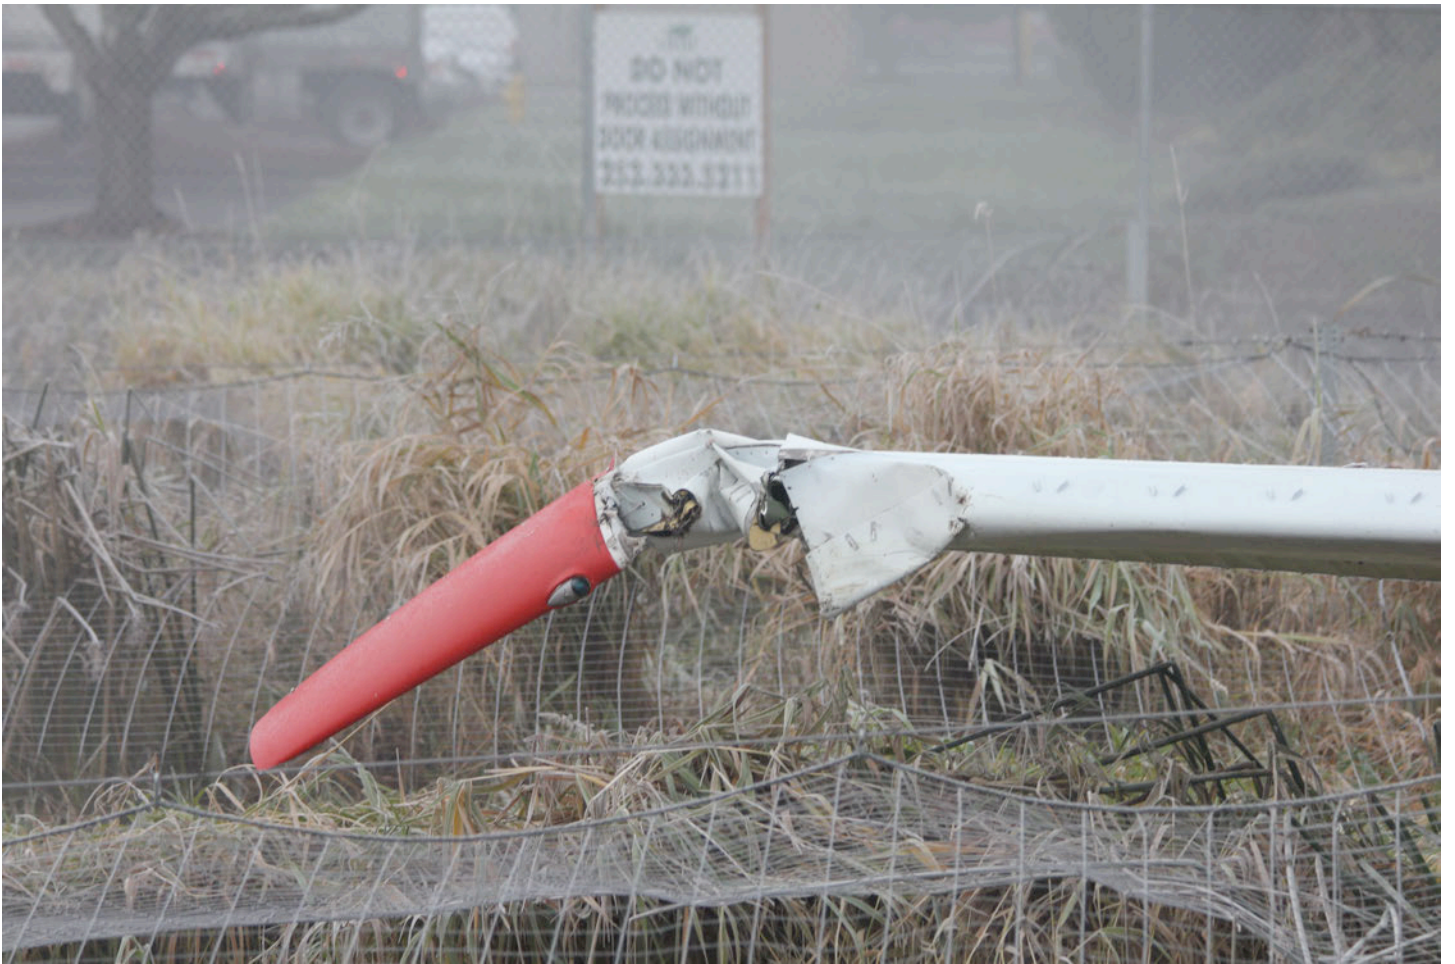
Illustration #4 – Right Wing tip broken
