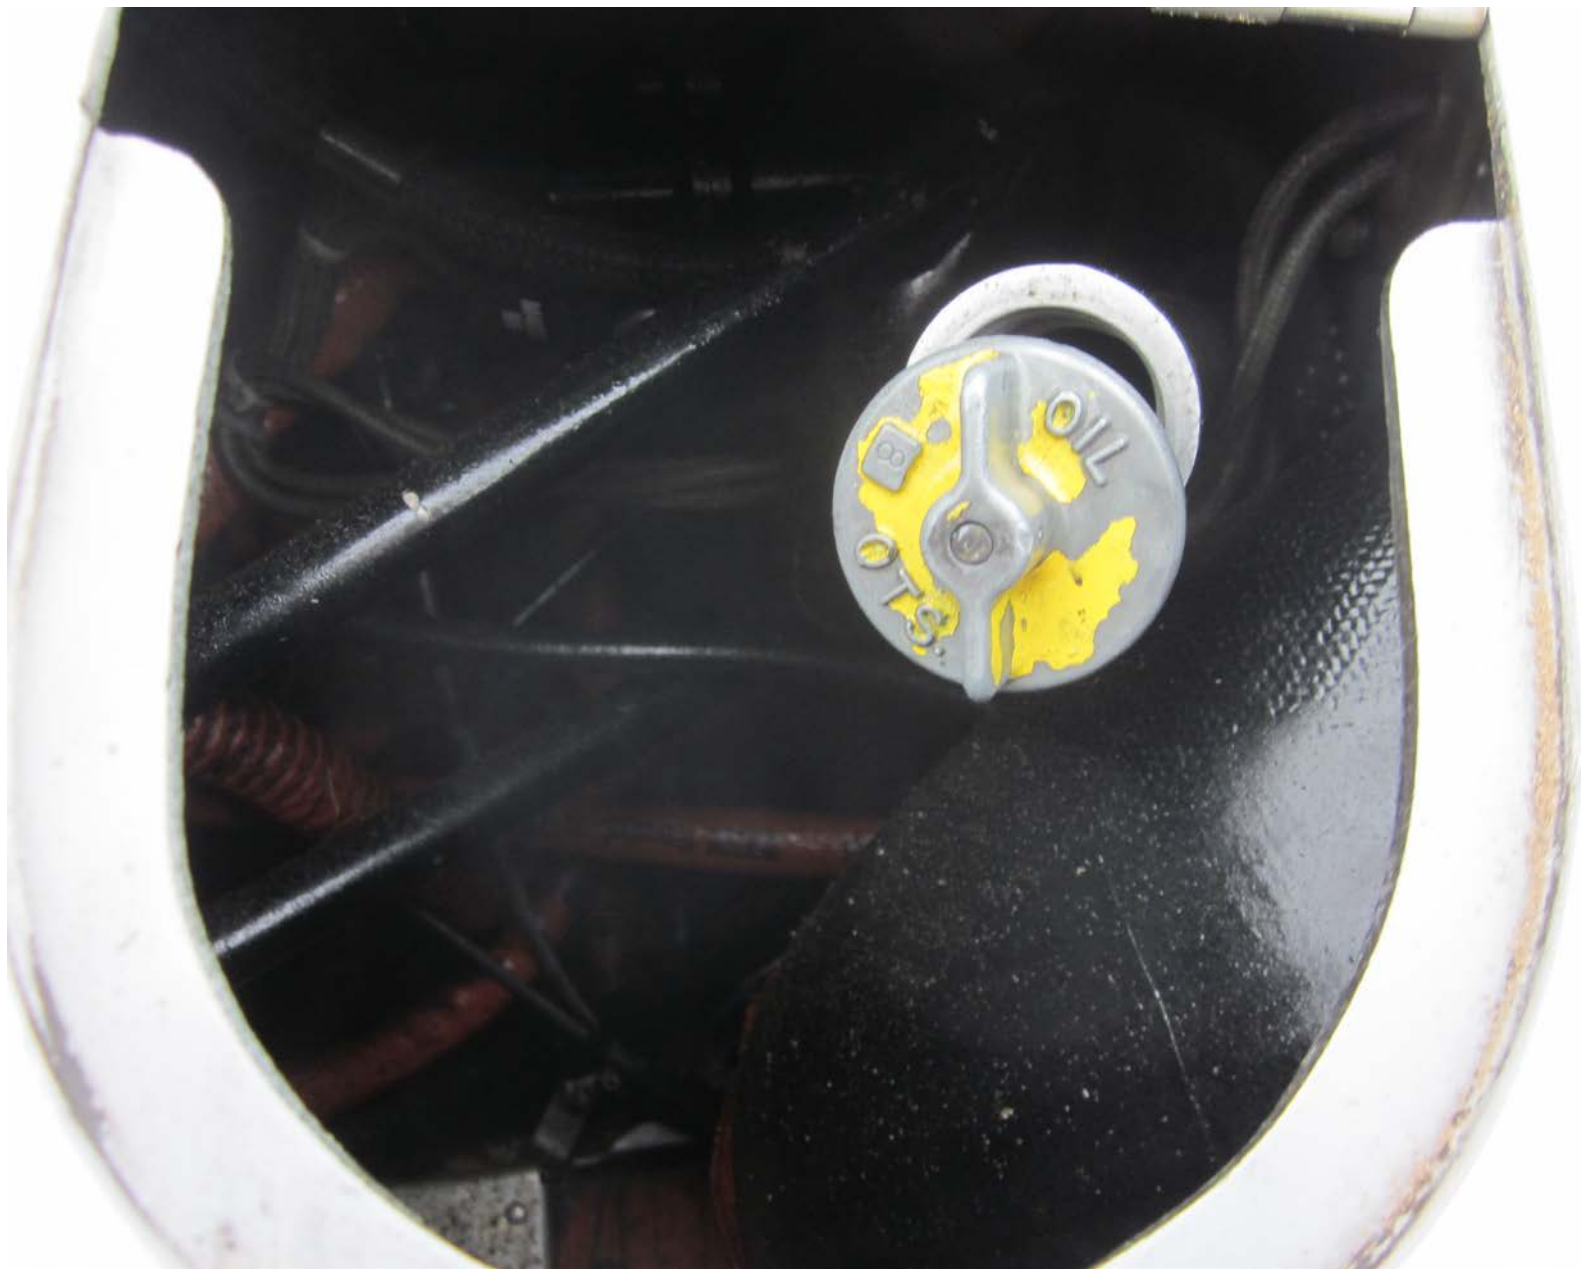
**Photo 1 – Loose oil cap seen through the access door on the engine cowling**

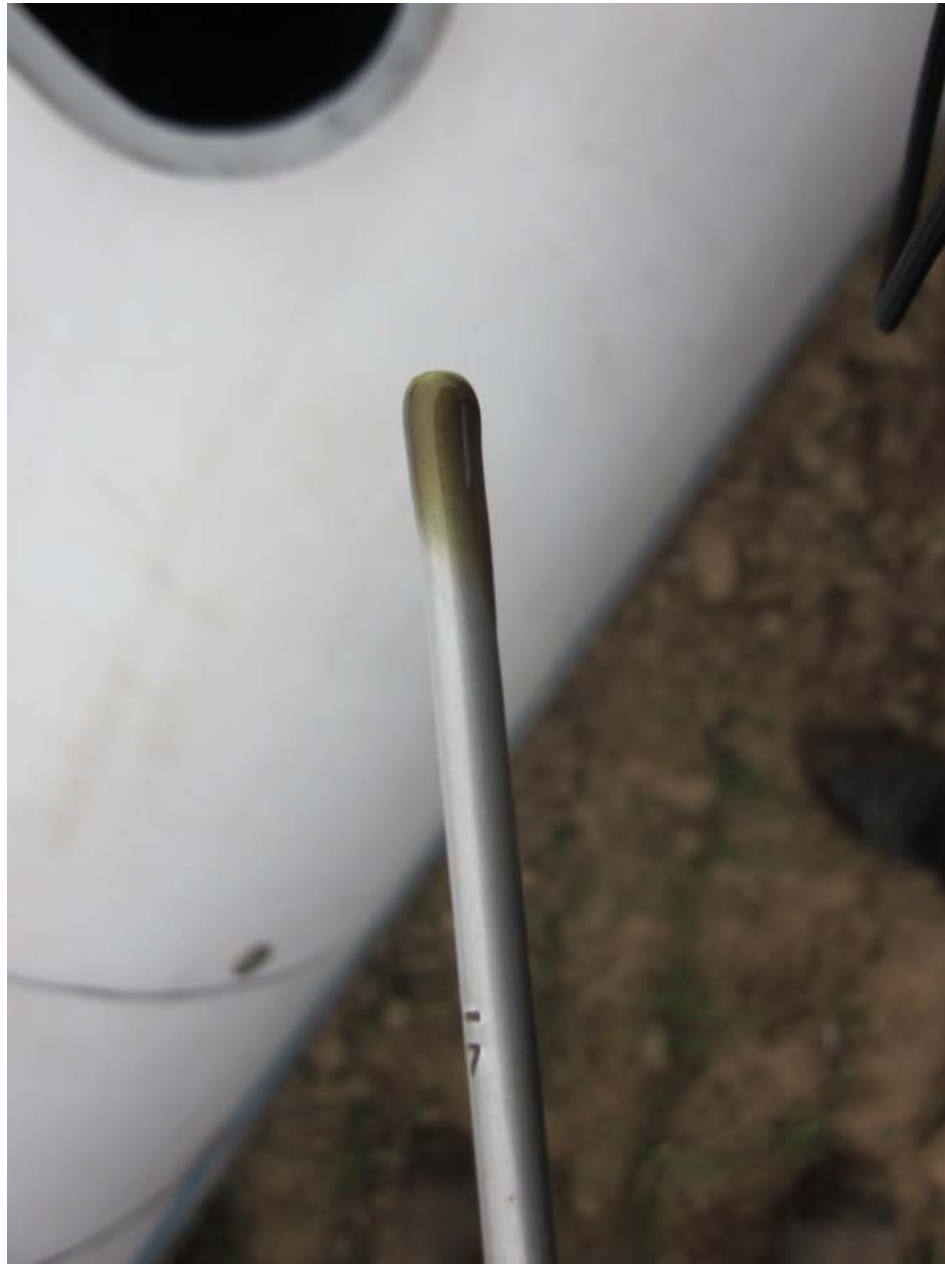
**Photo 2 – Oil dipstick**

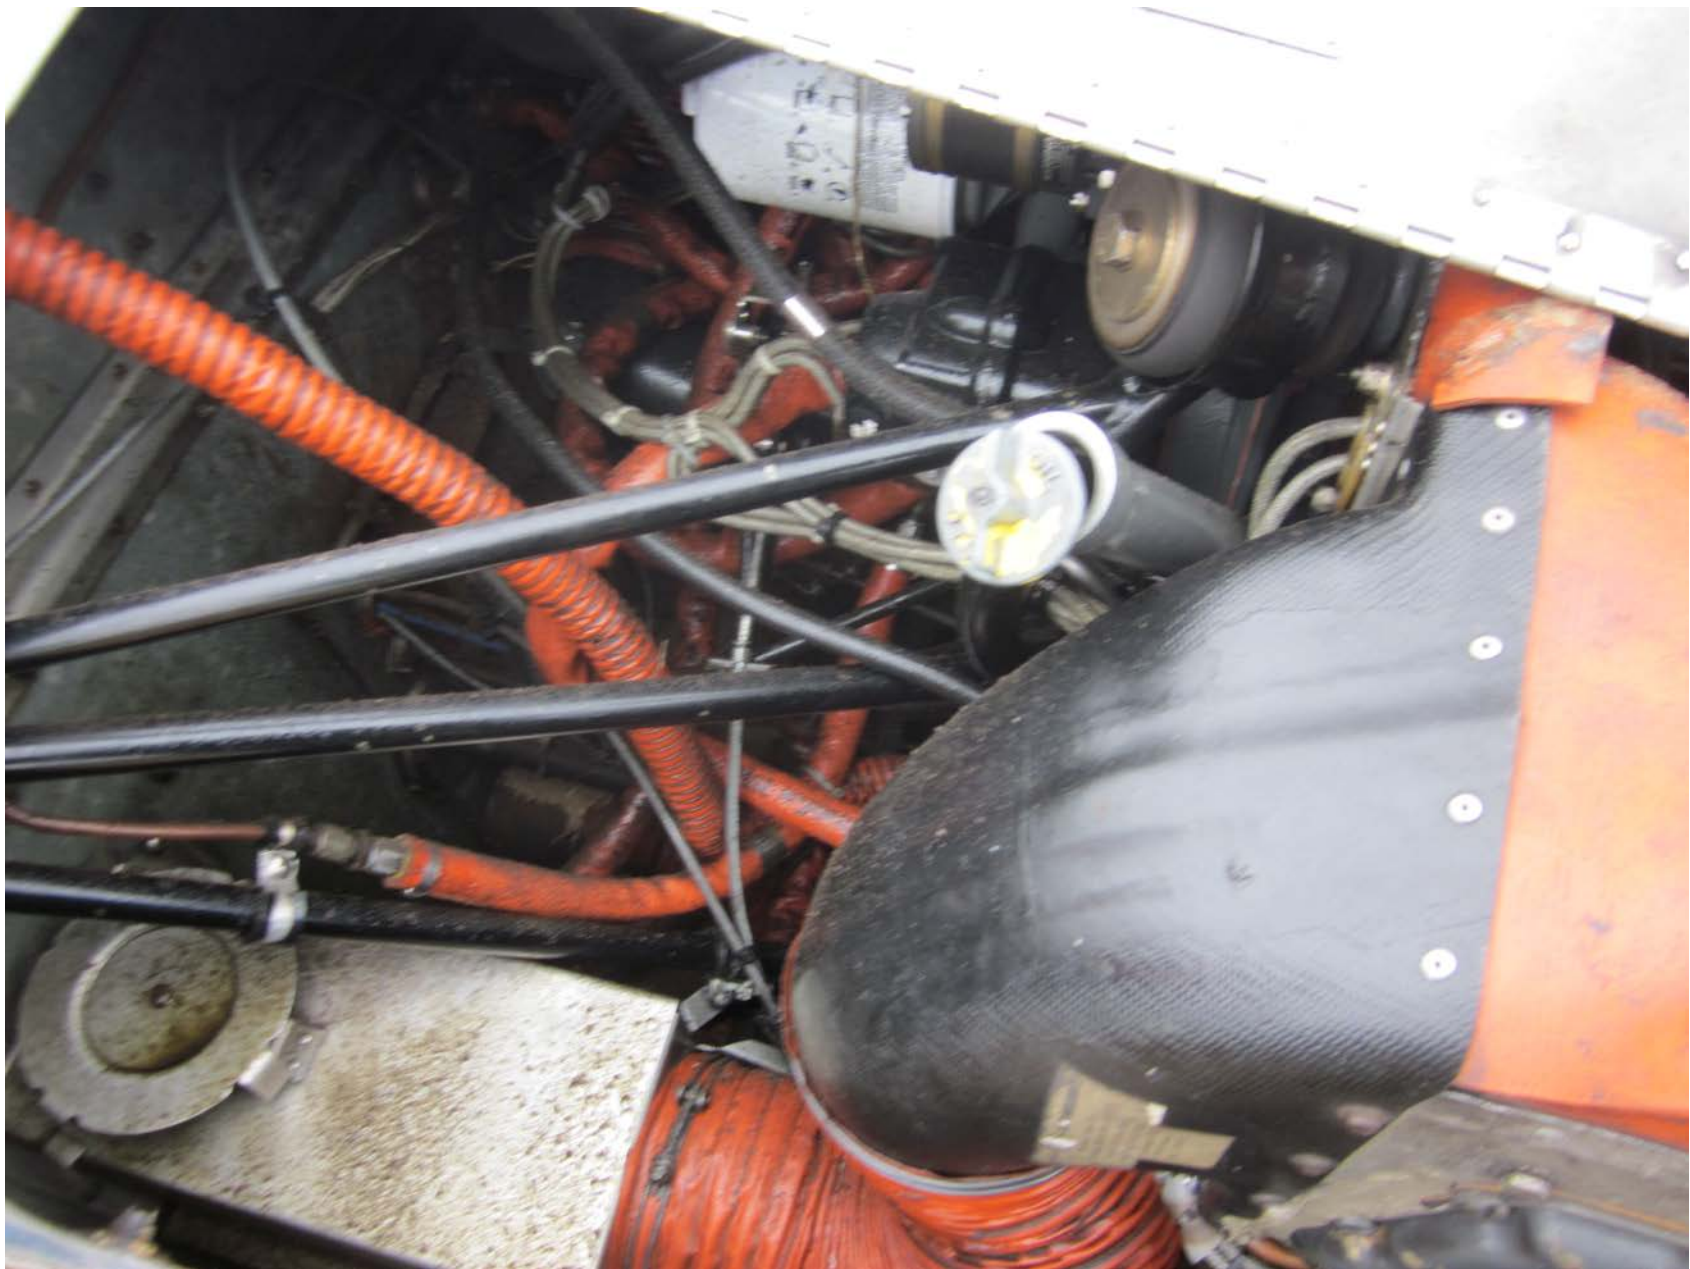
**Photo 3 – Oil splattered around the engine**
