**NATIONAL TRANSPORTATION SAFETY BOARD**

## **Recoverable Data Module**

**Specialist's Factual Report**  
**By Sean Payne**

Location: Aguila, Arizona  
Date: June 19, 2018  
Aircraft: Cirrus SR22  
Registration: N764CT  
Operator: Private  
NTSB Number: WPR18LA174

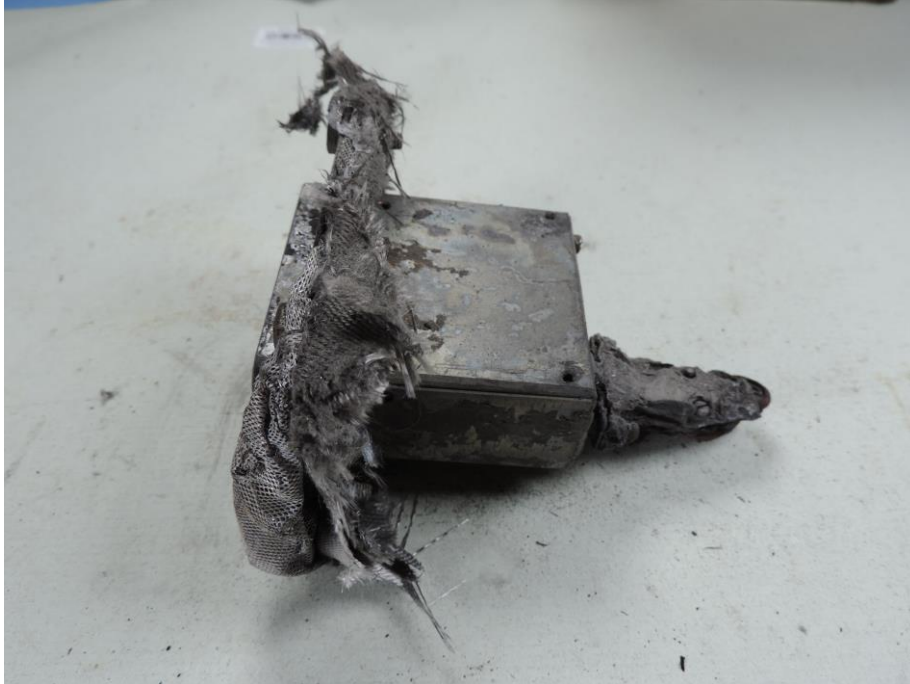
Upon arrival at the Vehicle Recorder Laboratory, an examination revealed the unit had sustained extensive heat damage. The extent of the damage is shown in figure 1.

**Figure 1. Photo of damaged unit**

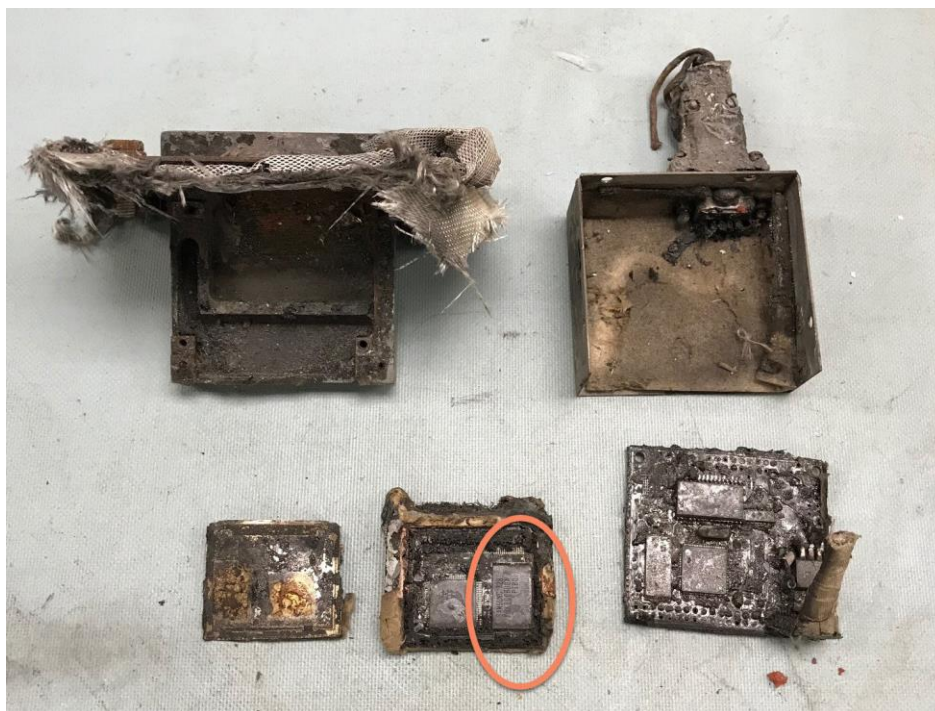
Figure 2. Photo of damaged unit opened, the NVM chip is circled in orange.

The unit was disassembled and an internal non-volatile<sup>1</sup> memory (NVM) chip was revealed. The internal memory chip is circled in figure 2. The memory component was extracted. The memory chip is shown in figure 3 after it had been extracted and cleaned. An orange reticle shows an area of crack propagation on the surface packaging of the chip. The chip was then x-rayed. The x-ray revealed no damage to the wiring of the chip. The x-ray was unable to image the chip's internal silicon die. Damage to the chip's internal silicon die was not observed but is likely. Figure 4 is an x-ray image of the chip which shows the internal wire bonds were not damaged.

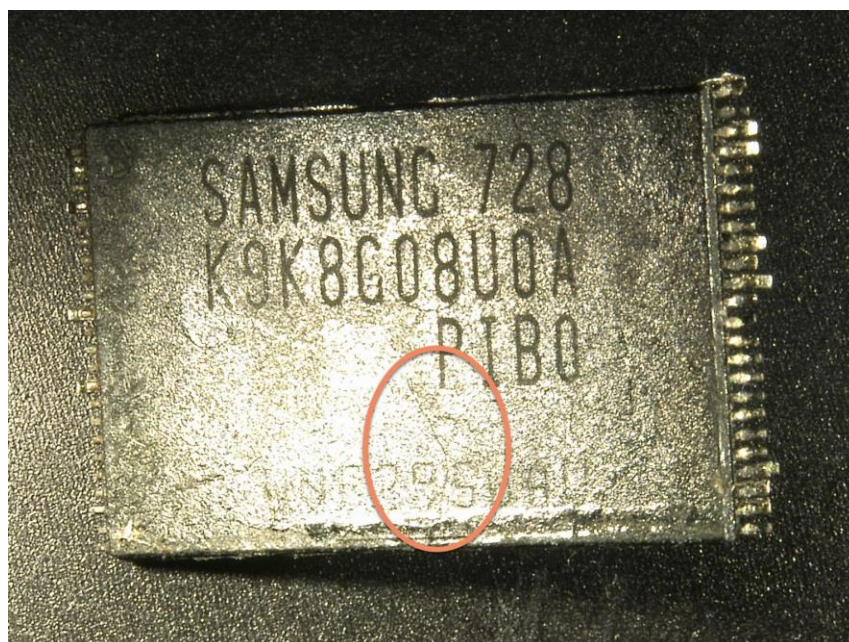
Figure 3. Photo of internal memory chip after removal and cleaning. The photo was taken at an angle to highlight the damage to the packaging. A crack on the surface of the chip packaging is circled in orange.

The chip was attempted to be read with the appropriate software and hardware configuration but resulted in an unsuccessful download.
