# TEARDOWN EXAMINATION

DATE 10/18/2018 N756NN C206

| Aircraft Make/Model | <u>Cessna T206G</u> |

| Engine Make | <u>Continental TSI0-520-M7B</u> |

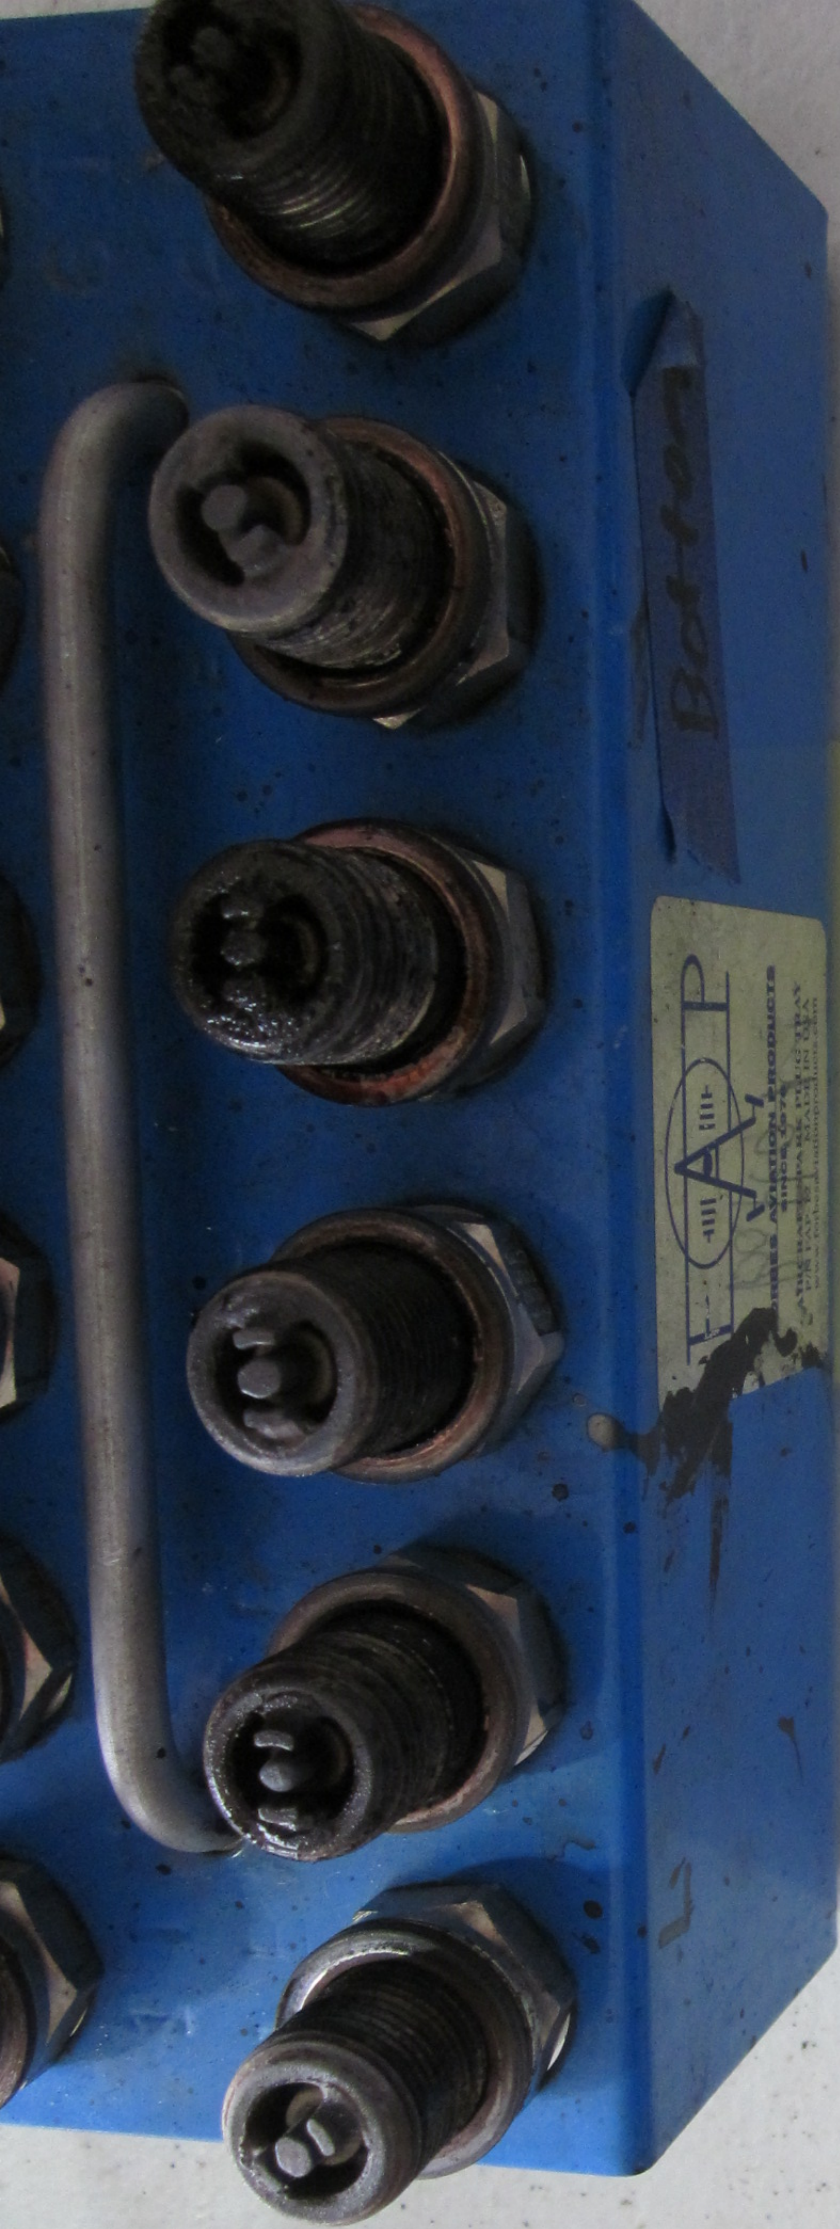
Bottom
