## RECORD OF CONVERSATION

**Date: April 19, 2018**  
**Person Contacted: Mr. Victor Hutchings (FAA Inspector)**  
**NTSB Accident Number: WPR18TA122**

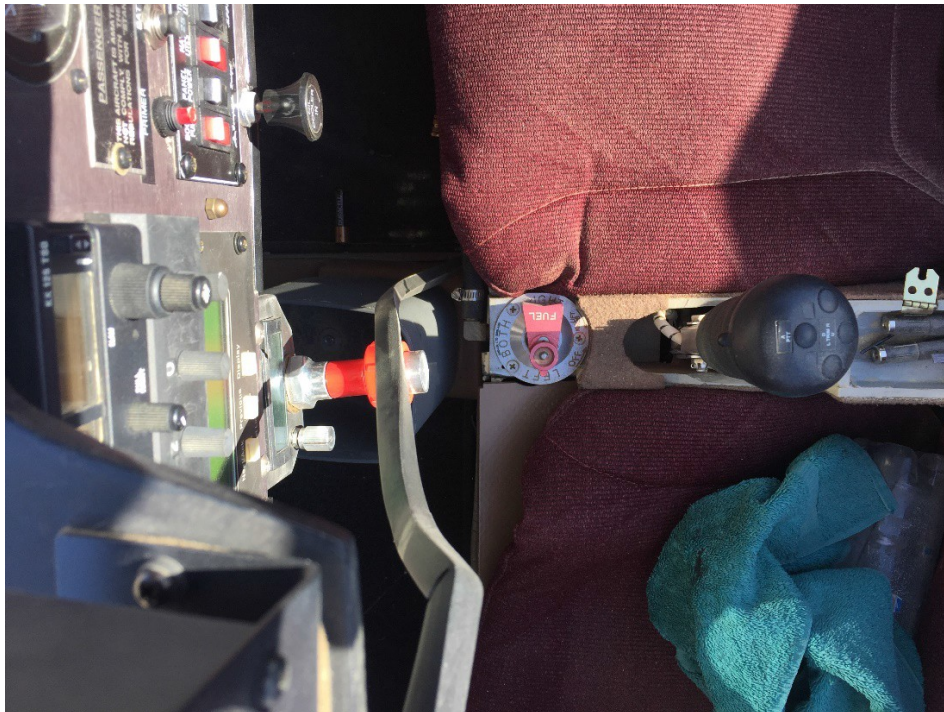
*Figure 1: Fuel Selector*

During a telephone conversation with Mr. Hutchings. He reported that while he was on scene, he observed the fuel selector valve positioned to the left fuel tank, however, there was no fuel present in the tank. In addition, he shared a photo of the fuel selector (see below). A photo could not be taken inside of the fuel tank due to the bright sunlight and reflection from the airplane. However, he was able to take a picture of the fuel gauge which indicated that the left fuel tank was empty and the right fuel tank was about  $\frac{1}{4}$  full.
