## **NATIONAL TRANSPORTATION SAFETY BOARD**

### **Weather Study**

# **METEOROLOGY**

WPR19FA025

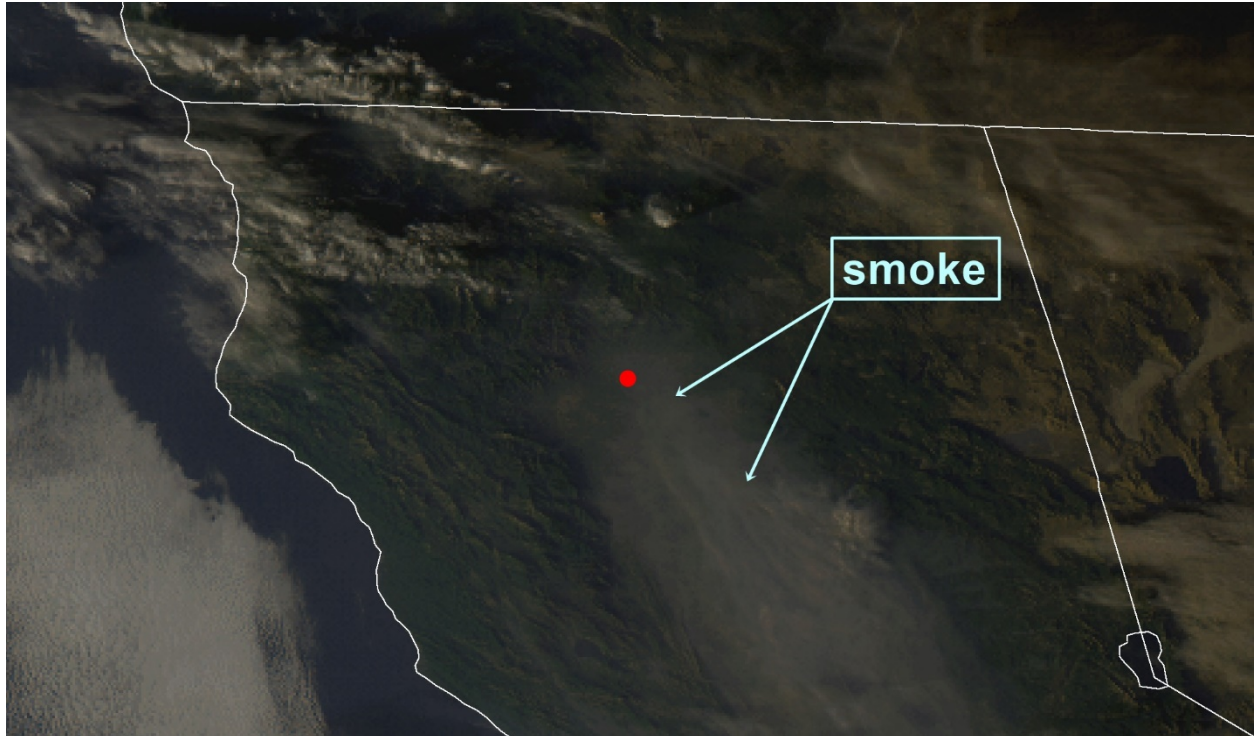
**Figure 2** – GOES-16 simulated “true color” imagery from 1701 PST. Accident location is denoted by the red dot. This image has not been corrected for parallax error.

Geostationary Operational Environmental Satellite (GOES)-16 data were obtained from an archive at the Space Science Engineering Center at the University of Wisconsin-Madison. Simulated “true color” imagery from 1701 PST (86 minutes prior to the accident time) is presented in figure 2. The simulated true color imagery depicts a smoke/aerosol cloud over central Northern California with the northern-most portion of the cloud over the accident location.
