## **NATIONAL TRANSPORTATION SAFETY BOARD**

### **VIDEO REVIEW SUMMARY**

**WPR19FA042**

Location: Aberdeen, Idaho  
Date: December 17, 2018  
Aircraft: Piper PA-24-250, N6283P  
NTSB Investigator-in-Charge: Joshua Cawthra

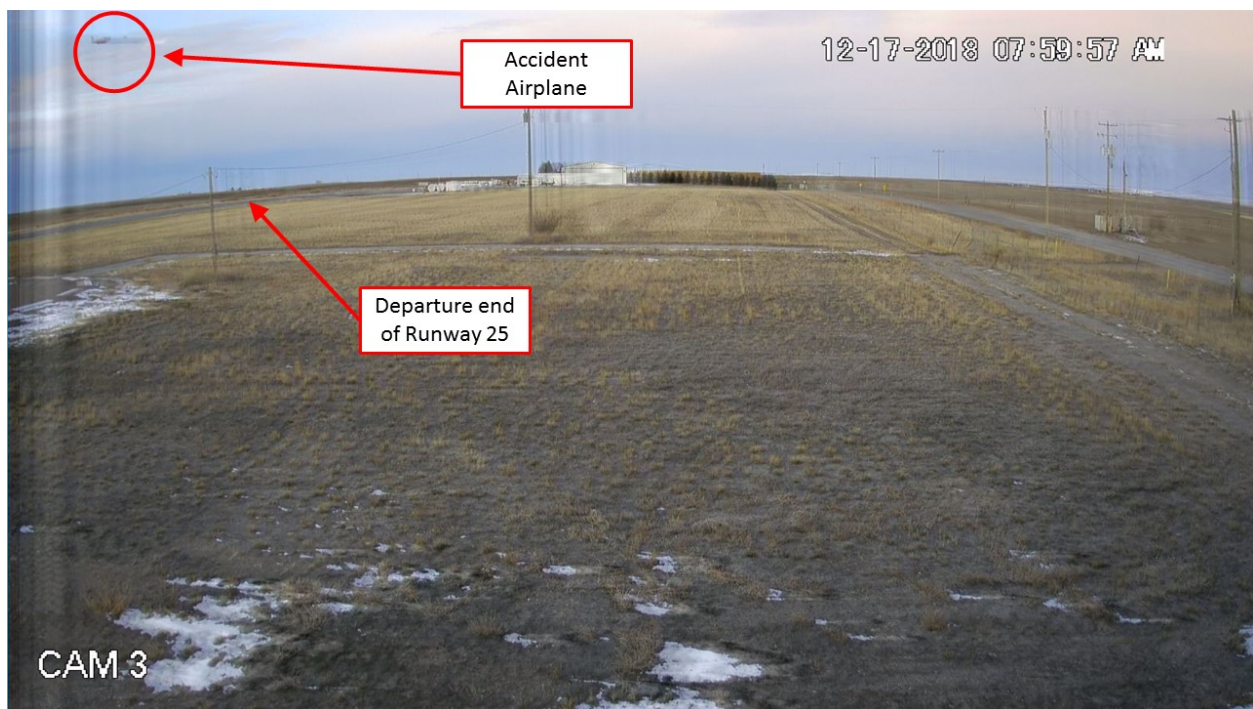
Figure 1: View of the airplane as it entered the camera frame.

Review of airport security camera video recordings revealed that the accident airplane departed runway 25, and entered a shallow climb, remaining on a westerly heading. About 14 seconds after the airplane entered the viewable area of the camera, it descended in a near vertical manner, out of view of the camera.

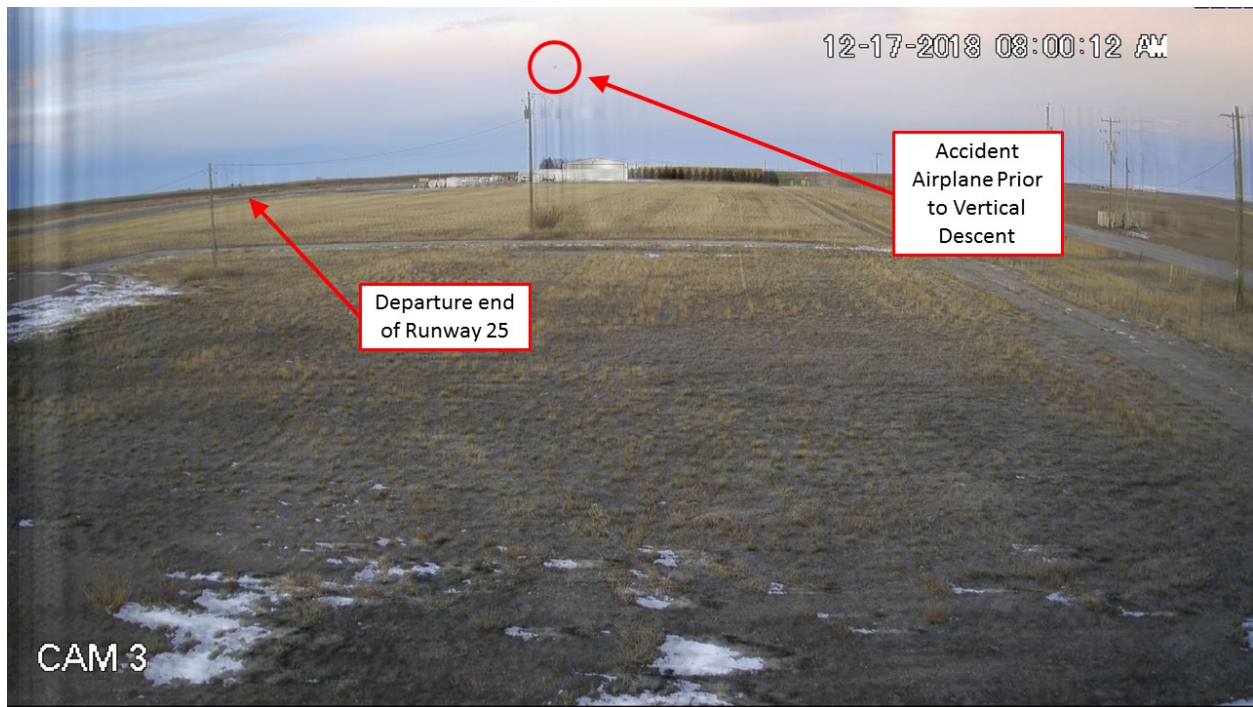
Figure 2: View of the airplane just prior to the vertical descent.
