**NATIONAL TRANSPORTATION SAFETY BOARD**

**RECORDED FLIGHT DATA**

**Specialist's Factual Report**

Location: Farmington, NM  
Date: March 31, 2019  
Aircraft: Cirrus SR22  
Registration: N173CT  
Operator: Private  
NTSB Number: WPR19FA103

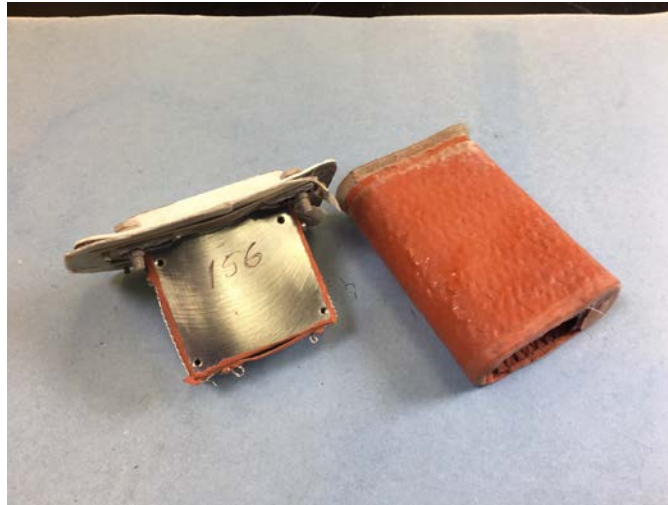
Upon arrival at the Vehicle Recorder Laboratory, an examination revealed the unit had sustained minor impact damage (figure 1), however the internal CF card was undamaged

(figure 2). The damaged exterior of the RDM after removal from its protective sleeve is shown in figure 1. The undamaged CF card removed from the RDM is shown in figure 2.

**Figure 1. Photo of damaged unit**

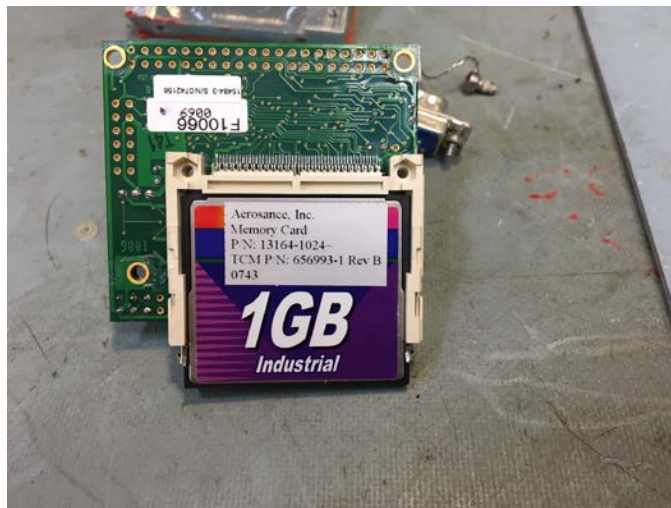
**Figure 2. Photo of undamaged CF card inside the unit.**

The data extracted included about 135 total hours including information from October 22, 2017 through October 13, 2018. The event occurred on March 31, 2019. There were no data pertinent to the event recorded on the device.

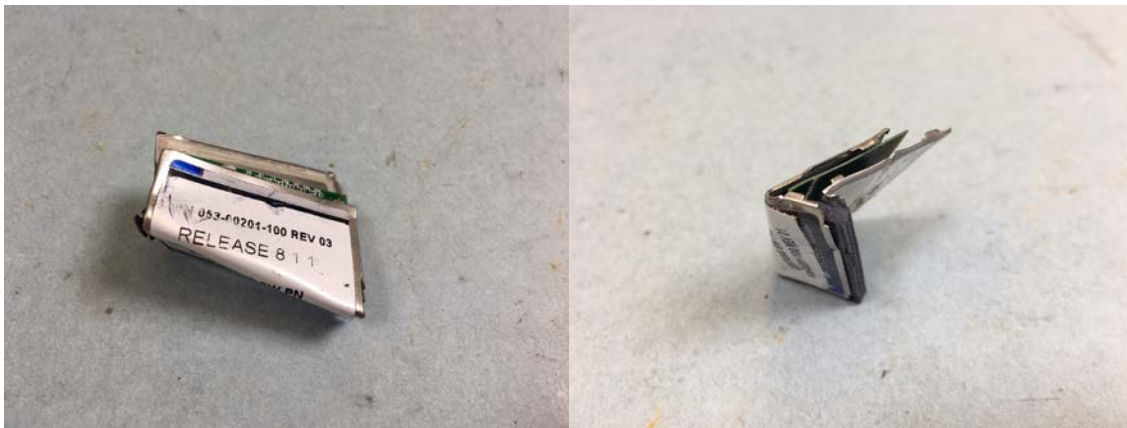
Upon arrival at the Vehicle Recorder Laboratory it was evident the device had sustained major impact damage. The card was folded and creased. See figure 3 for the as received condition of the card.

**Figure 3. Photos of damaged CF card.**

This device is capable of storing data in the non-volatile memory (NVM)<sup>1</sup>. The card was folded across the main memory chip, cracking it in half. The extent of the damage precluded any recovery procedures therefore no data pertinent to the event were recovered.
