**NATIONAL TRANSPORTATION SAFETY BOARD**  
Vehicle Recorder Division  
Washington, D.C. 20594

## **Electronic Devices**

### **Specialist's Factual Report by Nick Swann**

Location: Fullerton, CA  
Date: April 18, 2019  
Aircraft: Beech B60  
Registration: N65MY  
Operator: Private  
NTSB Number: WPR19FA115

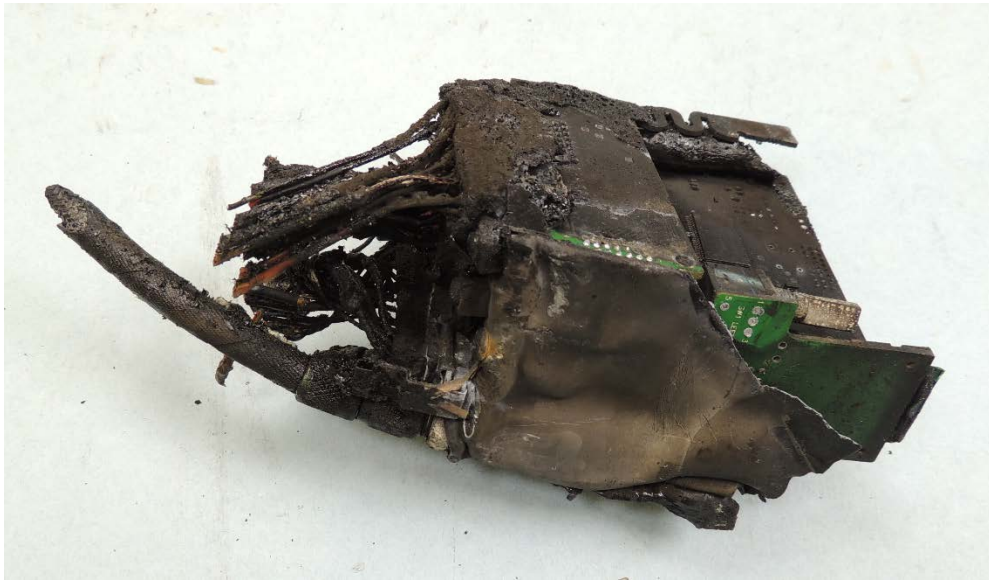
Upon arrival at the Vehicle Recorder Laboratory, an exterior examination revealed the unit had suffered severe fire and impact damage. There was significant charring on the exterior of the device as shown in figure 1. The SD card containing the recorded information was in the front of the device as shown in figure 2 and showed signs of fire damage as shown in figure 3. The SD card was removed from the device and after a visual and x-ray inspection the SD card was determined to be in likely in working order as shown in figure 4. The SD card was then read using lab equipment.

**Figure 1. Exterior Damage to Insight G4.**

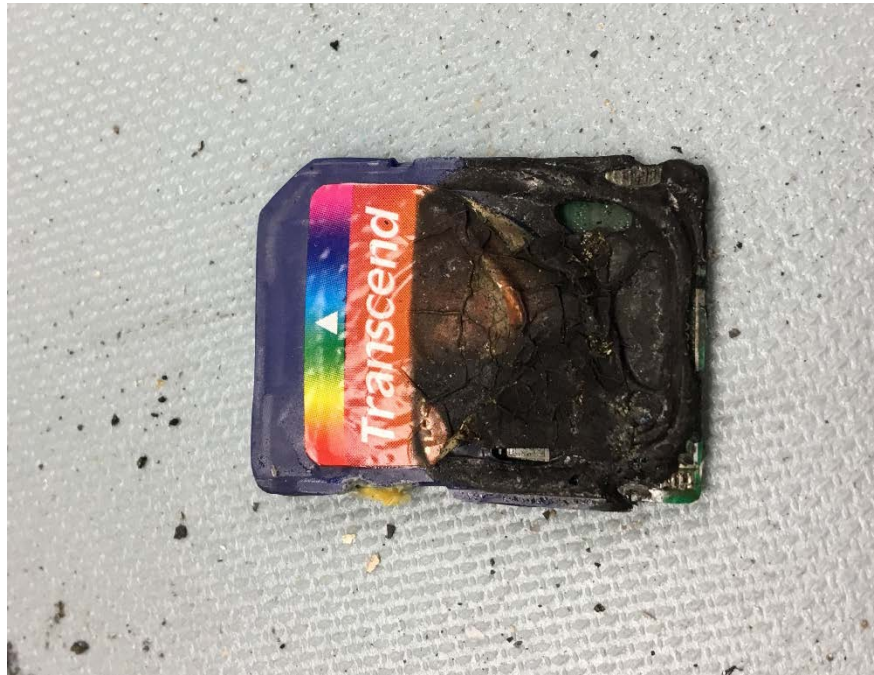
**Figure 3. Exterior Damage of SD Card.**

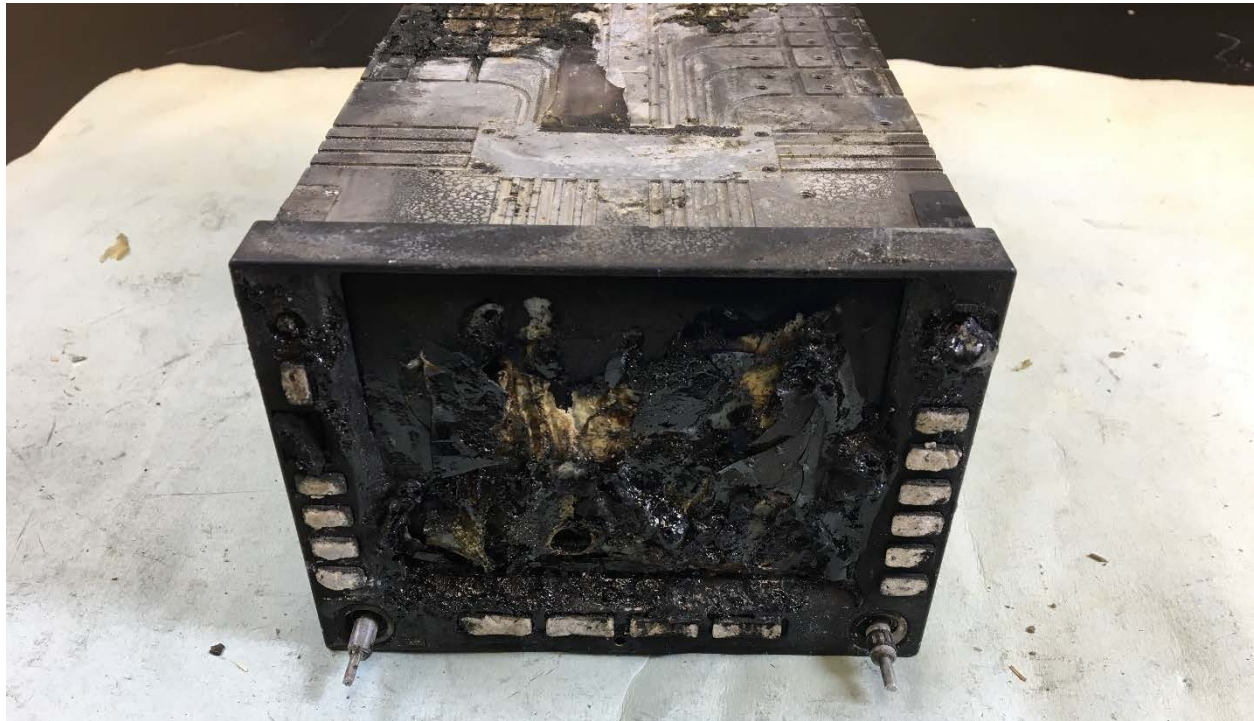
Upon arrival at the NTSB Vehicle Recorder Laboratory, the IFD 540 showed extensive signs of fire damage as shown in figure 5. Although the outside of the unit showed signs of fire damage, the inside of the unit had minimal charring as shown in figure 6. Figure 6 also demonstrates the location of the CF card inside the IFD 540.

**Figure 5. Exterior damage to IFD 540.**

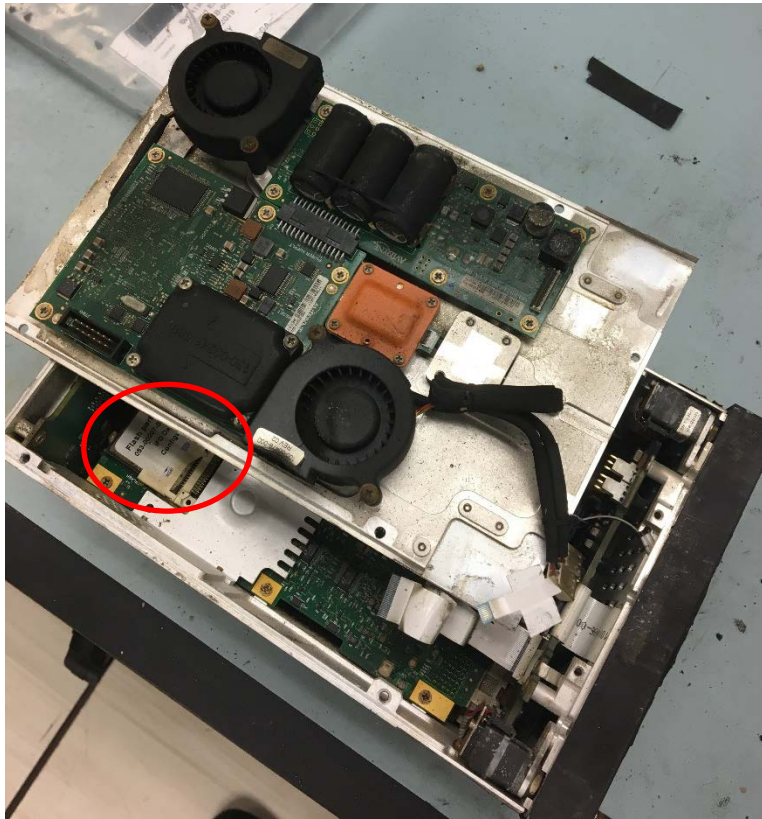
**Figure 6. Interior damage and location of CF card.**

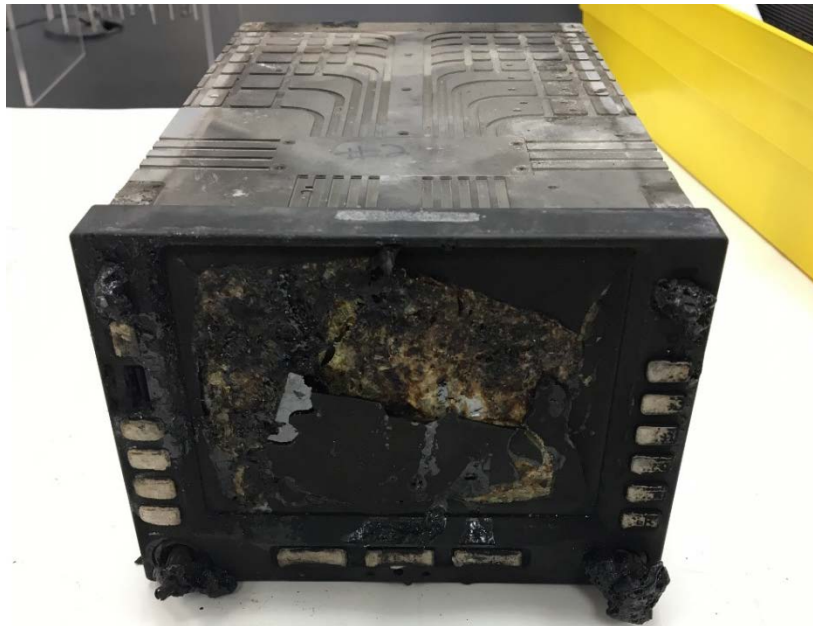
Upon arrival at the NTSB Vehicle Recorder Laboratory, the IFD 550 showed significant signs of fire damage as shown in figure 7. Although the outside of the unit showed signs of fire damage, the inside of the unit only showed minimal charring. The CF card was located and is shown in figure 8.

Figure 7. Exterior damage to IFD550.

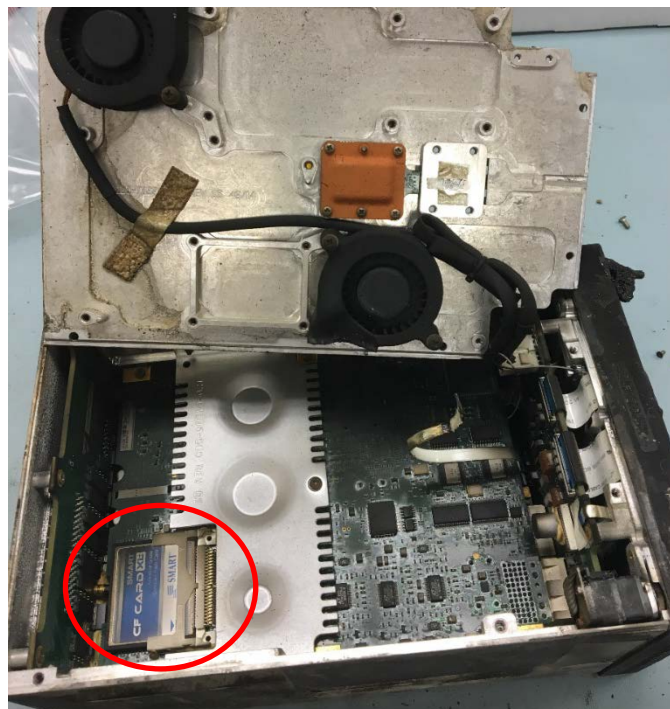
Figure 8. Interior damage to IFD550 and location of CF Card.
