**NATIONAL TRANSPORTATION SAFETY BOARD**  
Vehicle Recorder Division  
Washington, D.C. 20594

## **Electronic Device and Video**

### **Specialist's Factual Report By Deven Chen**

Location: Creswell, Oregon  
Date: May 11, 2019  
Aircraft: Top Dog Ultralights trike  
Registration: Unregistered  
Operator: Private  
NTSB Number: WPR19FA143

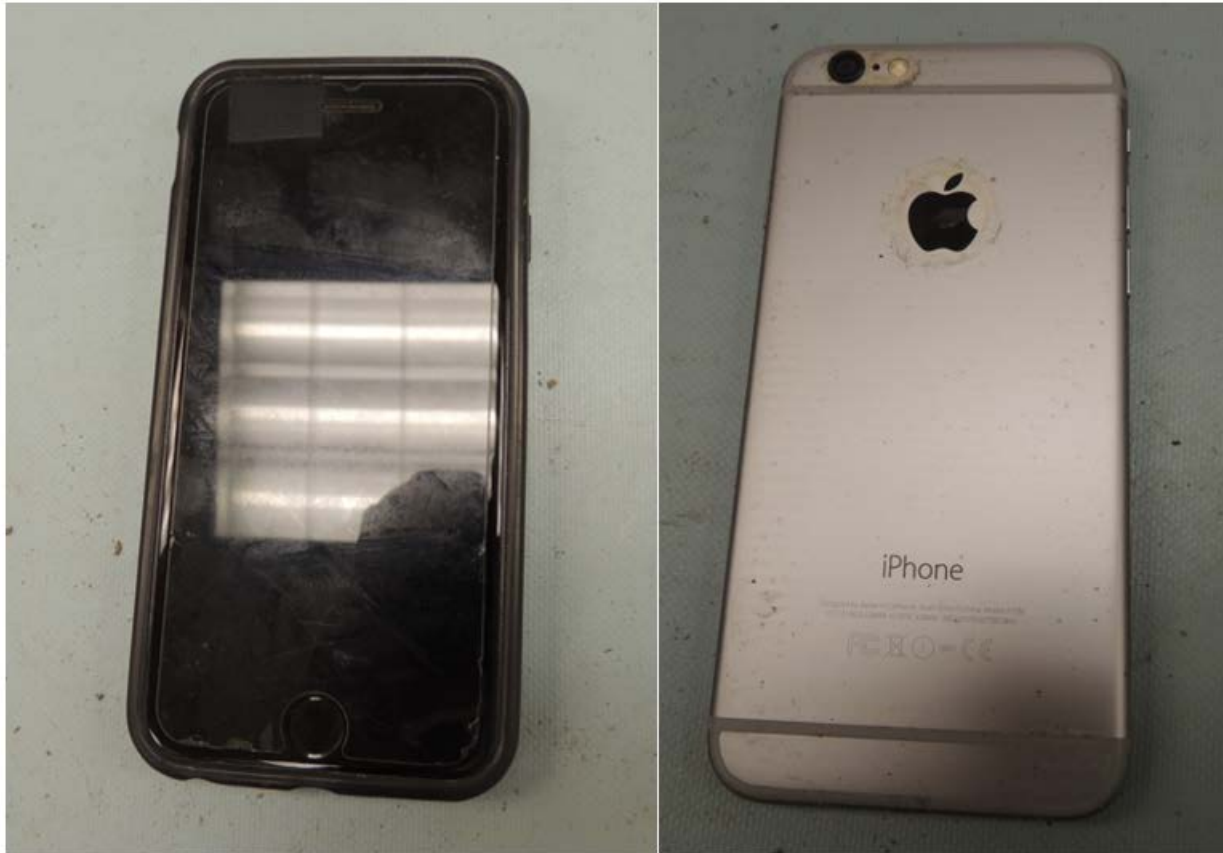
**Figure 1. Front and back of Apple iPhone 6 as received**

Upon arrival at the Vehicle Recorder Division, an exterior examination revealed the device had no damage, as shown in Figure 1. The device powered on. The device was connected to a PC and read using forensic evidence recovery software for PEDs.

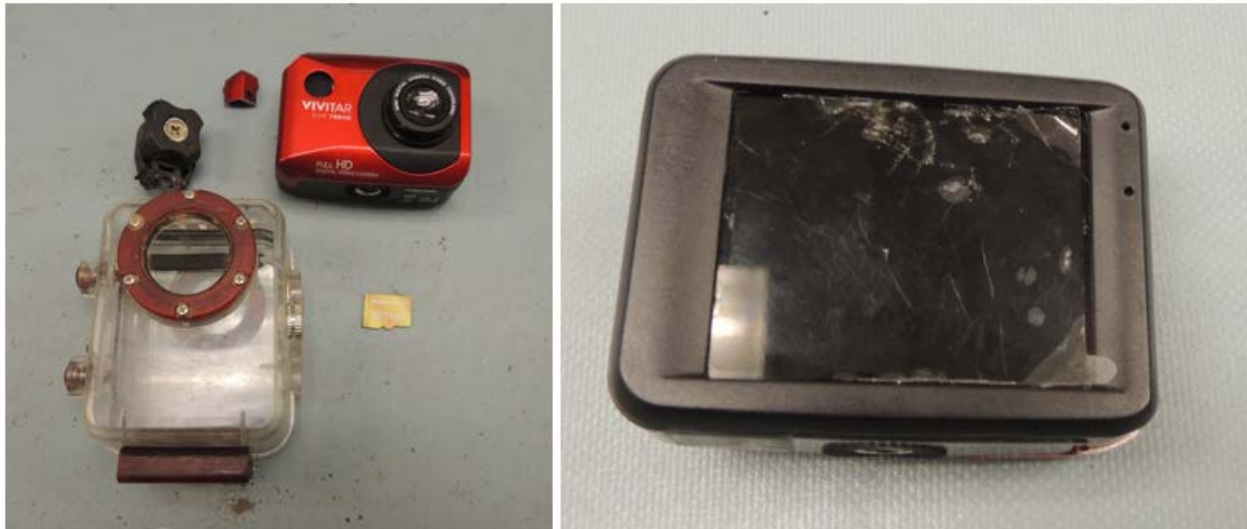
Figure 2. Camera kit as received (left), camera screen (right)

Upon arrival at the Vehicle Recorder Division, an exterior examination revealed impact damage to the unit, as shown in Figure 2. The camera had broken screen and did not power up, but its micro SD card was undamaged. Video information was extracted from the associated micro SD card.

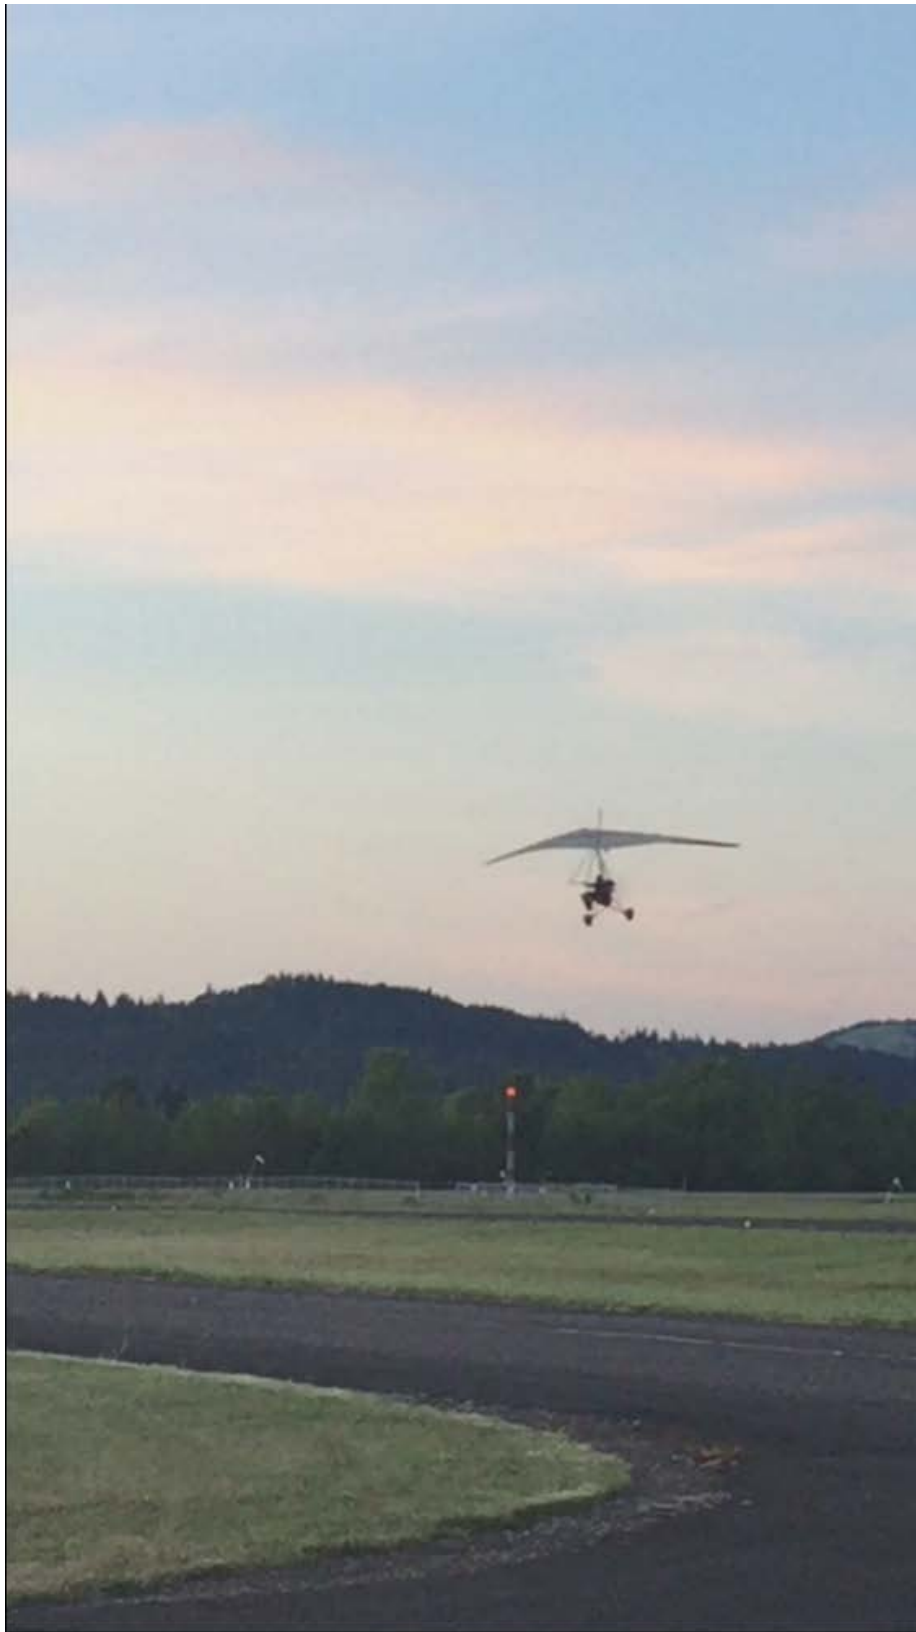
**Figure 3: snapshot at about 2:15 elapsed of the ground video**

are included in Attachment 1 to this report, each image labeled as snapshot (1) through snapshot (135). Attachment 1 is available as a shelf item. Information on how to request a shelf item is included in the attachment 1 PDF which is available on the public docket. Figure 3 shows an additional snapshot from about 2:15 elapsed of the ground video when the aircraft just took off. Figure 4 shows a clear snapshot (57) at about 4:08 elapsed of the ground video. The figure shows that the aircraft is in a steep left bank turn. As the accident sequence progresses, the aircraft went into a rapid descent and disappeared behind the trees.
