**NATIONAL TRANSPORTATION SAFETY BOARD**  
Office of Research and Engineering  
Washington, D.C. 20594

## **Video Study**

**NTSB Case Number:**  
**WPR19FA188**

Location: Hayward Executive Airport (HWD), Hayward, California  
Date: July 15, 2019  
Time: 1426 Pacific daylight time (PDT)  
Aircraft: Robinson R-44 II helicopter

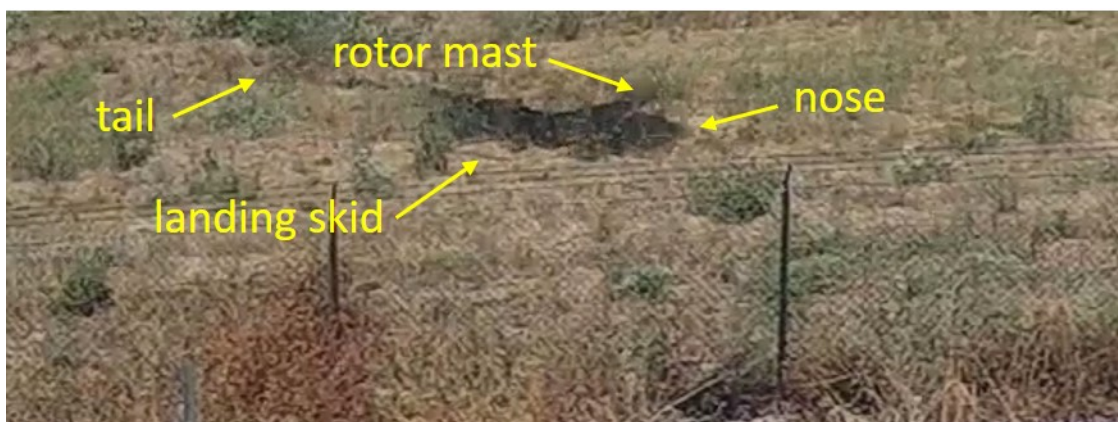
The ground surface in this accident was uneven and was covered with grass, weeds and bushes. Consequently, the image of the shadow that the camera recorded was incomplete and distorted compared to what it would have been if the surface was even and smooth, such as the surface of a runway. Figure 1 shows the image of the helicopter shadow in one of the video frames that were analyzed.

**Figure 1. Image of the Helicopter Shadow in a Video Frame**

One of the goals of the analysis was estimation of the roll angle of the helicopter. Figure 2 shows the schematic drawings of the R44-II helicopter. Examination of the helicopter schematics in Figure 2 and its shadow in Figure 1 reveals that a reasonably accurate roll angle estimation will have to rely on helicopter references that are maximally spaced in the vertical direction, i.e., the landing skids and the main rotor retaining nut (the top of the rotor mast). The accuracy of the roll angle estimates depends on the visibility of the landing skids and the main rotor retaining nut in the shadow of the helicopter. As seen in Figure 1, their visibility was limited. Furthermore, in most of the video frames the landing skids were not visible at all, making roll angle estimation impossible.

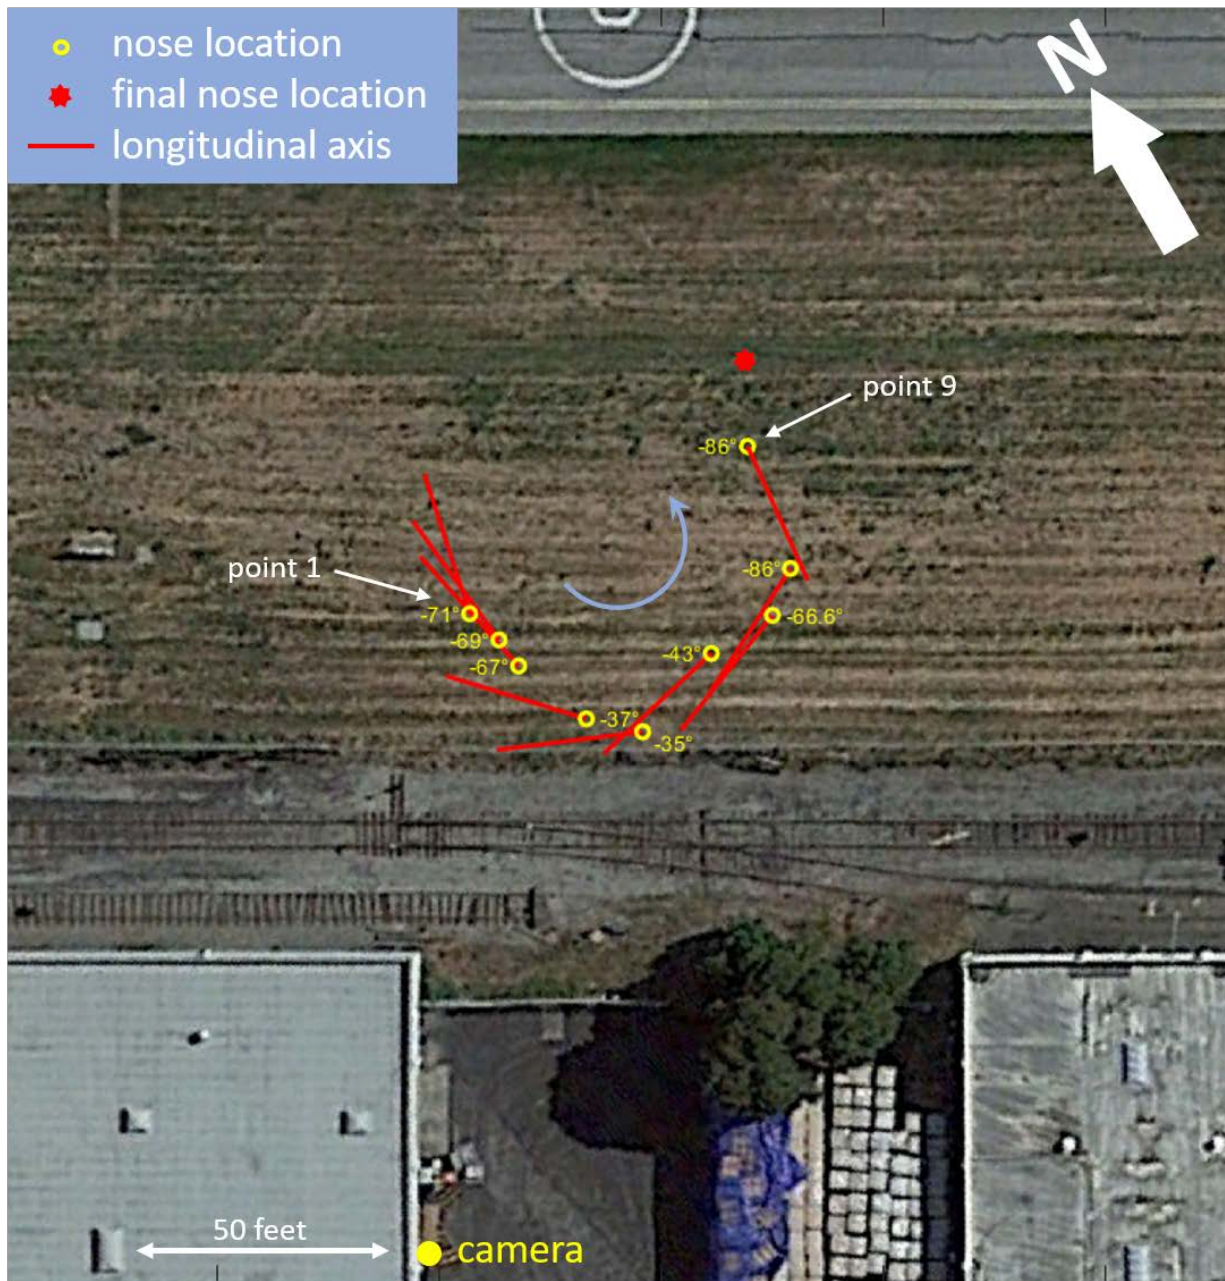
The yellow circular markers in Figure 3 shows the estimated locations of the nose of the helicopter at the time when the nine analyzed video frames were recorded (refer to Figure 5 or Figure 6 for the times corresponding to these nine points). The red lines originating at the yellow markers are the longitudinal axes of the helicopter. The lengths of the red lines correspond to the length of the helicopter. The orientation of the red lines are the estimated headings (yaw angles) of the helicopter. The yellow numbers indicate the estimated roll angle of the helicopter for each of the nine analyzed video frames.

Figure 3. Estimated Helicopter Locations and Headings (altitude: 15 feet)

Figure 5 is a plot of the estimated heading (yaw angle) of the helicopter, i.e., the orientation of the red lines in Figure 3. The markers are the nine estimated values and the curve interpolates in between them.

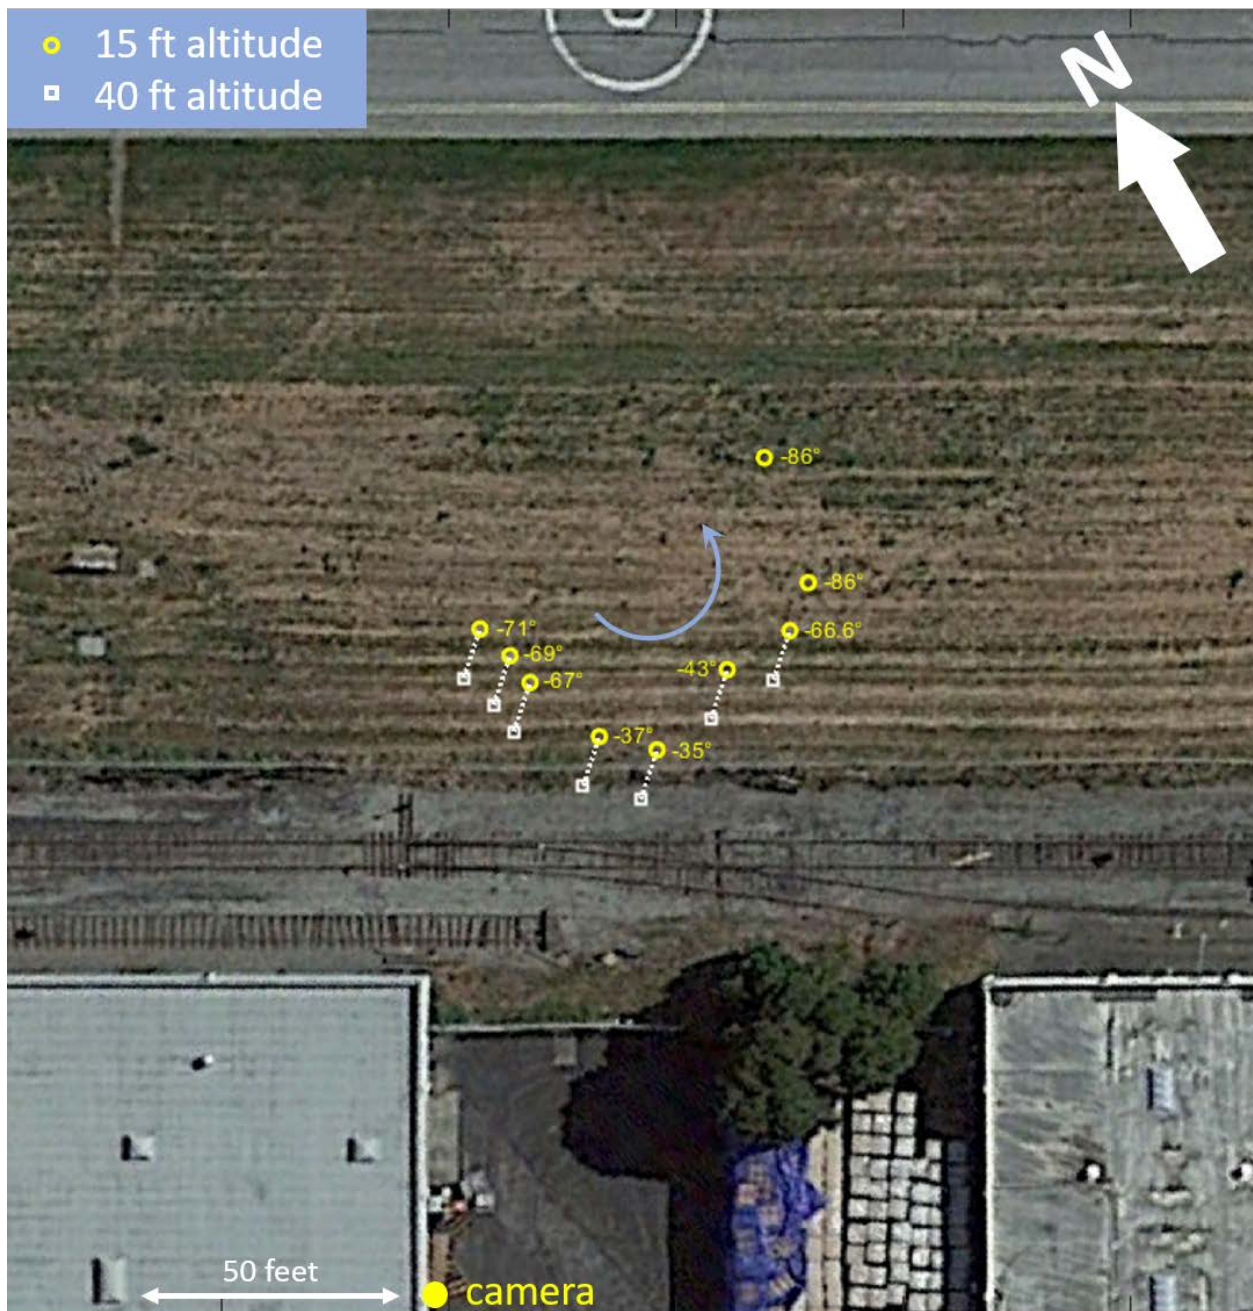
Since the helicopter altitude could not be estimated based on its shadow, the X-Y locations were also estimated assuming the altitude was 40 feet. Since the altitude could not be 40 feet when the rotor blades were contacting the ground, only the first seven X-Y locations were estimated. Figure 4 shows the estimated X-Y locations for both the assumed altitudes of 15 feet and 40 feet. The dotted lines connect helicopter nose locations corresponding to the same analyzed point. The orientation of these lines is  $228.6^\circ$ , the sun azimuth angle. The yellow numbers again indicate the estimated roll angle of the helicopter.

The relative proximity of the 15-foot locations and the corresponding 40-foot locations in Figure 4 suggests that the unknown helicopter altitude will not have a significant effect on the results from this study. Note that the shadow-based estimates of the helicopter yaw, pitch and roll angles are independent of the altitude.

Figure 4. Estimated Helicopter Locations (altitude: 15 feet and 40 feet)
