**NATIONAL TRANSPORTATION SAFETY BOARD**

## **Onboard Image Recorder**

### **Specialist's Factual Report**

Location: Big Spring, TX  
Date: August 23, 2019  
Aircraft: Meyers Midget 0100  
Registration: N881MM  
Operator: Private  
NTSB Number: WPR19FA235

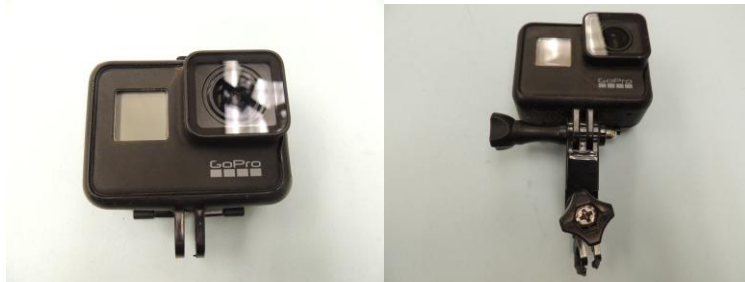
Upon arrival at the NTSB Vehicle Recorder Division, it was evident that the GoPro has sustained only light impact damage. Both cameras were still functional. MicroSD memory cards were removed from each device and the video and audio information was extracted from the memory card normally, without difficulty. Figure 1 is a photo of both units.

Figure 1. Photo of both GoPros recovered from the accident.
