# NATIONAL TRANSPORTATION SAFETY BOARD

## Onboard Image Recorder

### Specialist's Factual Report

| Aircraft: | Cessna 210L Centurion |

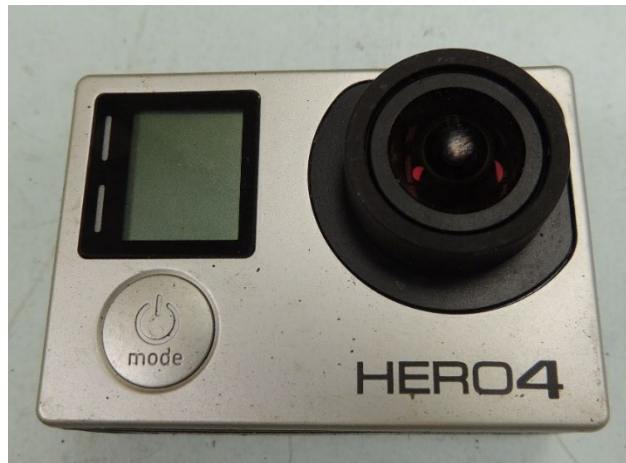
Upon arrival at the NTSB Vehicle Recorder Division, it was evident that the GoPro Hero 4 Session and the associated mounting hardware had sustained minimal impact damage (figure 1). A 128 GB micro SD card was found intact and seated securely in the device's memory card slot (figure 2).

Figure 1. The GoPro Hero 4.

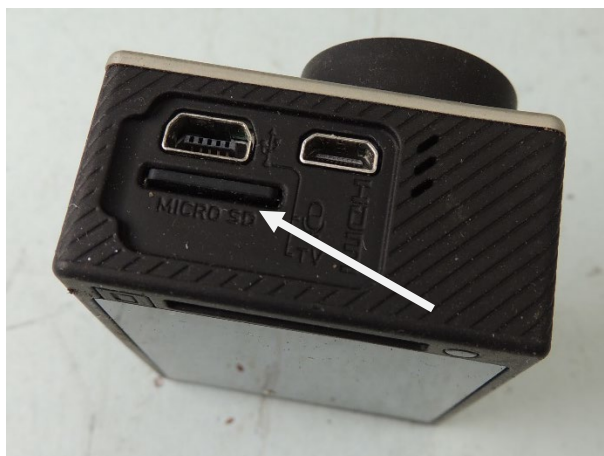
**Figure 2. The micro SD card seated properly in the device. The arrow denotes the location of the card.**
