## **NATIONAL TRANSPORTATION SAFETY BOARD**

### **Factual Report**

# **METEOROLOGY**

WPR19LA071

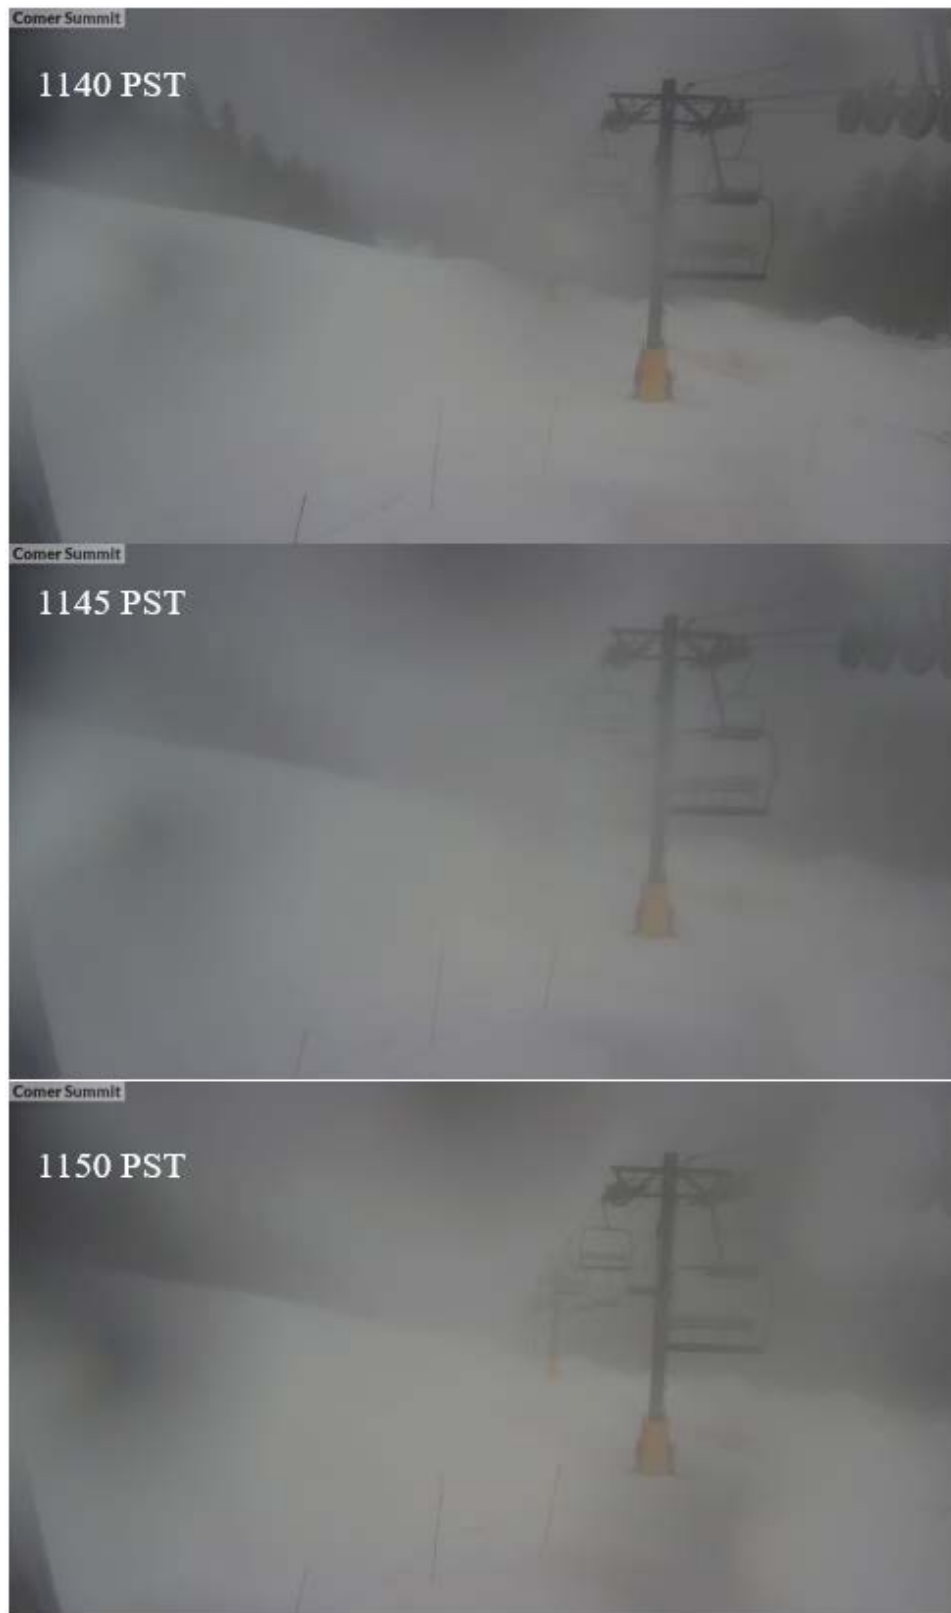
The webcam images depicted snow covering the surface with obscured sky conditions with fog. The conditions were consistent with those of a flat light condition, where a pilot's depth perception and contrast with the terrain can be lost.

**Figure 22 - Webcam from Comer Summit looking north at 1140, 1145, and 1150 PST**

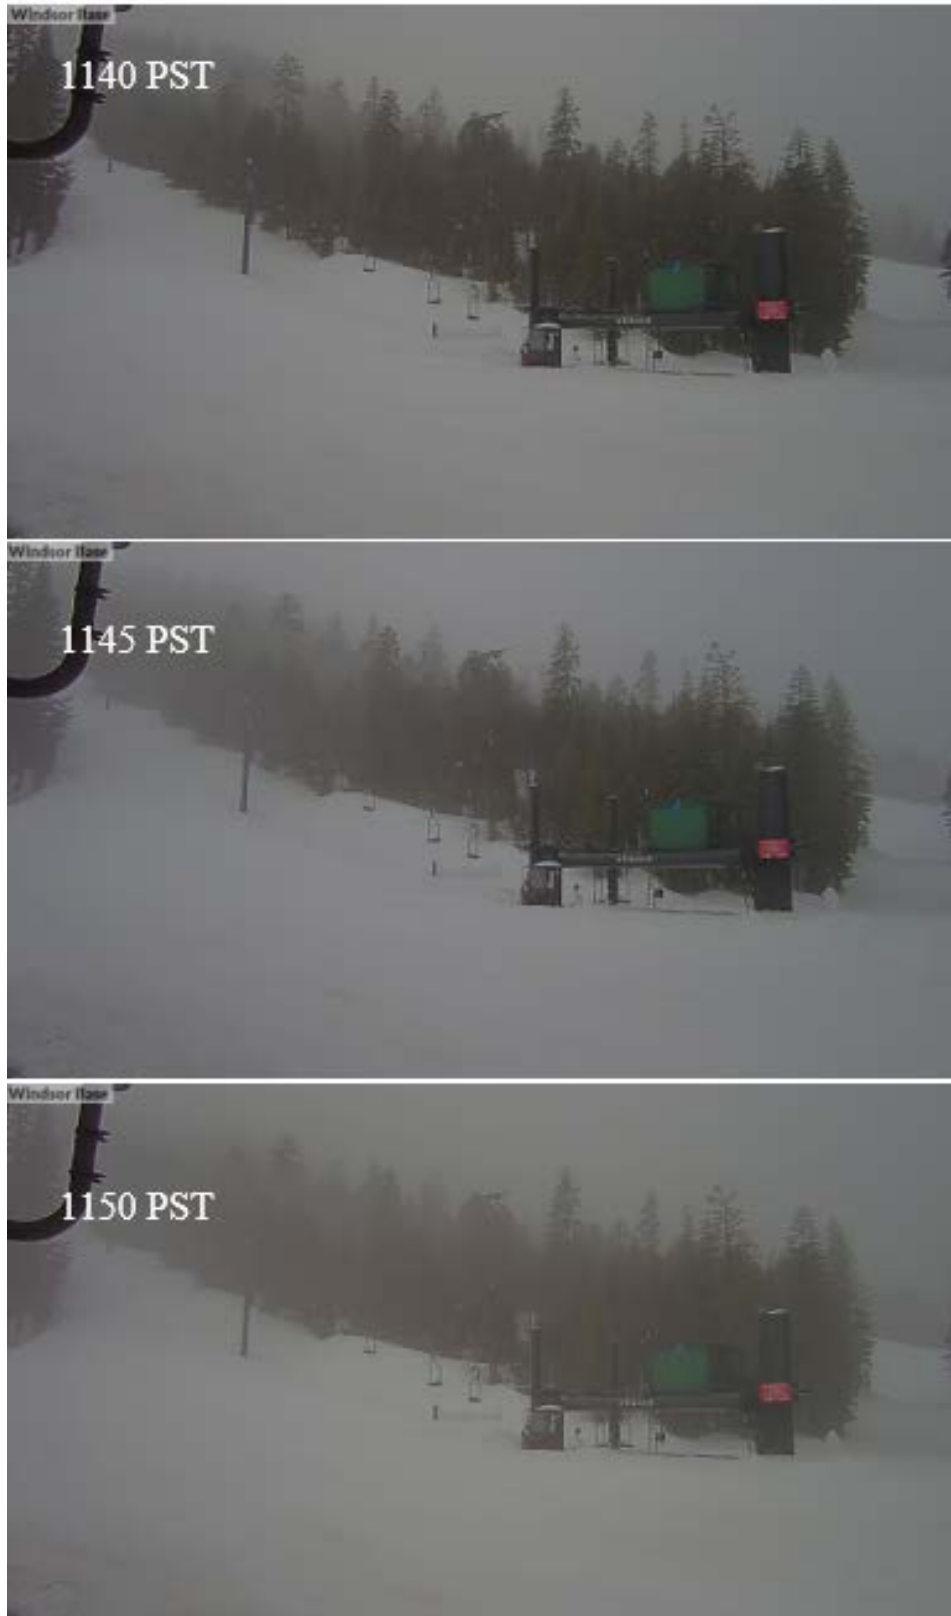
**Figure 23 – Webcam for Windsor Base looking west at 1140, 1145, and 1150 PST**

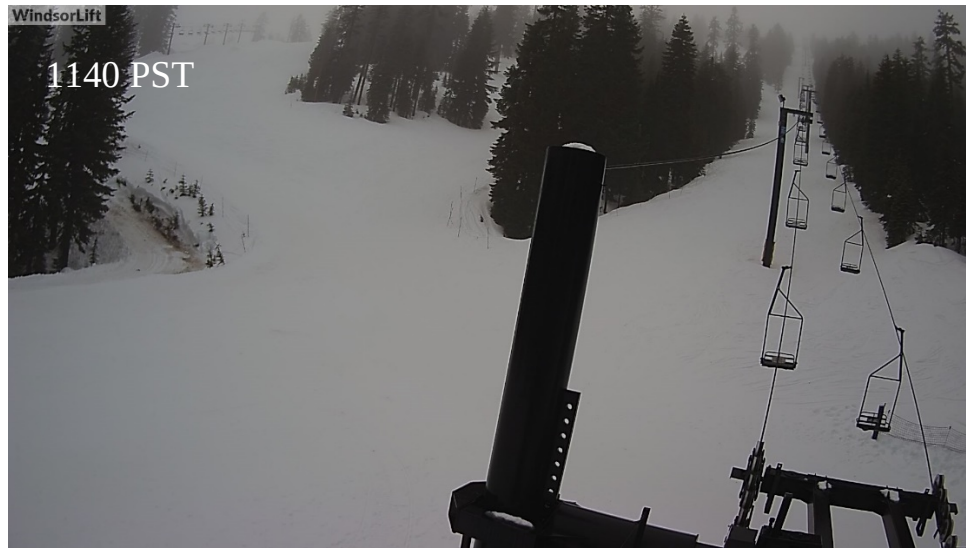
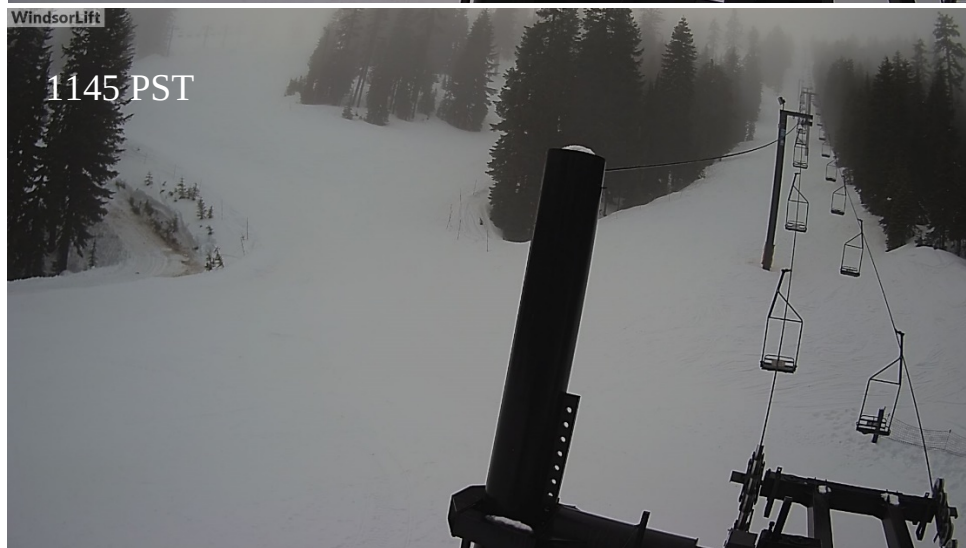
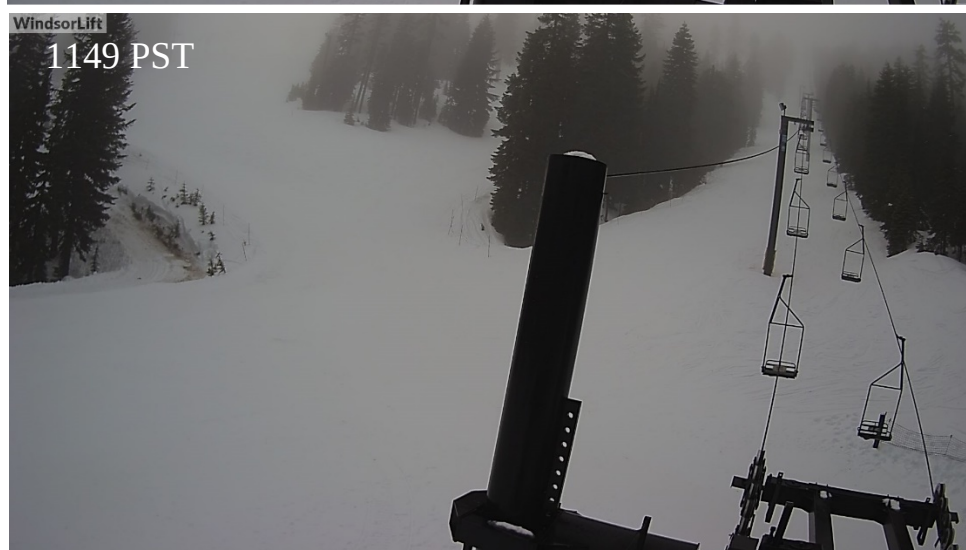
**Figure 24 - Webcam of Winsor Lift looking south at 1140, 1145, and 1149 PST**
