# Engine Investigation

Allison  
M250-C20B  
Engine CAE 836362

MD 369E  
Registration: N506PH

**Accident date: February 21, 2019  
Investigation date: March 5-7, 2019  
At Keystone: May 15, 2019  
Report date: July 8, 2019**

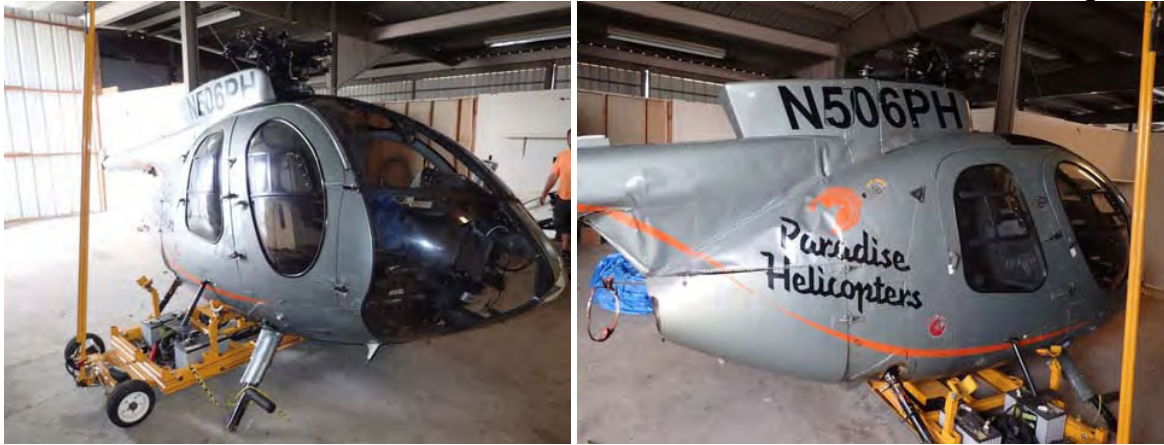
Fig 1

The helicopter was positioned upright on a dolly. All main rotor blades had been removed. The tail boom was separated just forward of the tail rotor with the tail rotor gear box and tail rotor blades remaining attached. Both main landing gear skids were absent. The fuselage exhibited overall damage with the majority of the front wind screen and chin bubble plexi-glass being absent.

Helicopter at Recovery

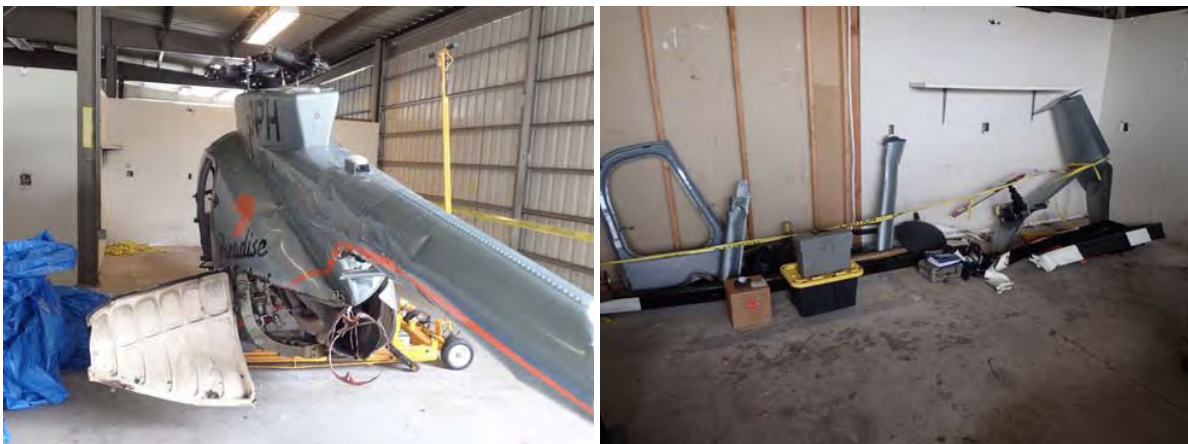
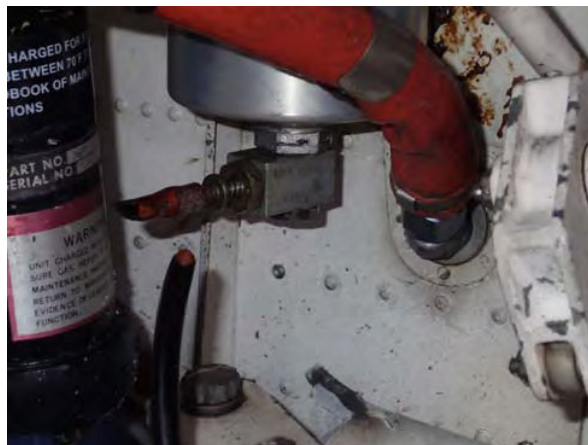
The engine remained in position and securely attached to the airframe. No visible impact damage was noted to the engine. A visual and tactile examination of all engine pneumatic, fuel and oil lines was conducted where all "B" nuts and associated fittings were found to be at least finger tight. Oil and fuel line interface connections between the engine and airframe were examined where all were found at least finger tight with no evidence of leakage. The power turbine governor was examined where collective movement resulted on correct movement at the governor. Rotation of the throttle was not possible due to control linkage damage beneath the right collective position. A vacuum check of the engine fuel system was conducted where the engine fuel system aft of the airframe fuel filter held specified vacuum for excess of two minutes. Impact damage to the airframe fuel filter drain fitting prohibited vacuum testing of the entire fuel system. (Fig1)

Airframe Fuel Filter  
[Return](#)

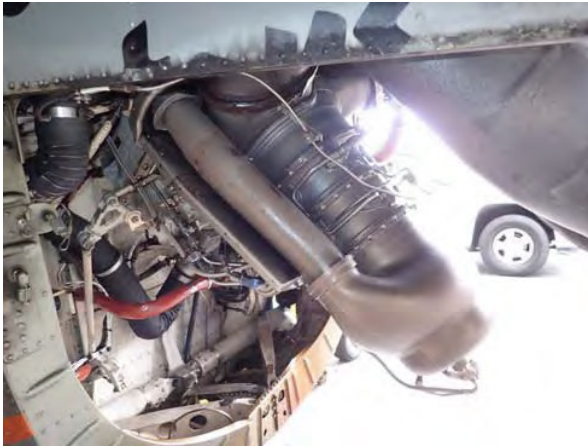
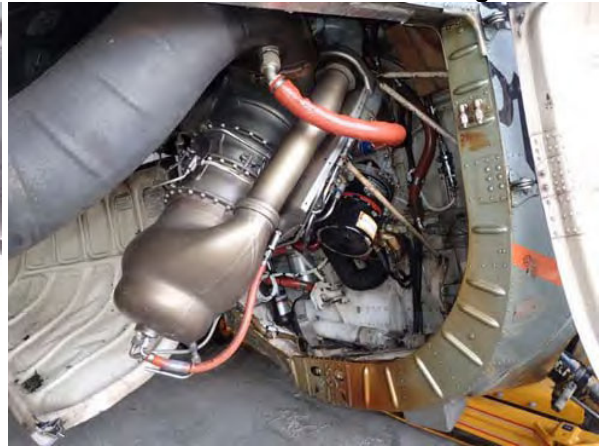
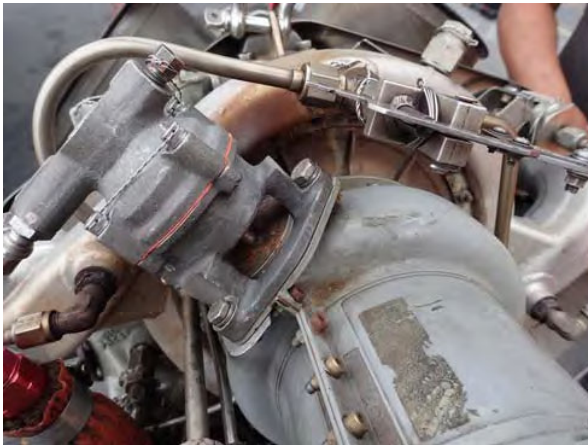
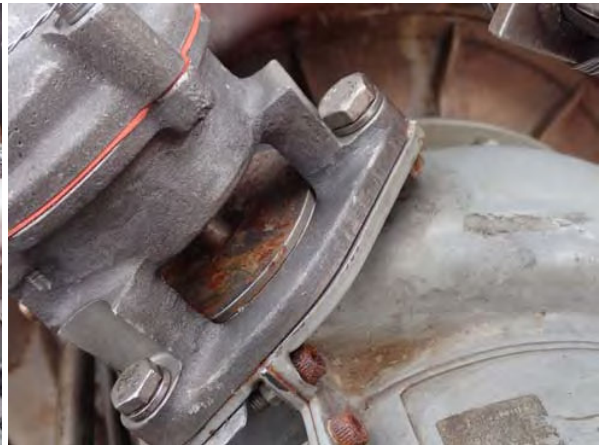
Fig 2

During examination fuel was noted both within the fuel pump filter bowl and approximately two tablespoons of fuel noted in the line at the fuel nozzle. The only noted anomaly was the compressor bleed valve which was stuck in the closed position and the poppet valve could not be manually actuated. (Fig 2)

Engine as Recovered

Compressor Bleed Valve

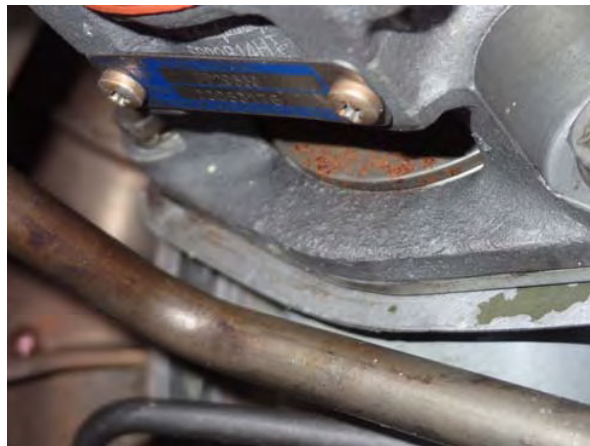
Fig 3

Upon removal of the engine from the airframe both N1 and N2 drive trains were rotationally free and smooth. Examination of both upper and lower chip detectors revealed both to be void of material. The decision was then made to recover the engine to Keystone Turbine Services for run as received testing of the engine. (Fig 3)

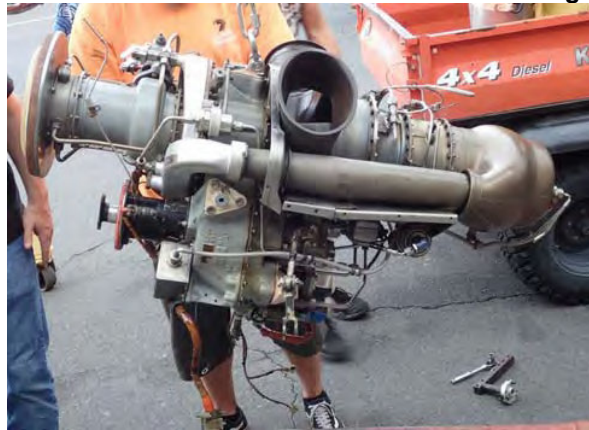
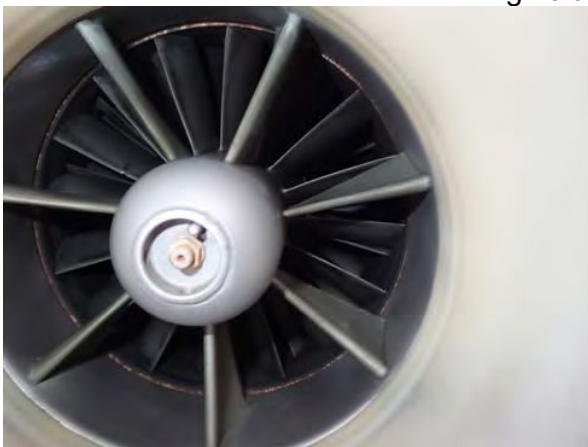
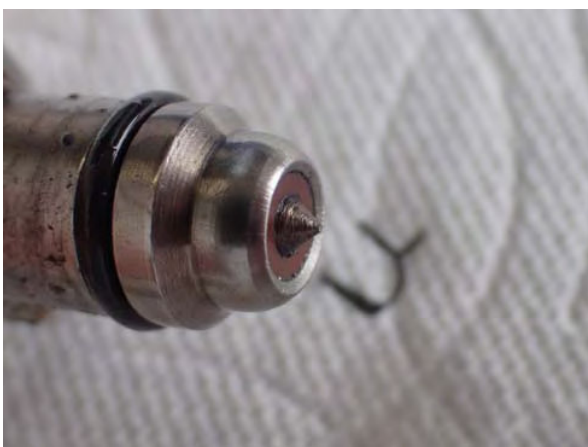
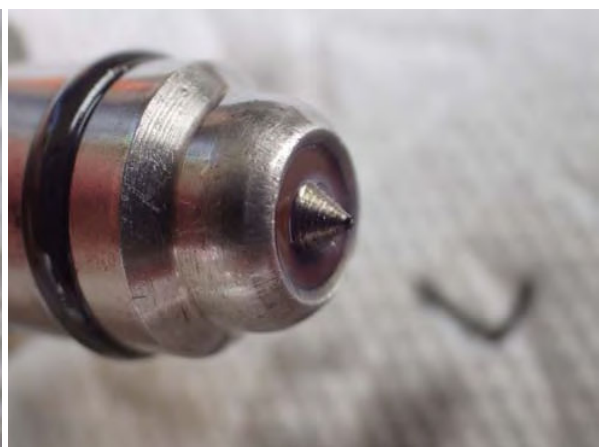
Engine at Removal

Compressor Inlet

Exhaust Collector / Stage 4 Turbine Wheel

Upper Chip Detector

Lower Chip Detector

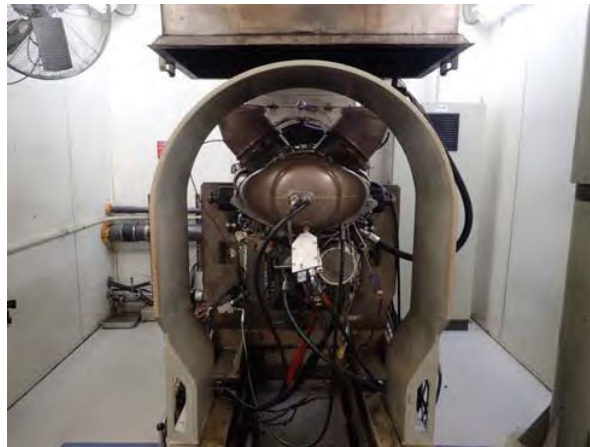
**Fig 4**

On May 15, 2019 "Run as Received" testing was conducted on the subject engine at Keystone Turbine Services Coatesville, PA. Testing was conducted to Rolls-Royce Overhaul specifications. Testing was conducted under the auspices of the NTSB IIC. The engine was removed from the container and placed onto an engine stand where preparation and pre run examination of the engine was conducted. (Fig 4)

The engine was then placed into the test cell where the engine started within specification time and temperature and stabilized at ground idle power. Following engine warm up and with vibration scans being within specification, the engine was accelerated to a flight idle power where the bleed valve, although reluctant to close was confirmed in the closed position. A power calibration of the engine was then conducted where the engine met specification at all points including take off power. The engine was then shut down normally.

Engine in Test Cell

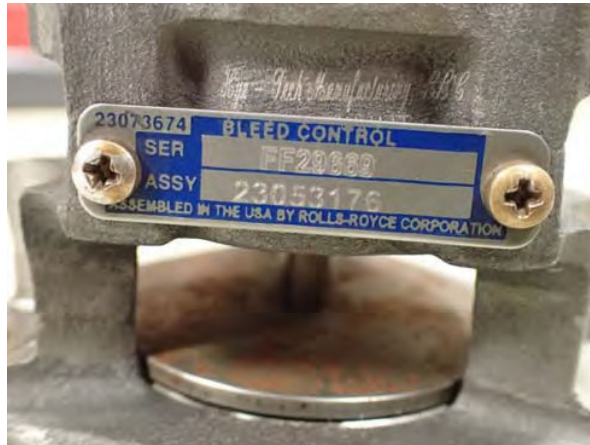
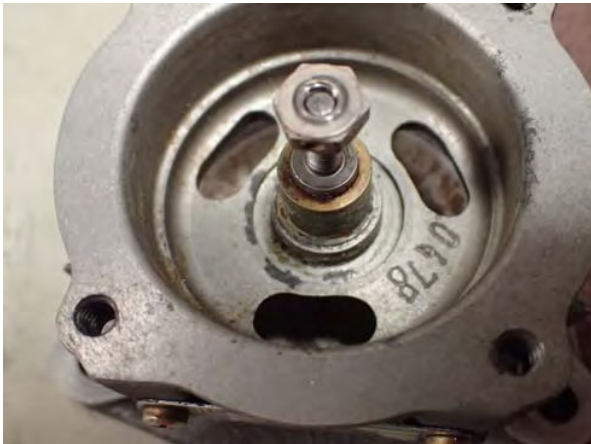
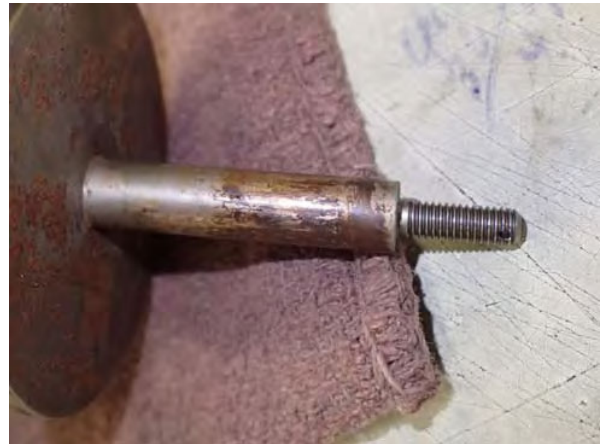
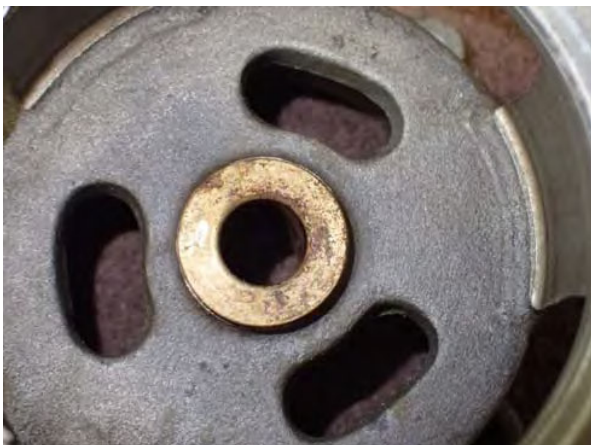
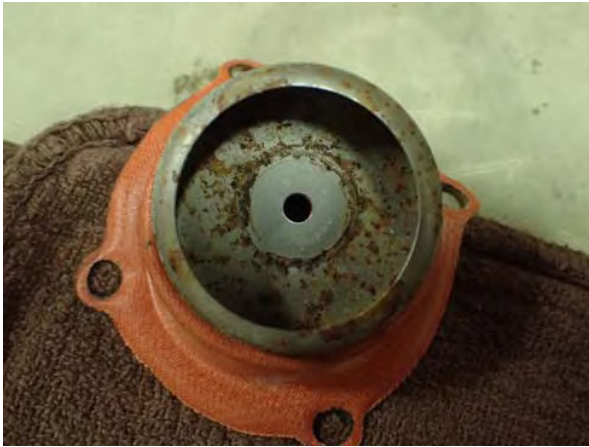
Fig 5

Following the engine run testing, the failed bleed valve which log records indicate had been overhauled 94.5 hours prior to the accident flight was disassembled by technicians for inspection at the direction of the NTSB IIC. Inspection revealed all internal components to be PMA parts which during inspection by technicians revealed the poppet valve and bushing failed to meet tolerances. The poppet valve was also found to exhibit levels of corrosion where when coupled with tolerance deviations resulted in the valve not being able to cycle as designed. (Fig 5)

Bleed Valve Disassembly
