**NATIONAL TRANSPORTATION SAFETY BOARD**

**Electronic Flight Instrument System Device**

**Specialist's Factual Report**  
**By Deven Chen**

Location: Winters, California  
Date: April 13, 2019  
Aircraft: Europa XS  
Registration: N120EJ  
Operator: Private  
NTSB Number: WPR19LA108

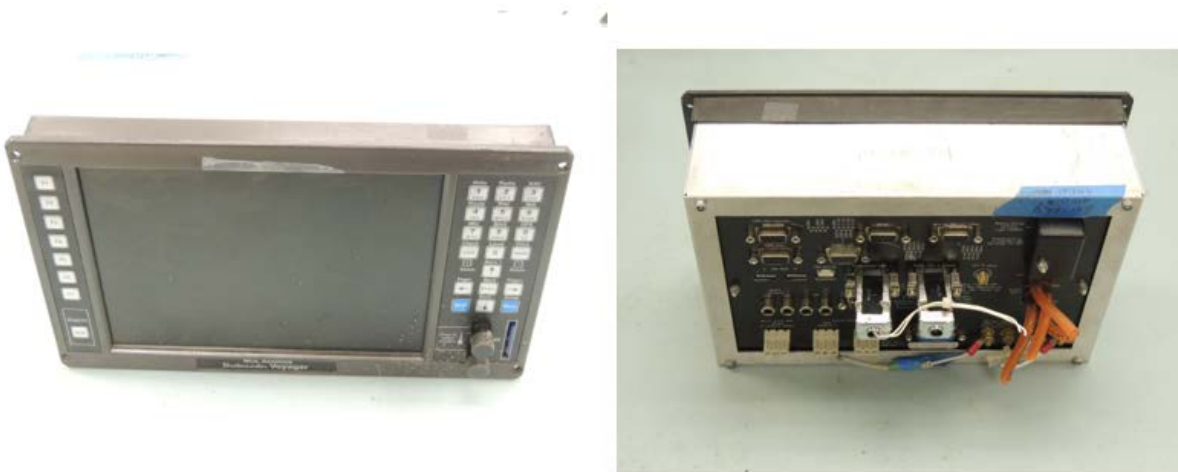
Upon arrival at the Vehicle Recorder Division, an exterior examination revealed no visible damage to the device, as shown in Figure 1, and the device had a SD card mounted on its front panel. The device powered on normally. However, a .rec file which stores all the flight data was not in the SD card, nor in the device's internal solid-state disk. No accident related data were recovered from the device.

**Figure 1. Front and back of MGL Avionics Stratomaster Voyager as received**
