**WPR19LA128 N6864Q**  
**Fuel Leak Signatures**

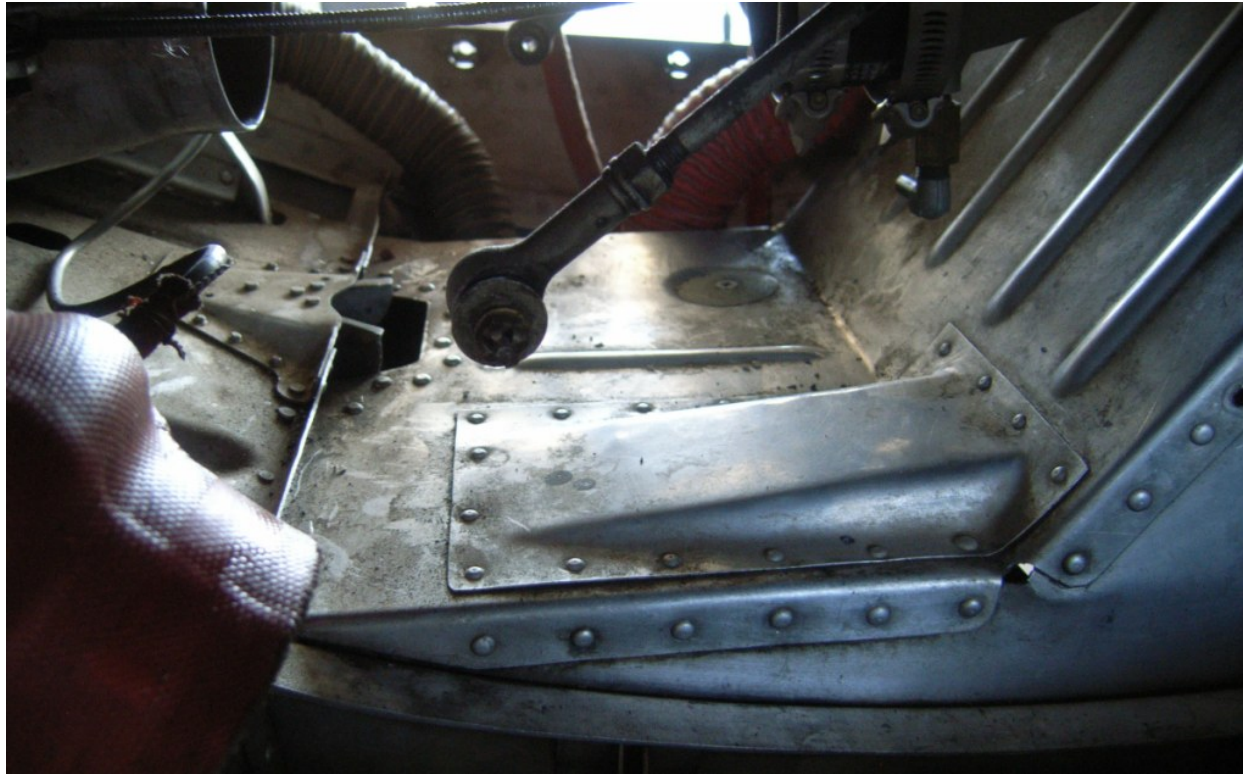
**Figure 1 - Structure Below (removed) T/MA**

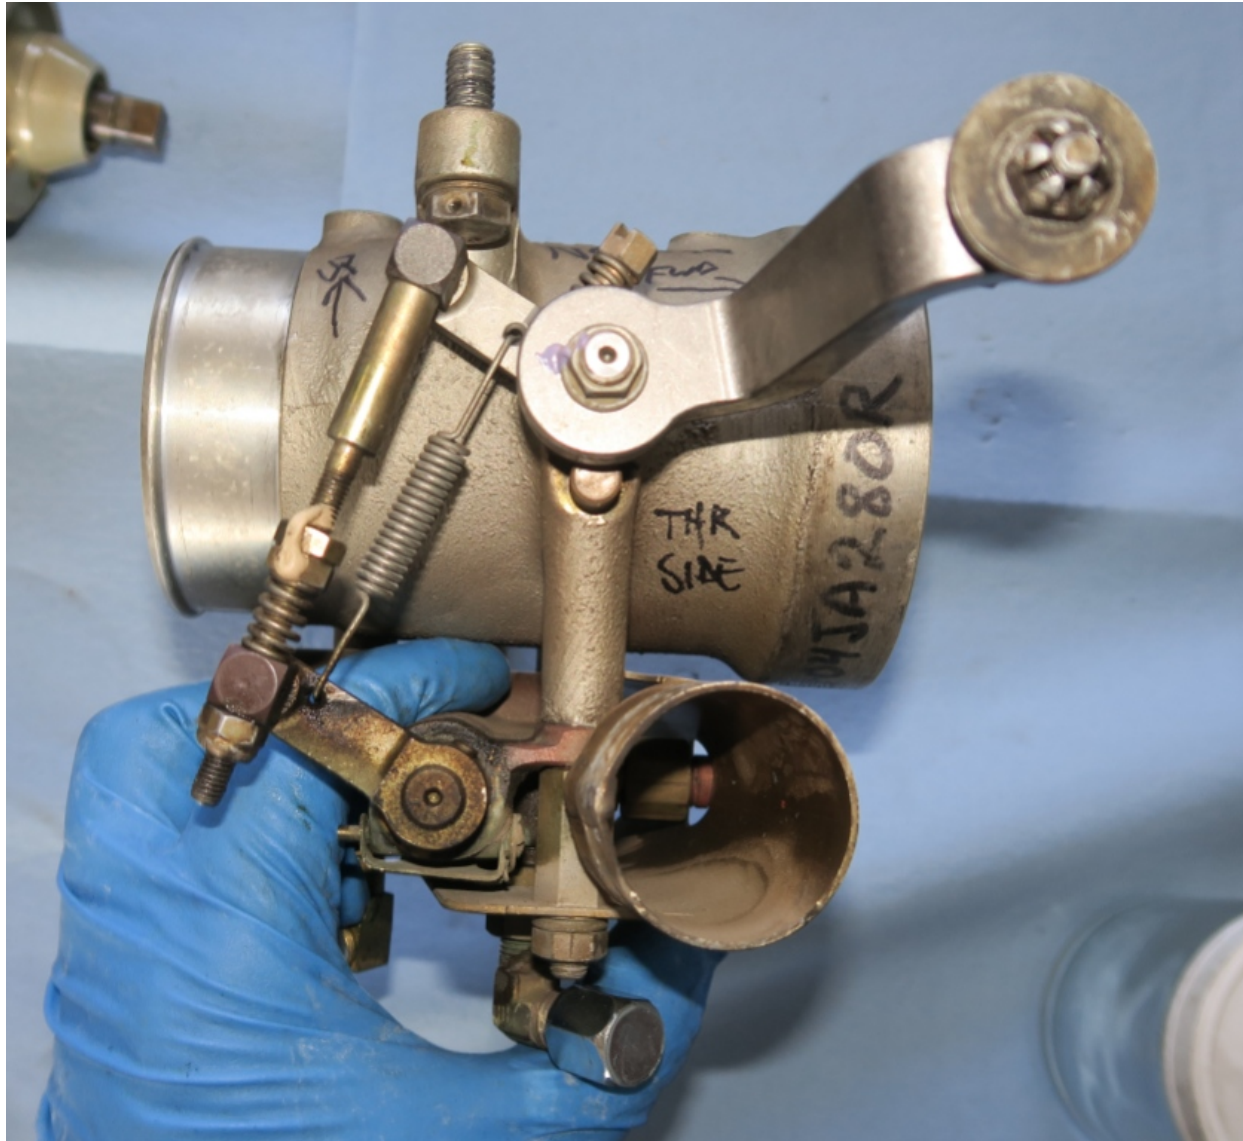
**Figure 2 - T/M with Shaft Exit Staining/Grime (throttle side)**

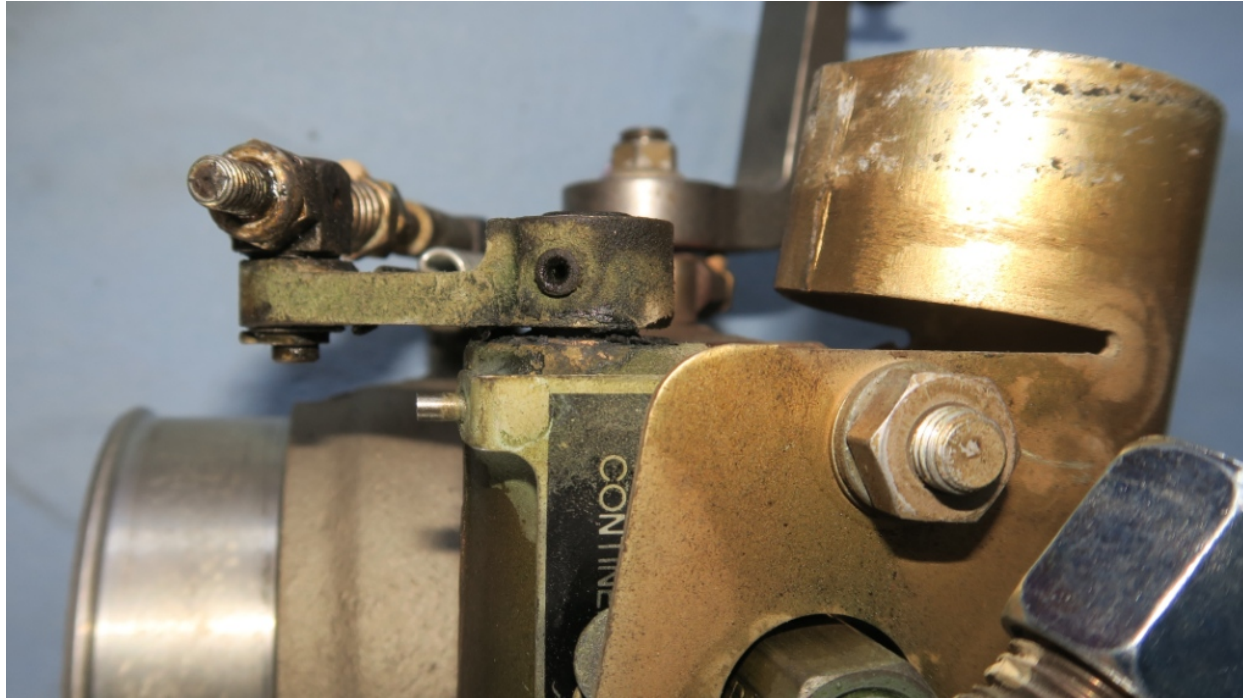
**Figure 3 - T/MA with Staining/Grime at Shaft Exit**
