SAFO 21001  
DATE: 01/06/21

**Subject:** The Improper Maintenance and/or Installation of F&M Enterprises, Inc., and Stratus Tool Technologies, LLC, Oil Filter Adapters.

**Service Bulletin: SB-001 Rev B**

**SUBJECT: OIL FILTER ADAPTER GASKETS**

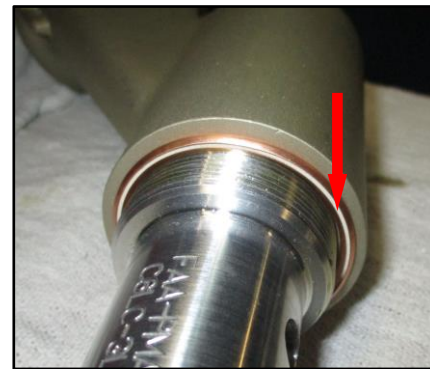
**Figure 9**

Slide the spool through the sleeve's bore and place the second copper gasket on the spool with the split side of the gasket away from the sleeve, see Figure 9.

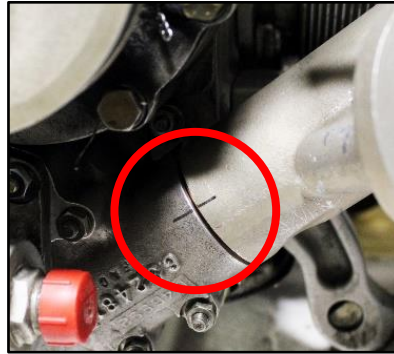
**Figure 10**

Thread the spool into the oil pump housing, when the adapter is ready to be tightened, use a fine point felt pen to make a match mark on the sleeve and oil pump housing as shown in Figure 10.

With the block in place, tighten the spool to 65 ft-lbs torque. If the match marks misalign by more than 1/32 inch after tightening the spool, i.e., the sleeve has moved relative to the oil pump housing, remove the adapter assembly from the engine as previously described. Replace both gaskets with new copper gaskets, relube the sleeve, spool, and top gasket with engine oil as shown in figures 6 and 7 and reinstall the adapter in accordance with the instructions contained in the Installation Instructions and ICA applicable to your model adapter.

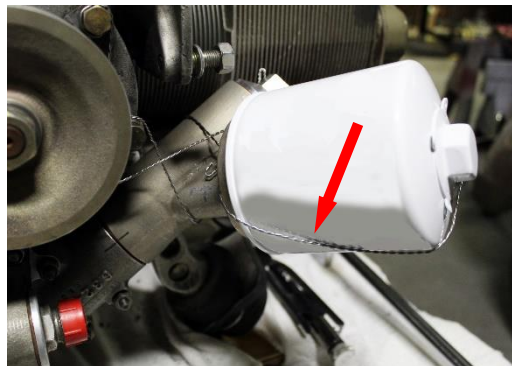
**Figure 15**

Install the oil filter. Tighten it to the torque recommended by the filter manufacturer. Safety-wire the filter to the safety-wire tab on the sleeve, see Figure 15.
