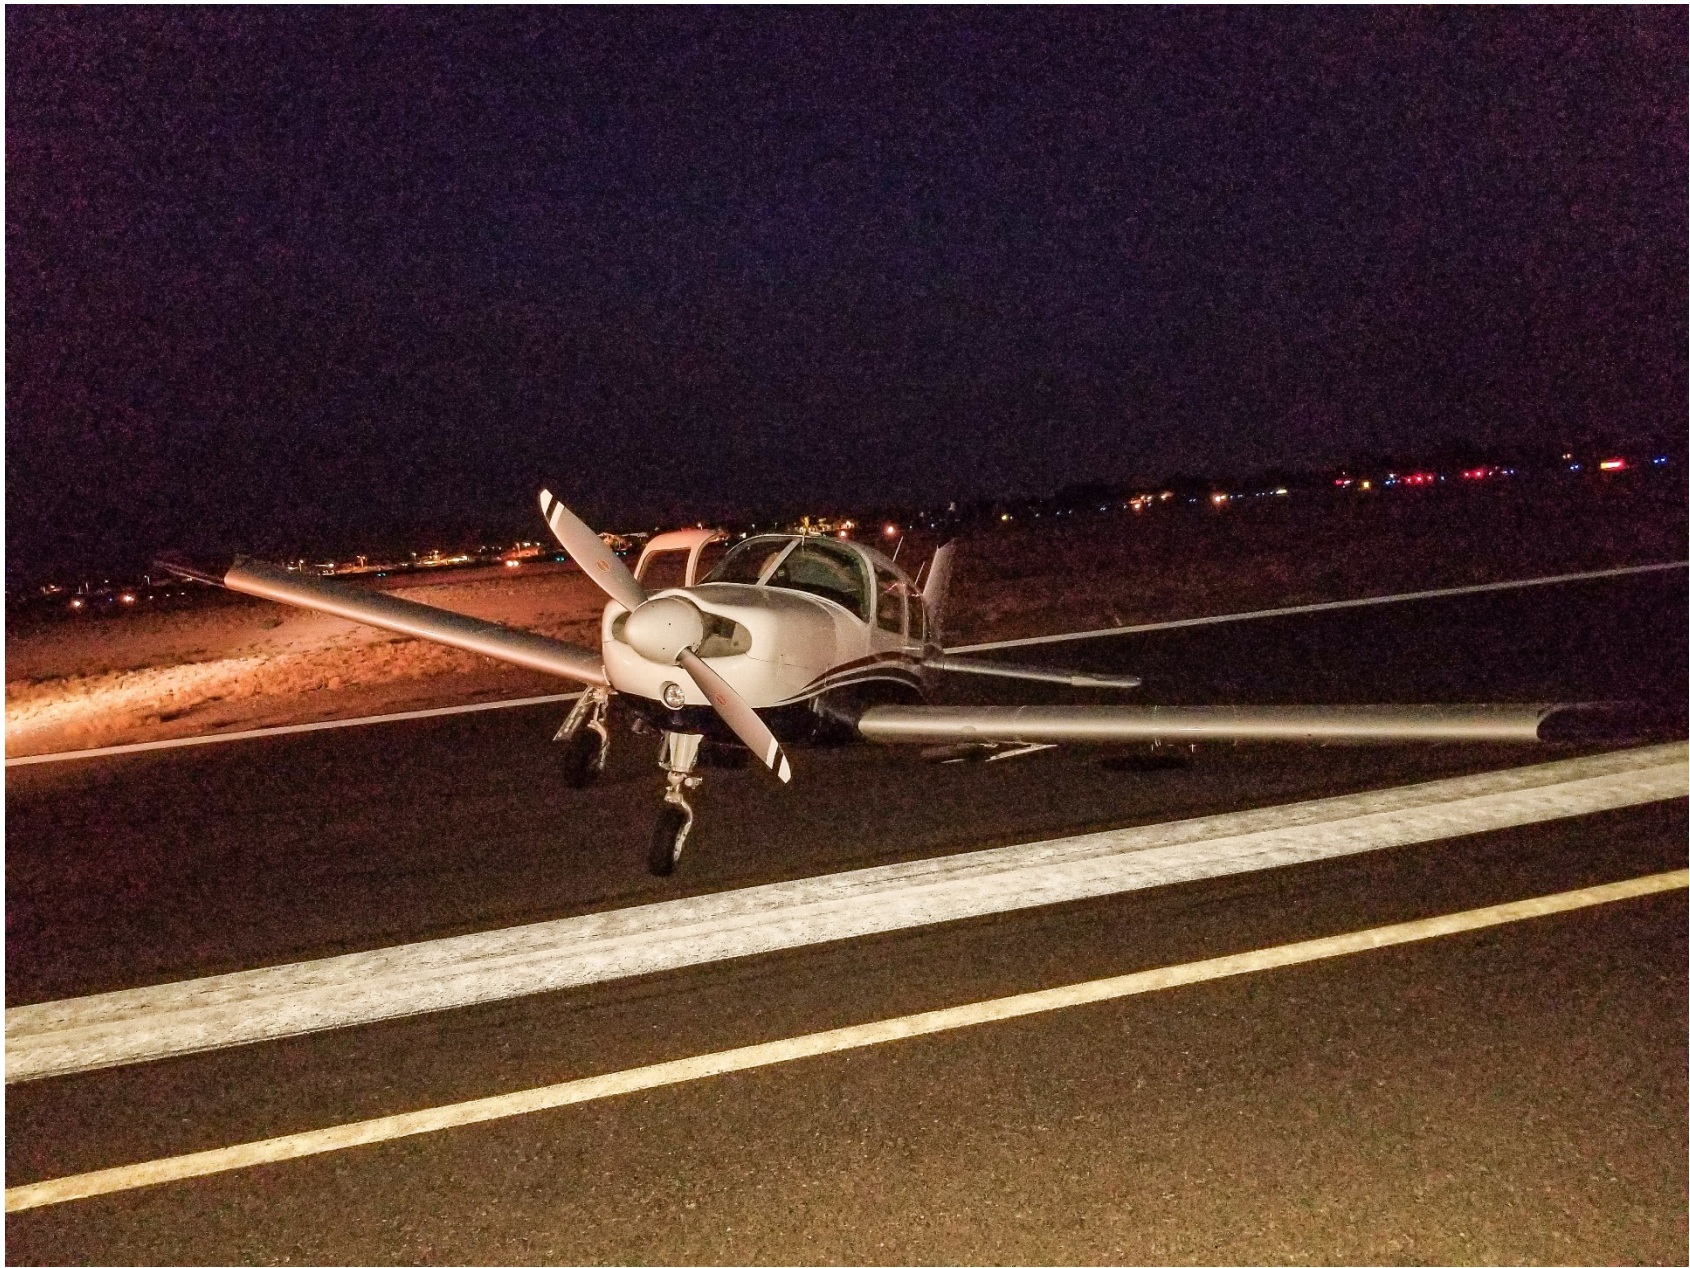
**Photo 1 – View of airplane on the runway with a collapsed left main landing gear**

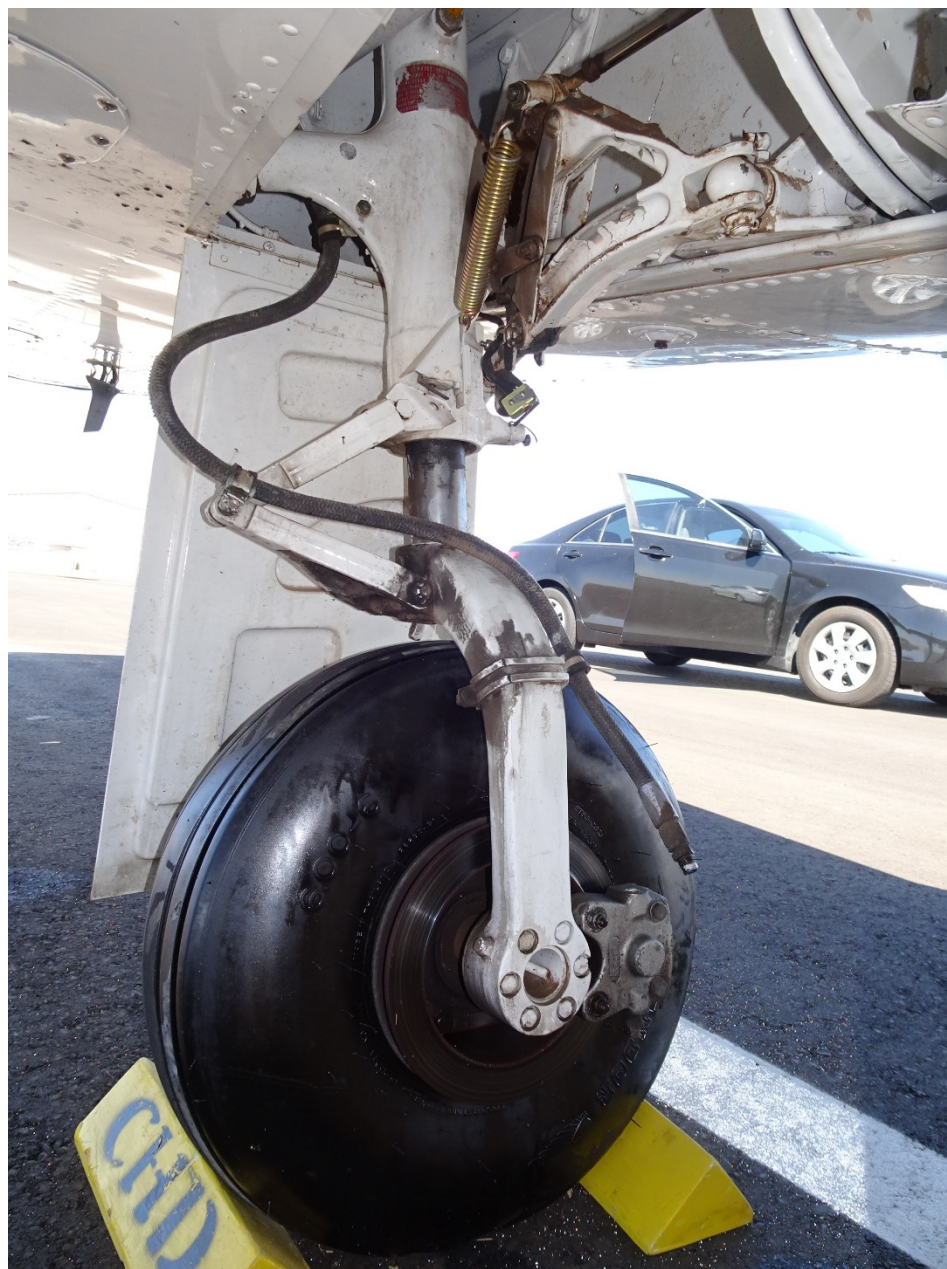
**Photo 2 - View of extended left main landing gear with a bent upper side brace link**

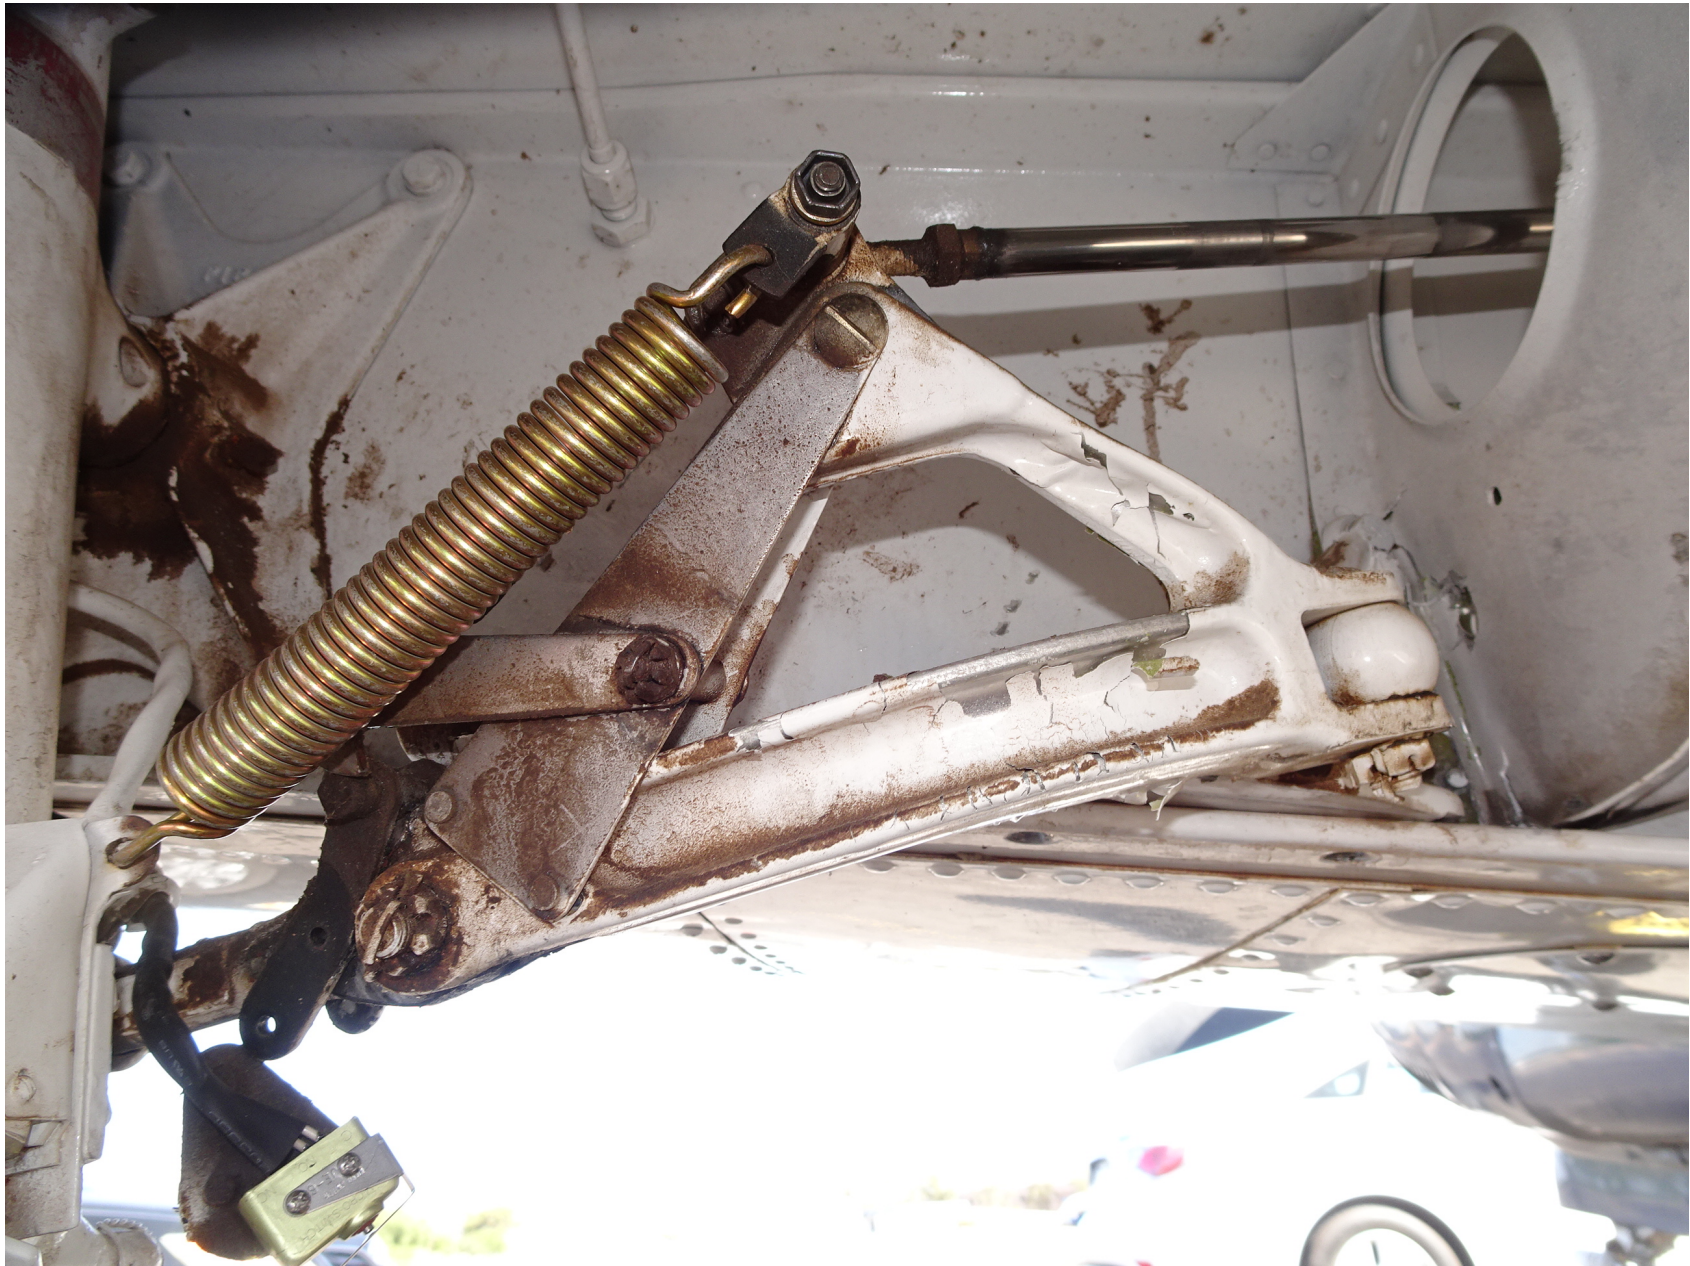
**Photo 3 – Closeup view of bent left main landing gear upper side brace link**
